Technical Memorandum

Subject: County Ditch 60 Repair Project

Date: July 12, 2019

Project: 6255-0011

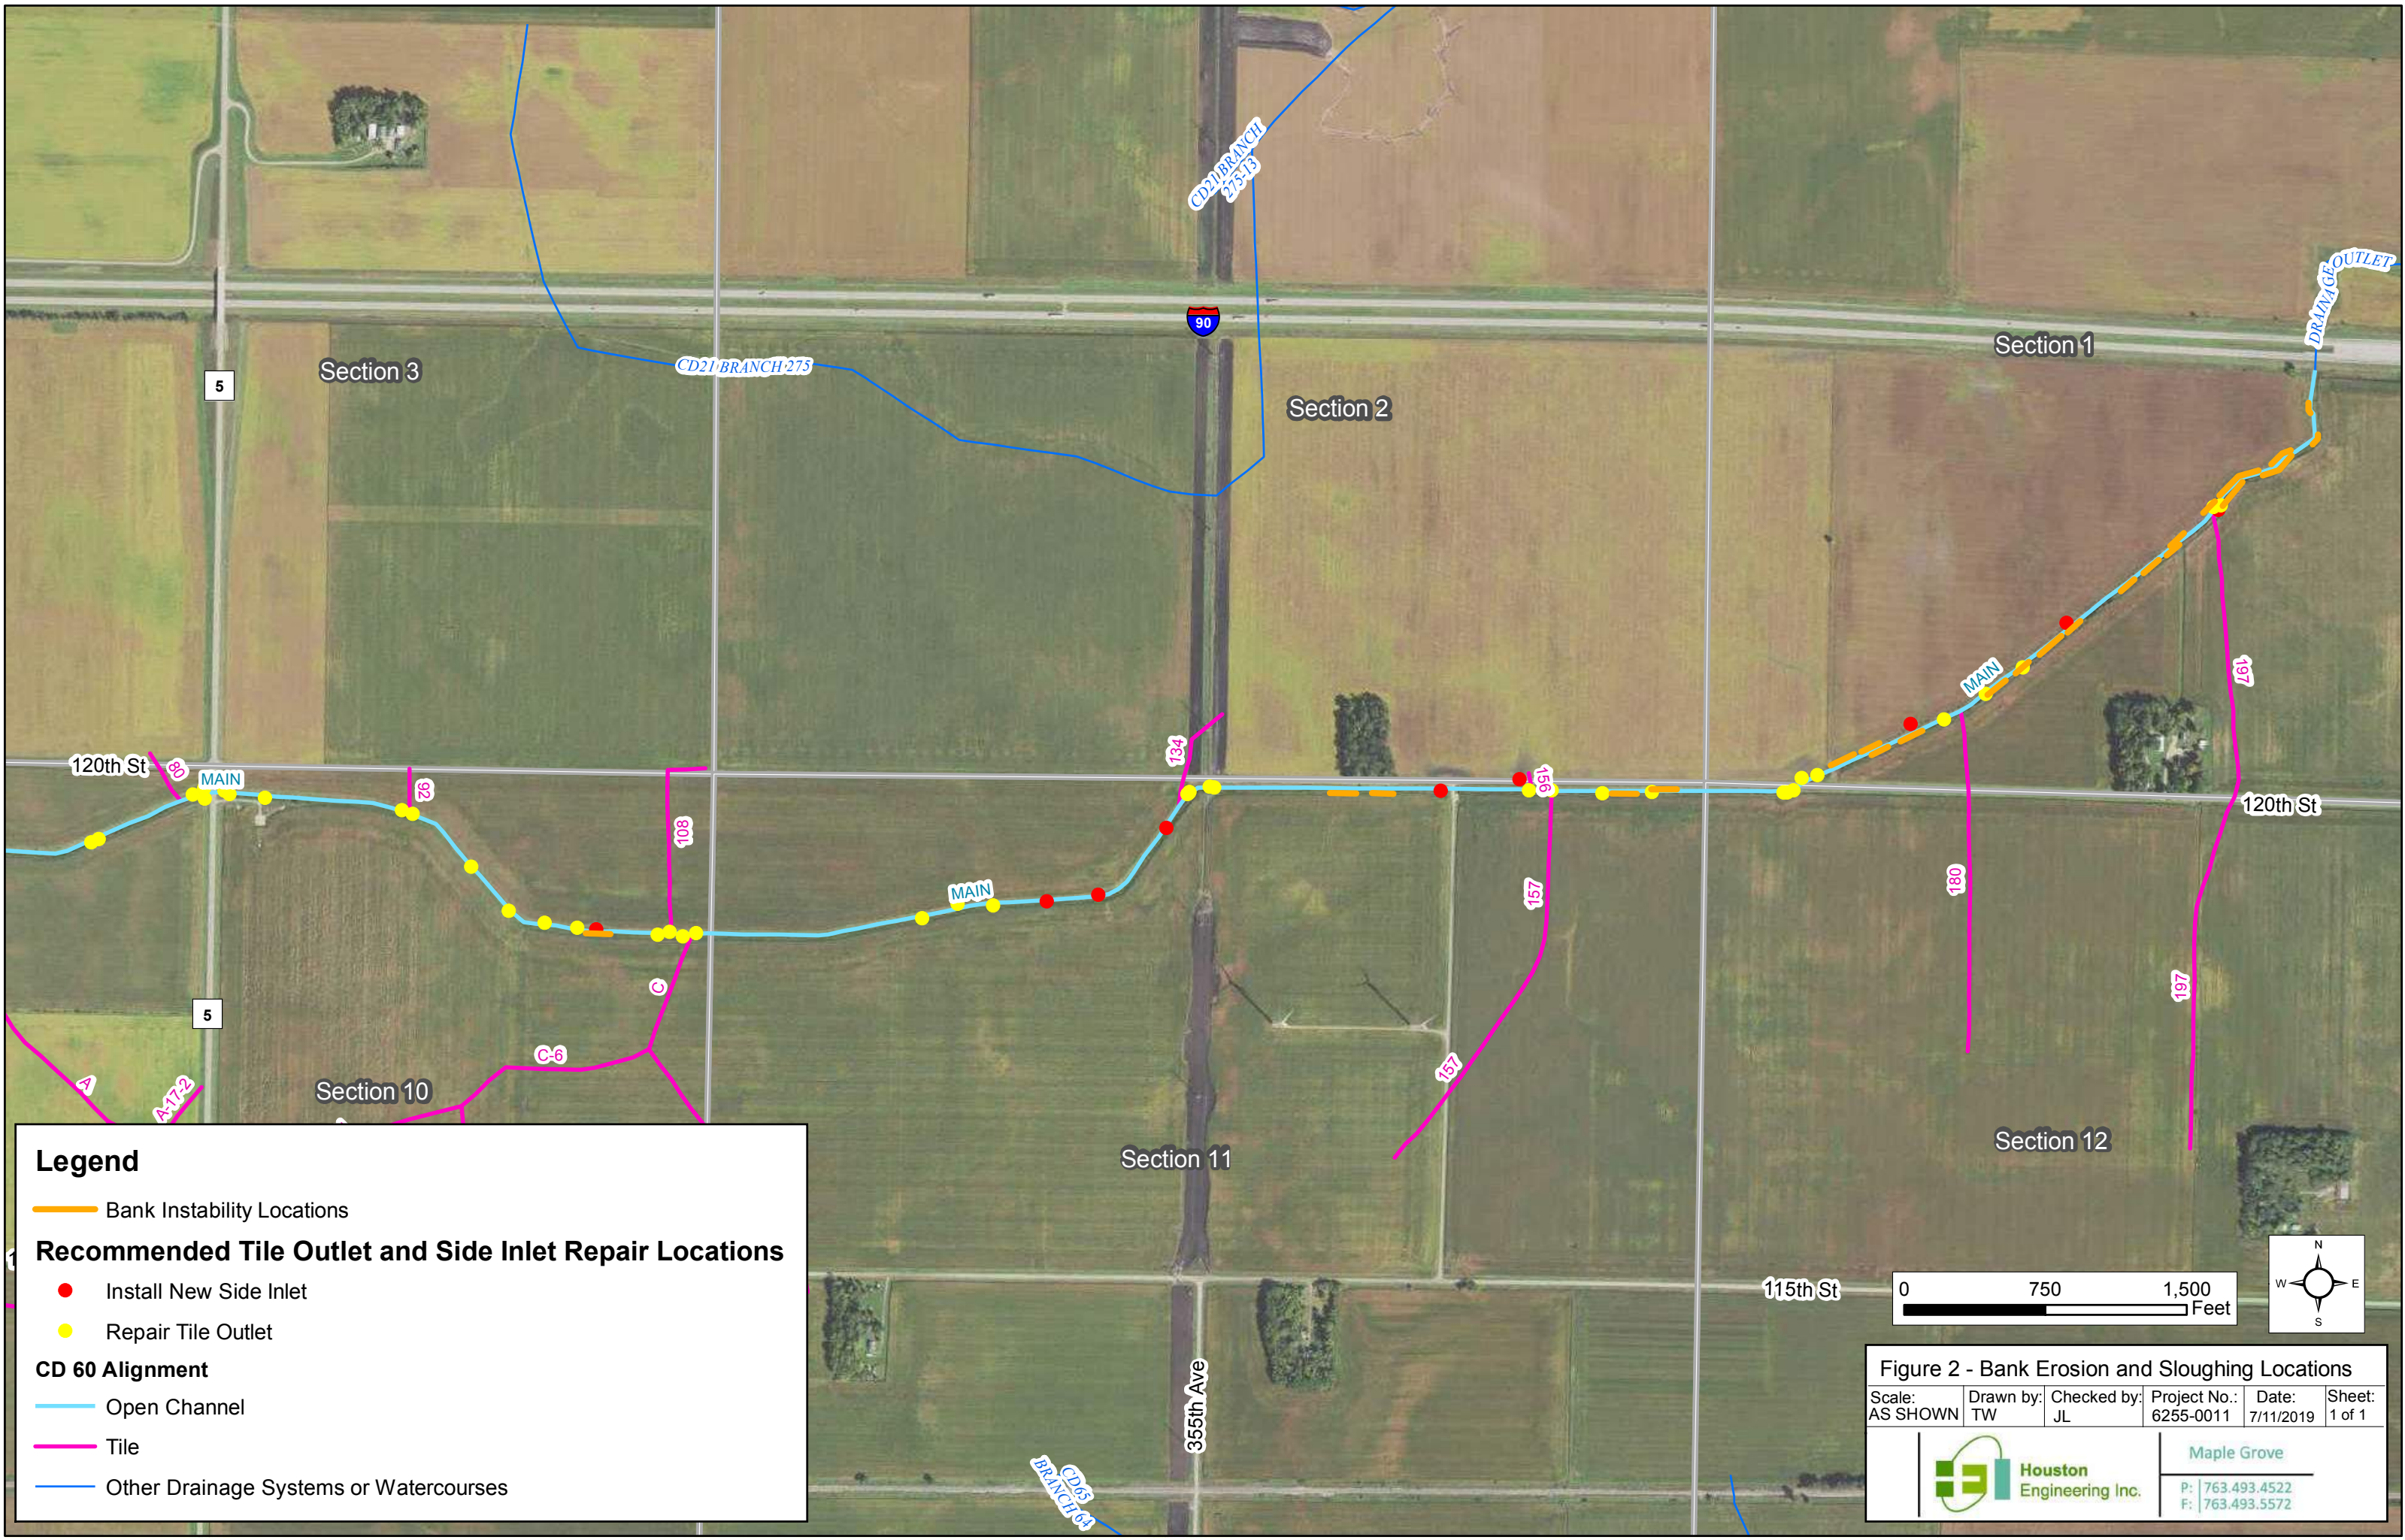
Figure 2 - Bank Erosion and Sloughing Locations

Along the open channel ditch, there are numerous tile outlets from both private and public laterals. Many of these outlets have caused bank erosion by discharging onto the unprotected channel bank or the tile itself is in poor condition. There are also several locations where bank erosion is being caused by concentrated surface flow entering the open channel from adjacent fields. These locations are adding sediment to the ditch which is reducing the functionality of the ditch and reducing downstream water quality. **Figure 2** shows a map of the locations.

Additionally, there is bank sloughing along some portions of the open channel. The most widespread and severe sloughing is located between I-90 and 120th Street. Bank sloughing leads to a widening of the channel and deposition of sediment in the channel over time impacting the function of the drainage system and contributes to the degradation of water quality downstream. The locations of bank sloughing are shown on **Figure 2**.

This approach seeks to limit repair costs by limiting slope repairs to the locations currently experiencing channel bank instability. Based on the field survey, approximately 3,000 linear feet of channel bank should be repaired, as shown on **Figure 2**. For those segments, the side slopes should be flattened from a 1.5:1 to a 2:1 slope, and vegetation should be rapidly reestablished by seeding and installing erosion control blanket or hydromulch. This work will likely require the acquisition of right-of-way for the widened channel top-width and temporary damages for spoil placement. An additional option with this approach is to install riprap to protect the toe and thereby prevent bank sloughing further up the bank slope. This protection measure is more commonly applied in more isolated bank instability locations. A downside of installing riprap is that it can create difficulty for future routine maintenance to remove accumulated sediment. The cost of riprap is not included in the preliminary opinion of probable construction cost.

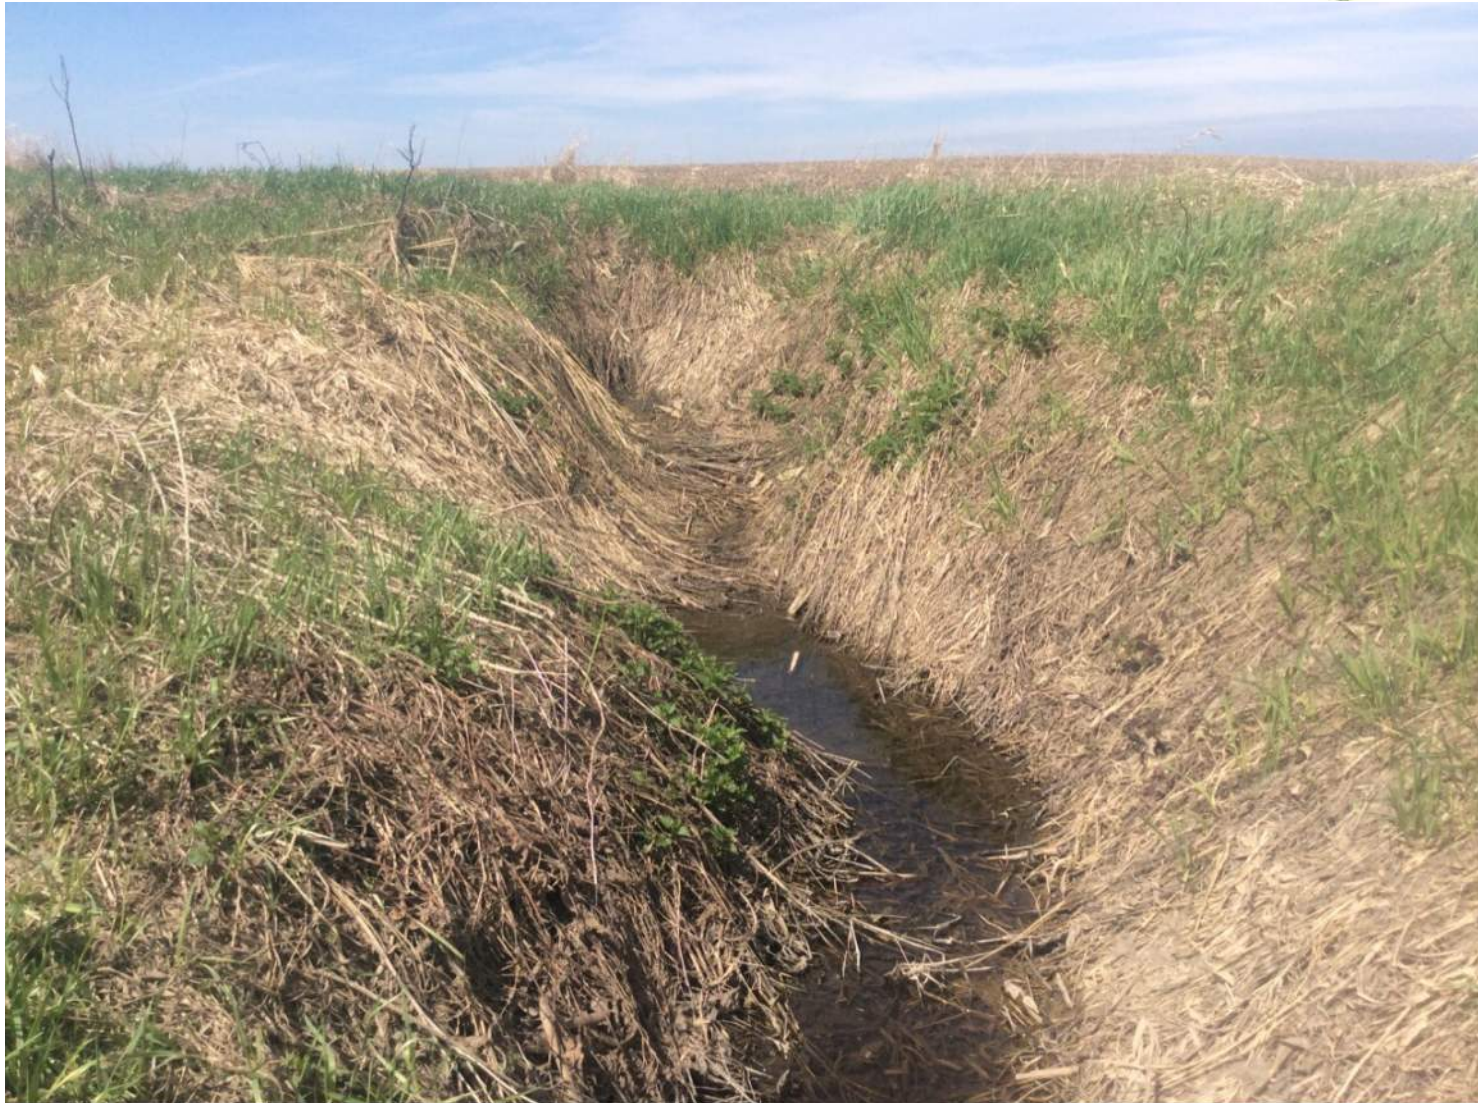
Field Survey Photograph 1: Eroded Bank at Station 6+00

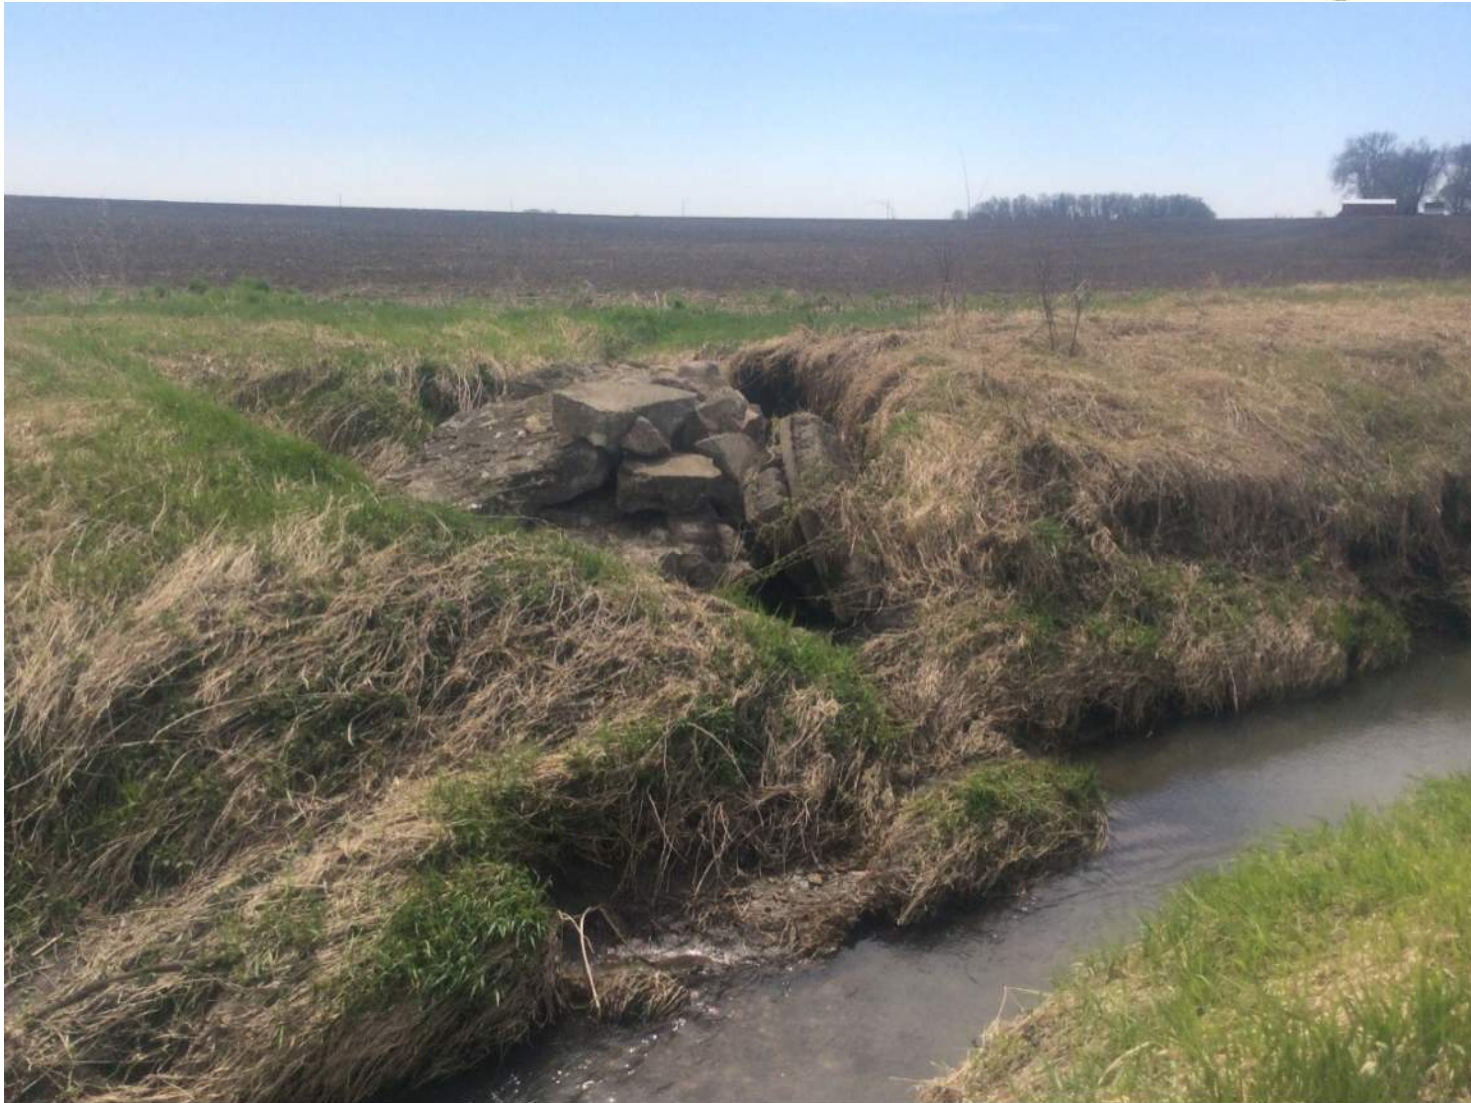
Field Survey Photograph 2: Eroded Bank and Fill at Station 10+50

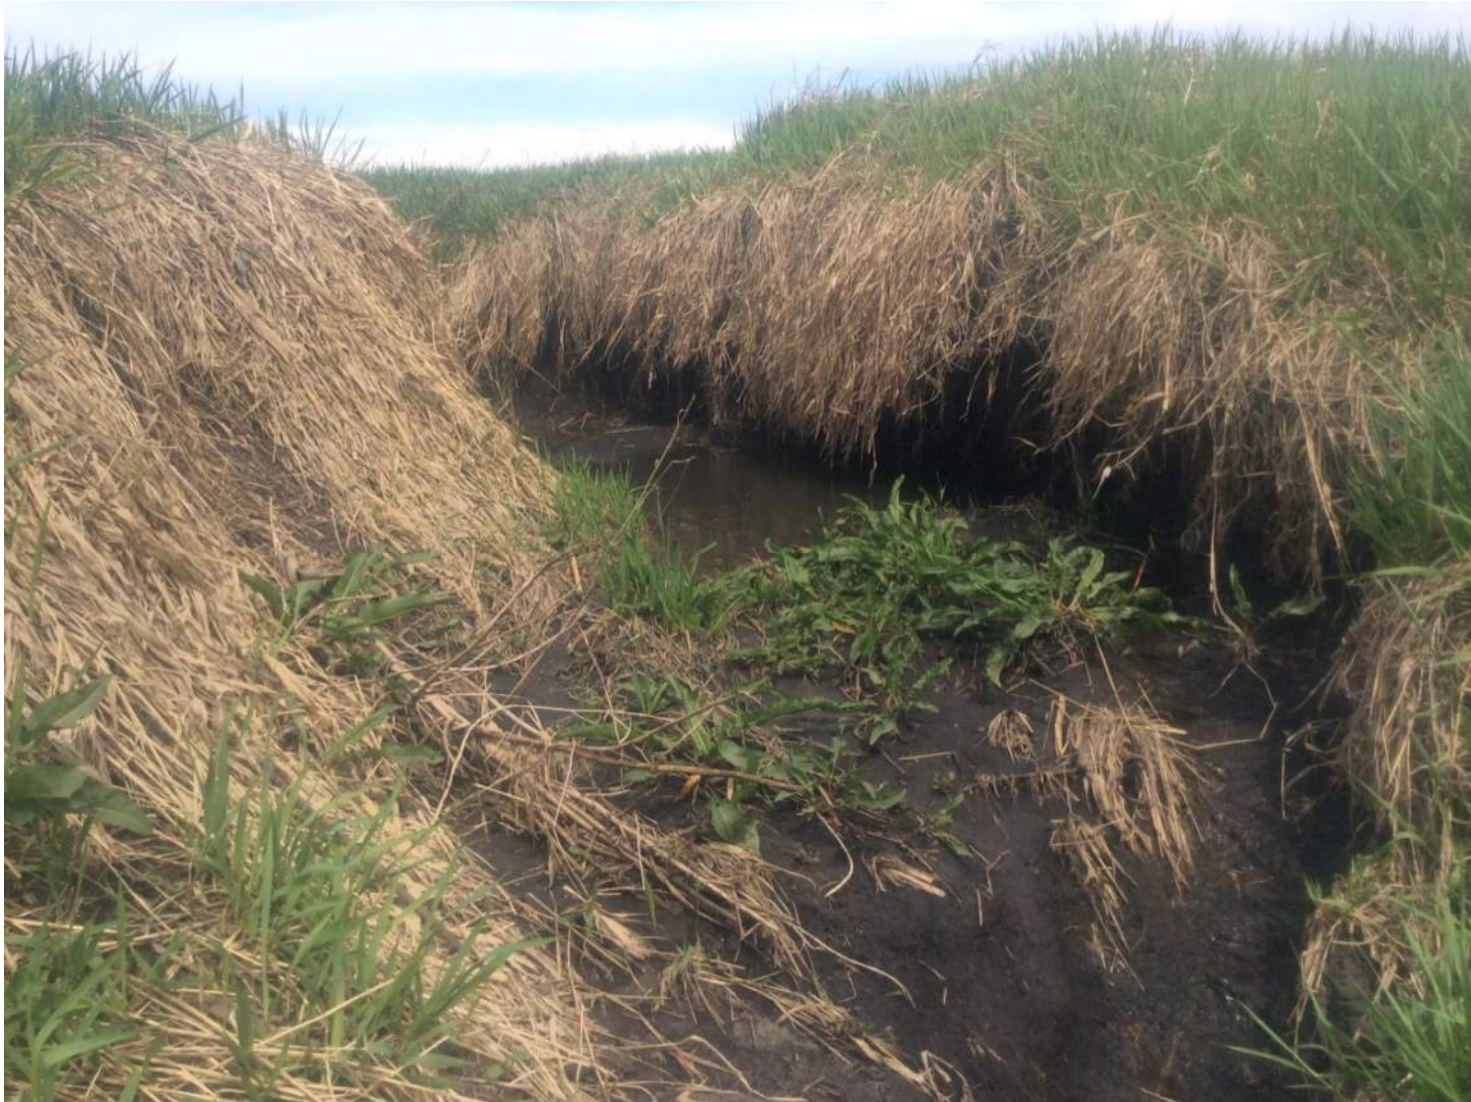
Field Survey Photograph 3: Eroded Bank at Station 18+00

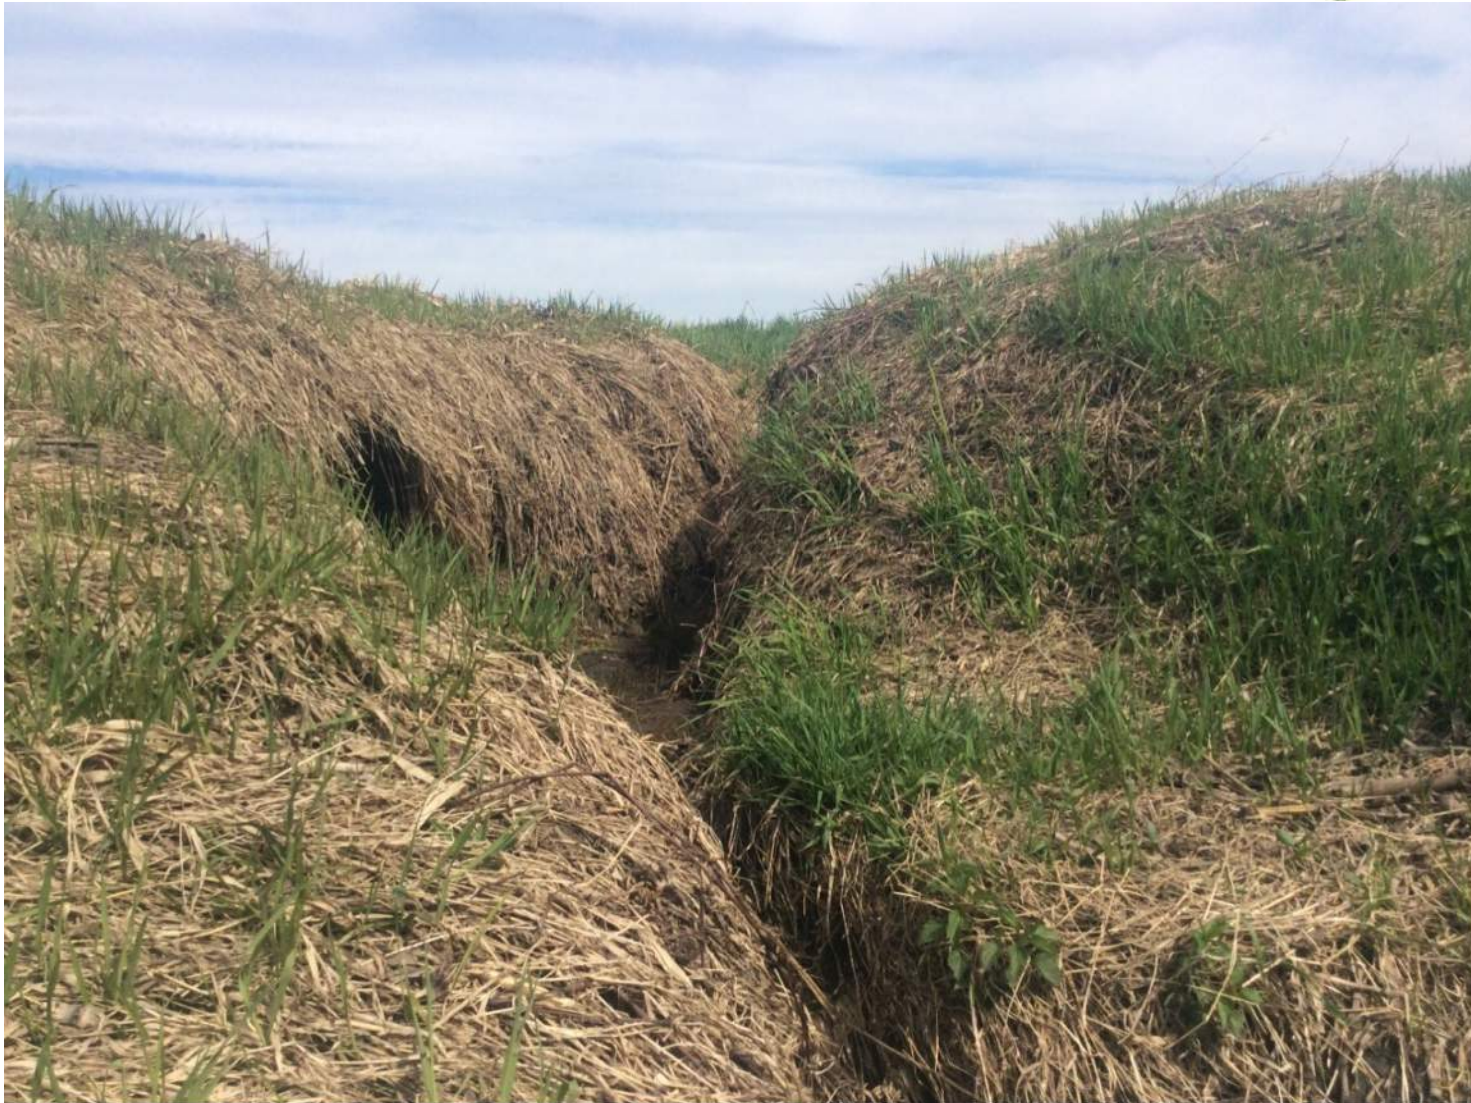
Field Survey Photograph 4: Eroded Bank at Station 30+00

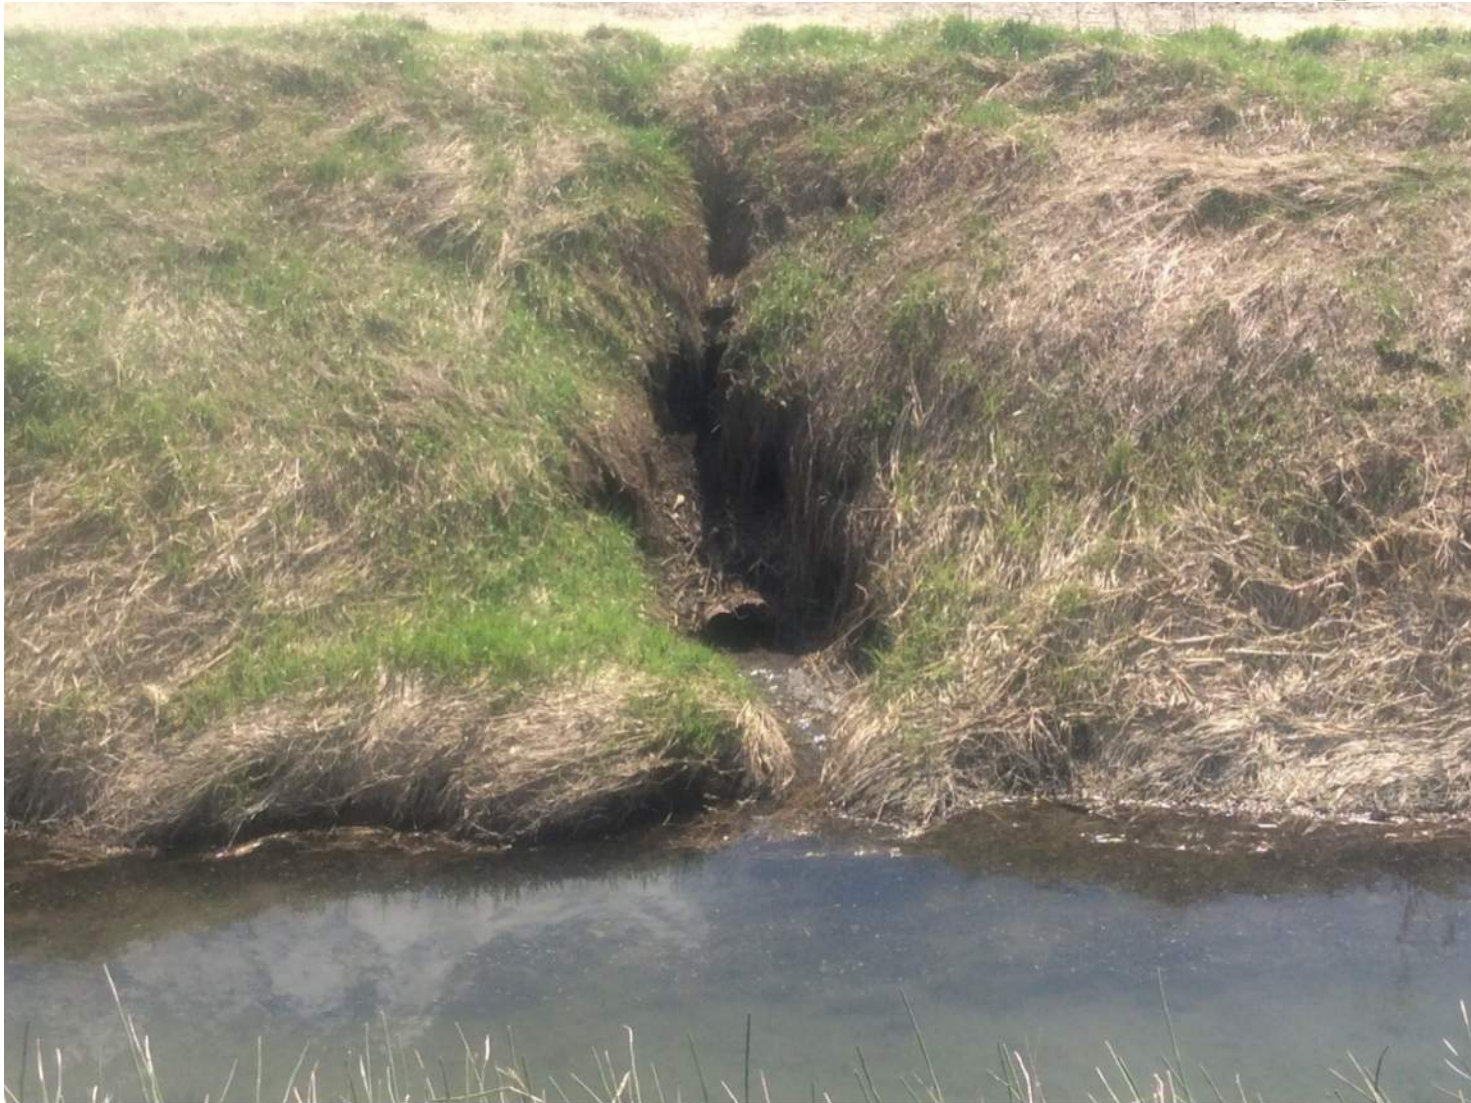
Field Survey Photograph 5: Erosion and Side Inlet at Station 45+50

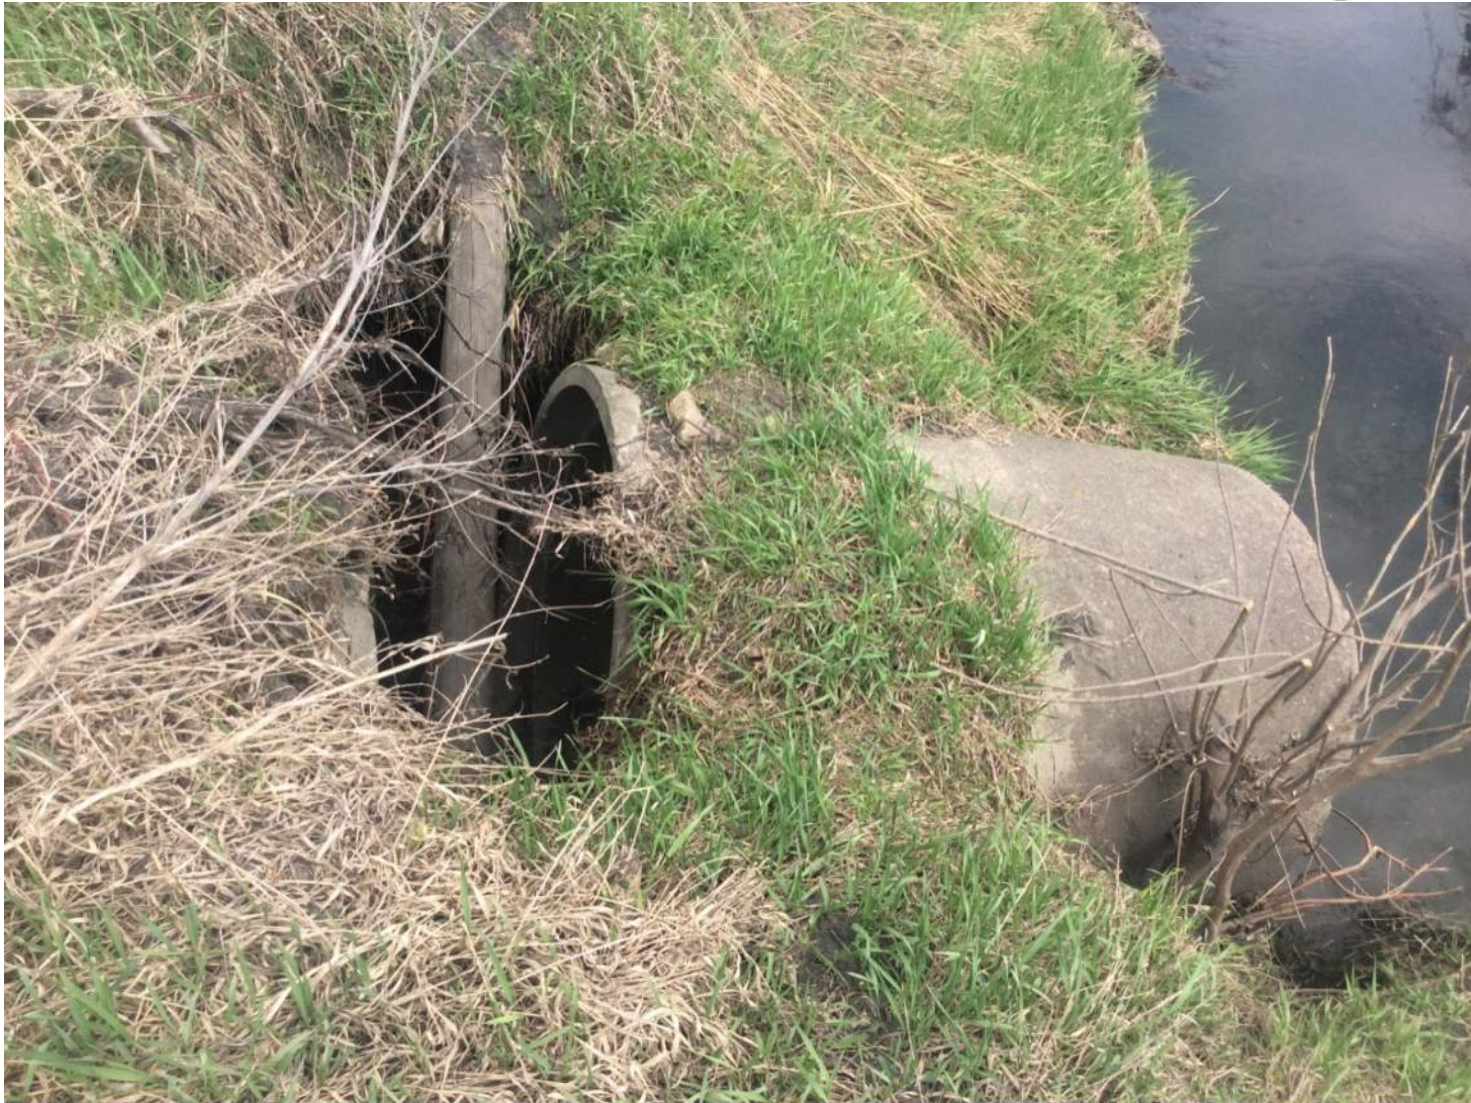
Field Survey Photograph 6: Broken 42" RCP at Station 69+00

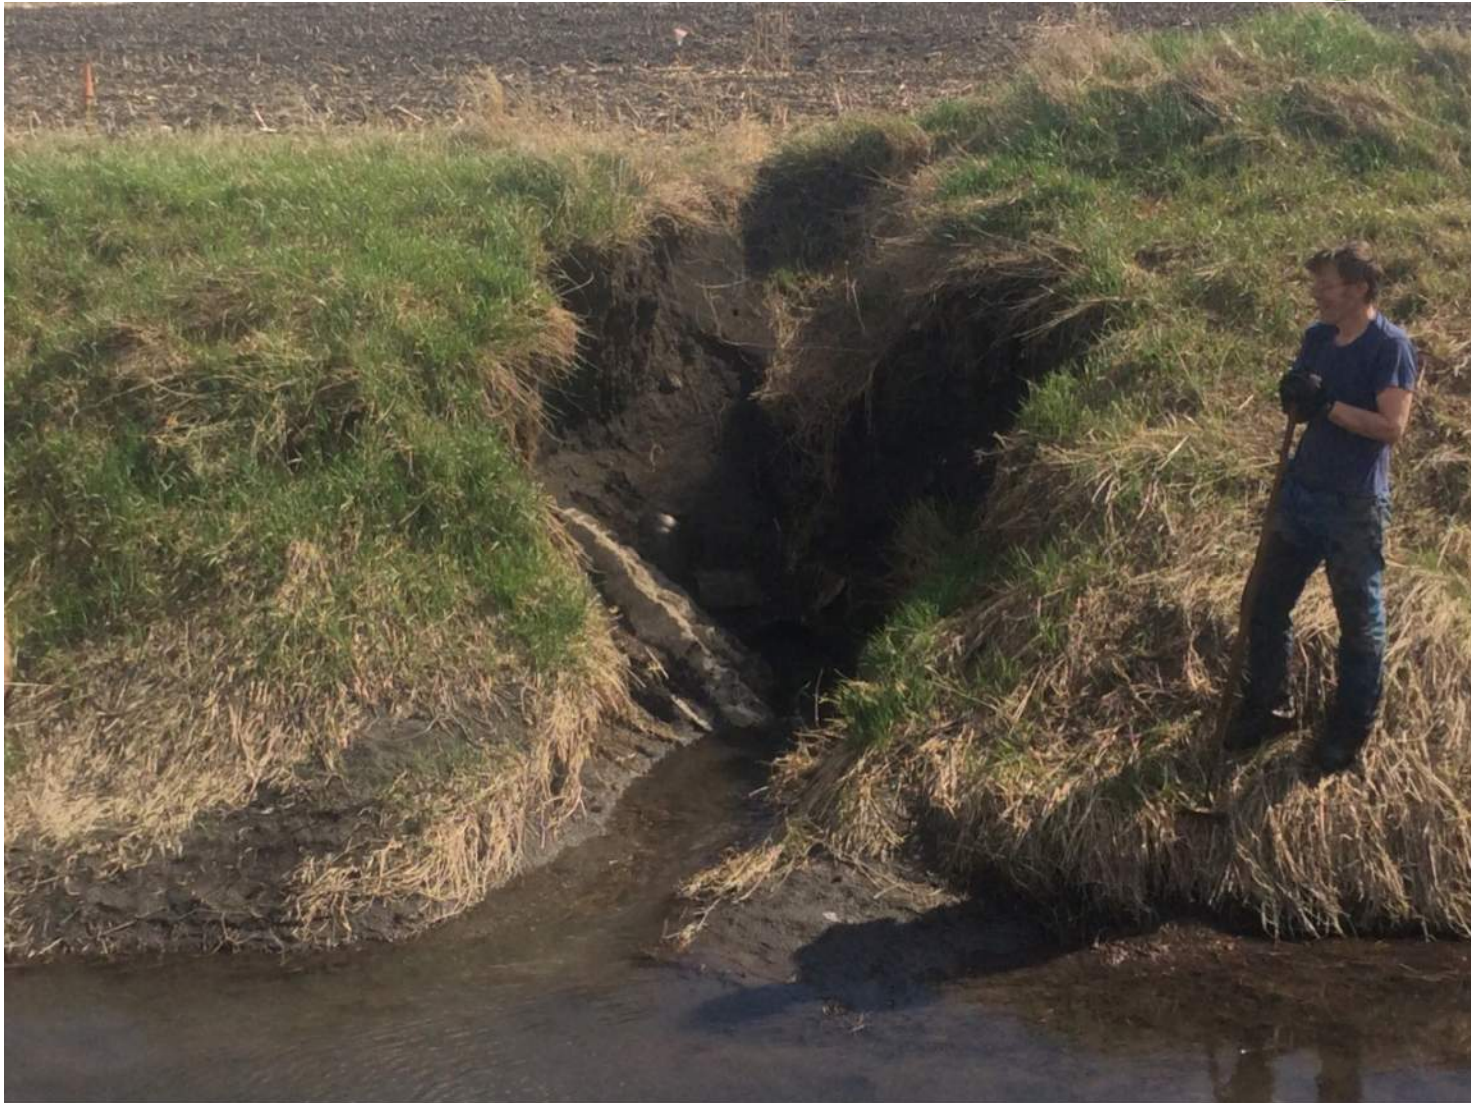
Field Survey Photograph 7: 12" RCP Drain tile Outlet and Eroded Bank at Station 100+00

Bank erosion occurring from tile outlets, side inlets and surface flow also need to be addressed. Specifically, rip rap is recommended to be installed at the outlets to prevent further erosion. Furthermore, where the tile pipe is or close to deteriorating to a condition where it may fail in the near future, it is recommended that the last 20-feet of pipe be replaced with Corrugated Plastic Pipe (CPP) of the same size. This will extend the life of the tile and decrease the likelihood that a failed outlet will impact upstream drainage. Likewise, we recommend that a drop inlet be installed at locations where erosion is being caused by surface flow into the channel from adjacent fields.

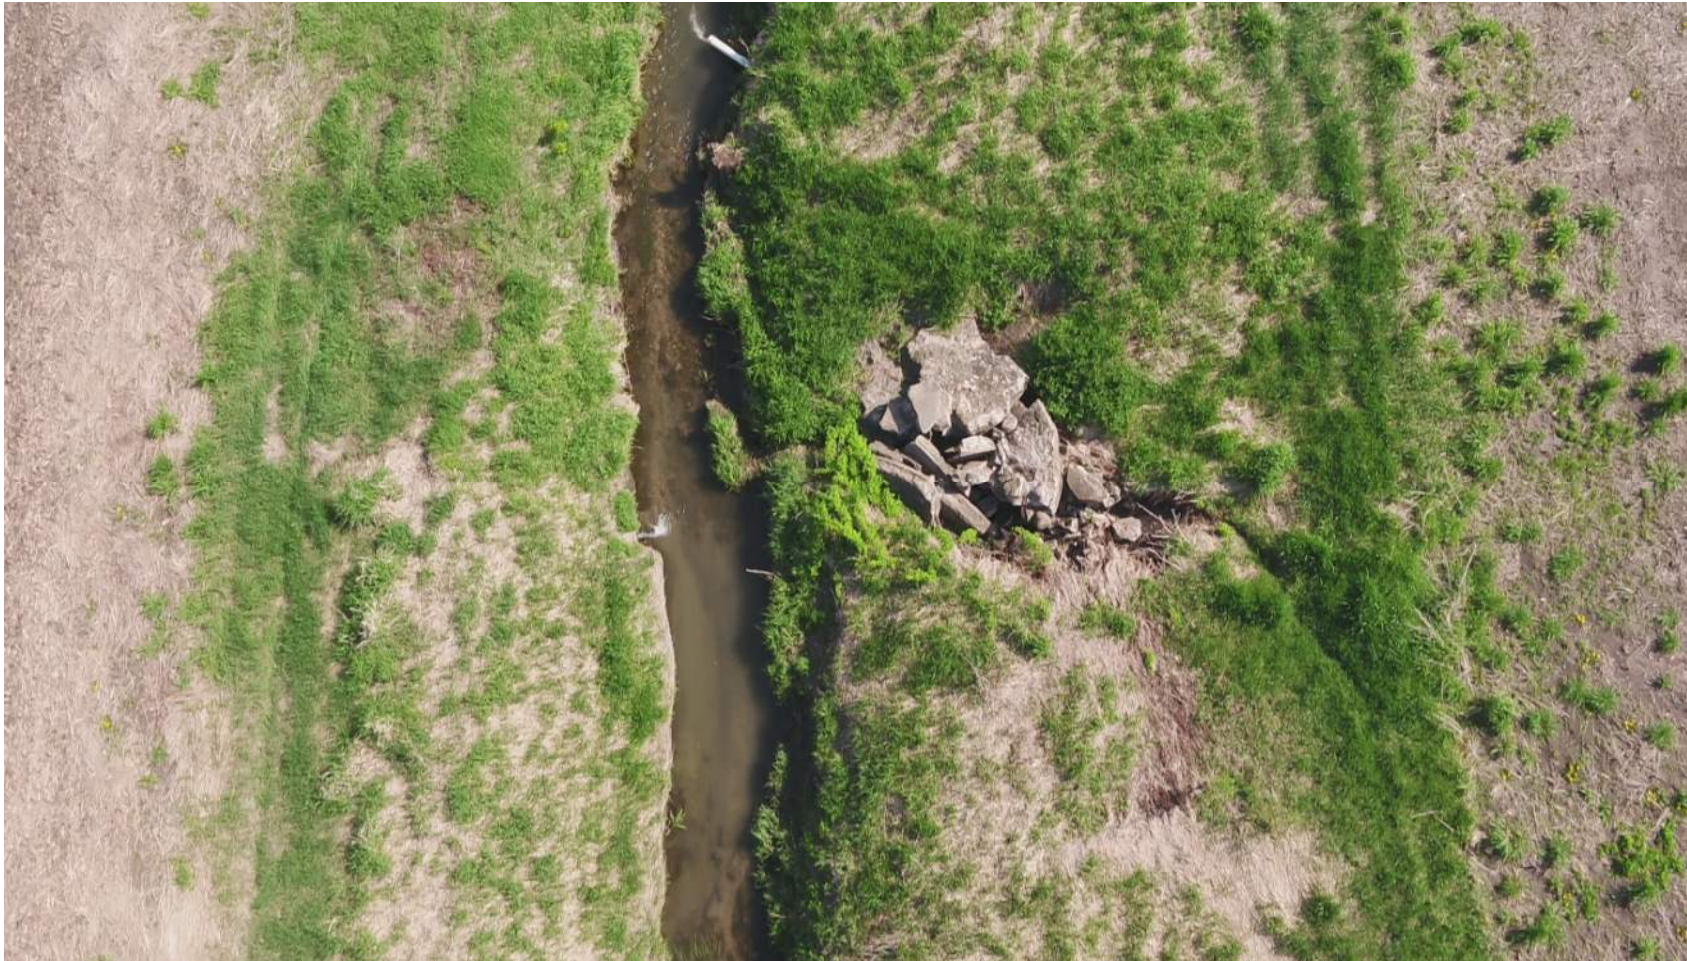
Drone Survey Photograph 1: Eroded Bank and Fill at Station 10+50

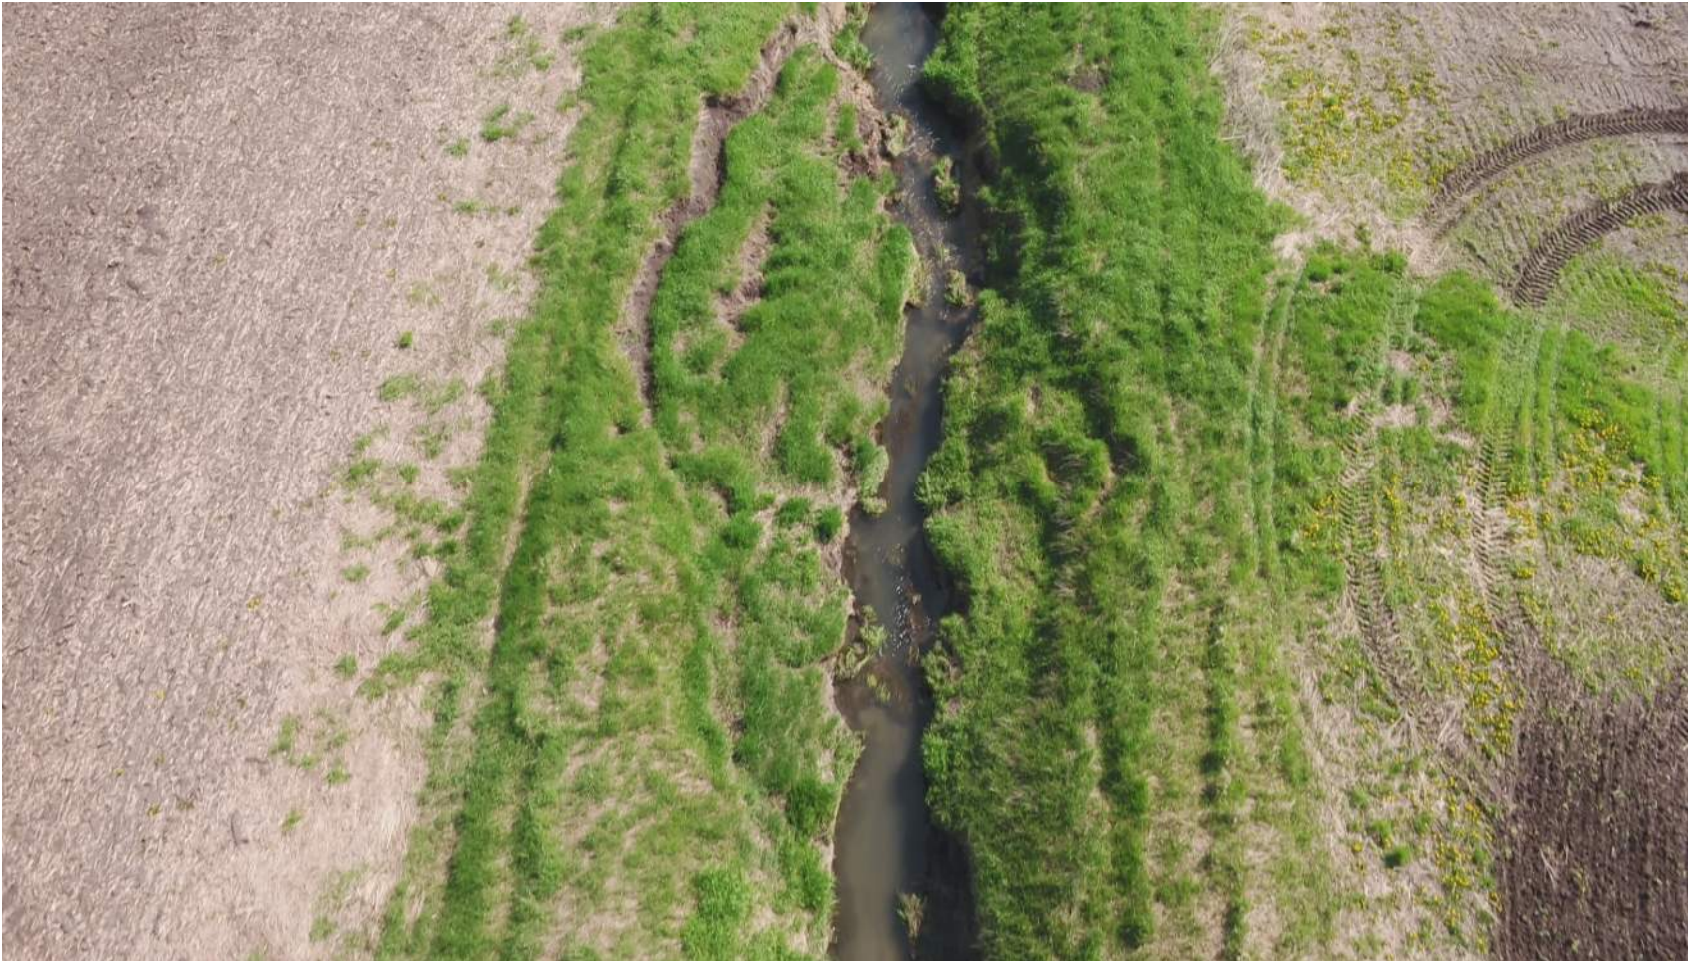
Drone Survey Photograph 2: Sloughed Bank at Station 14+00

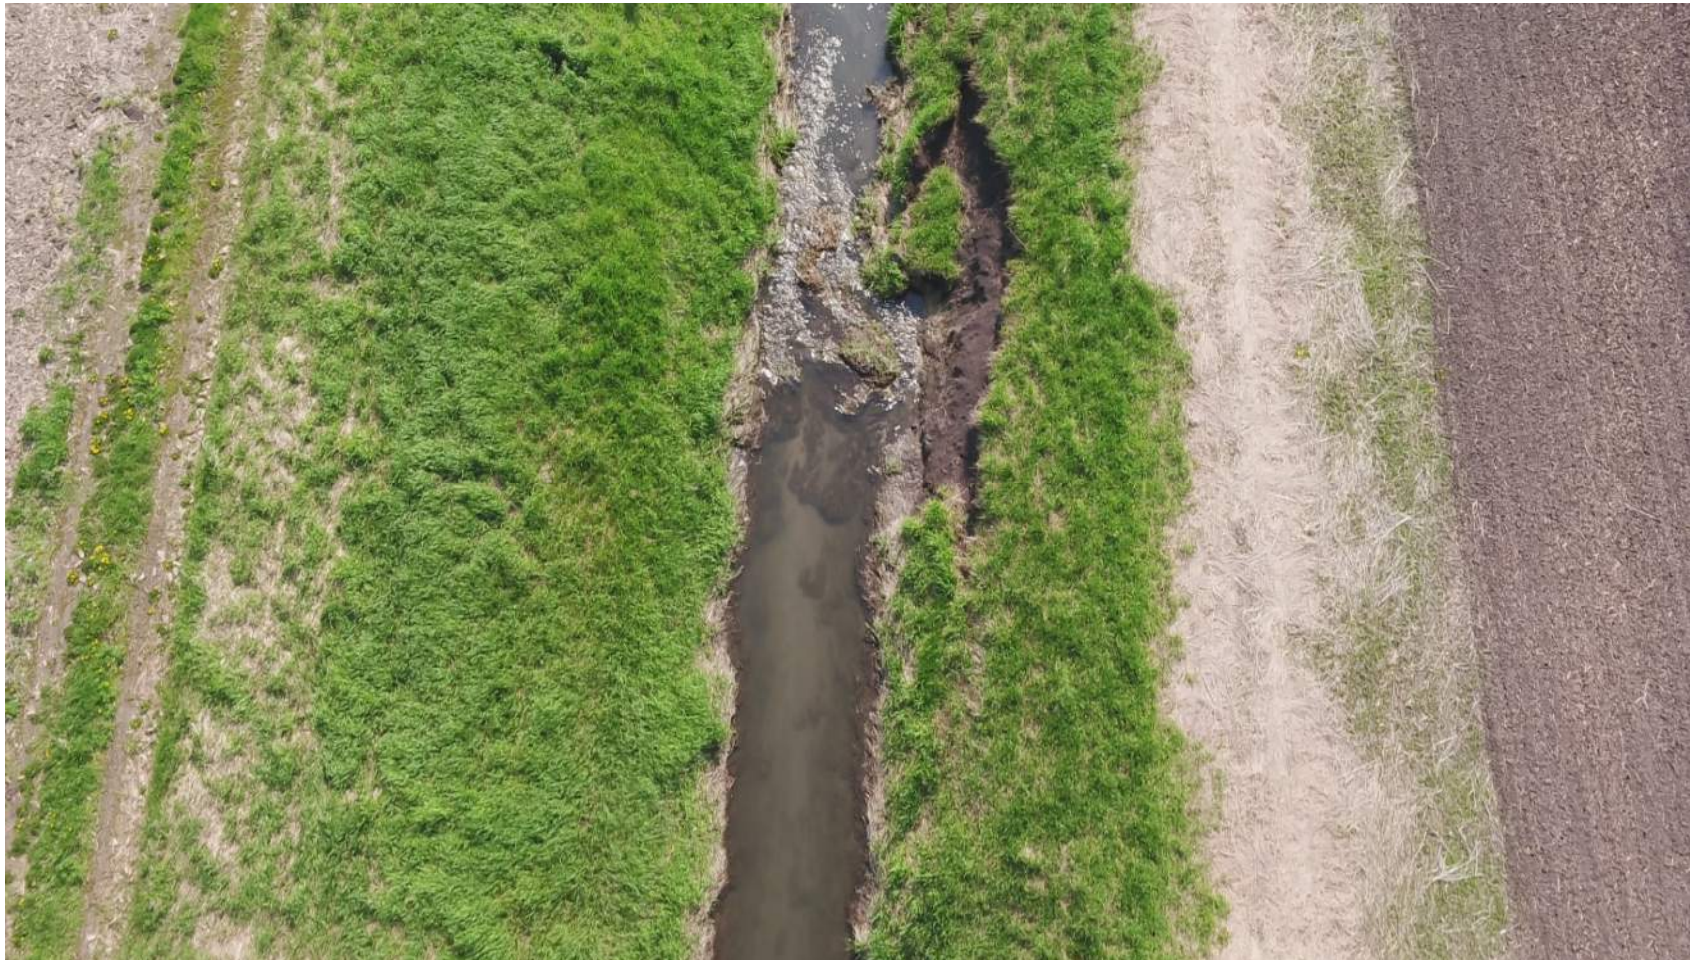
Drone Survey Photograph 3: Sloughed Bank at Station 46+00

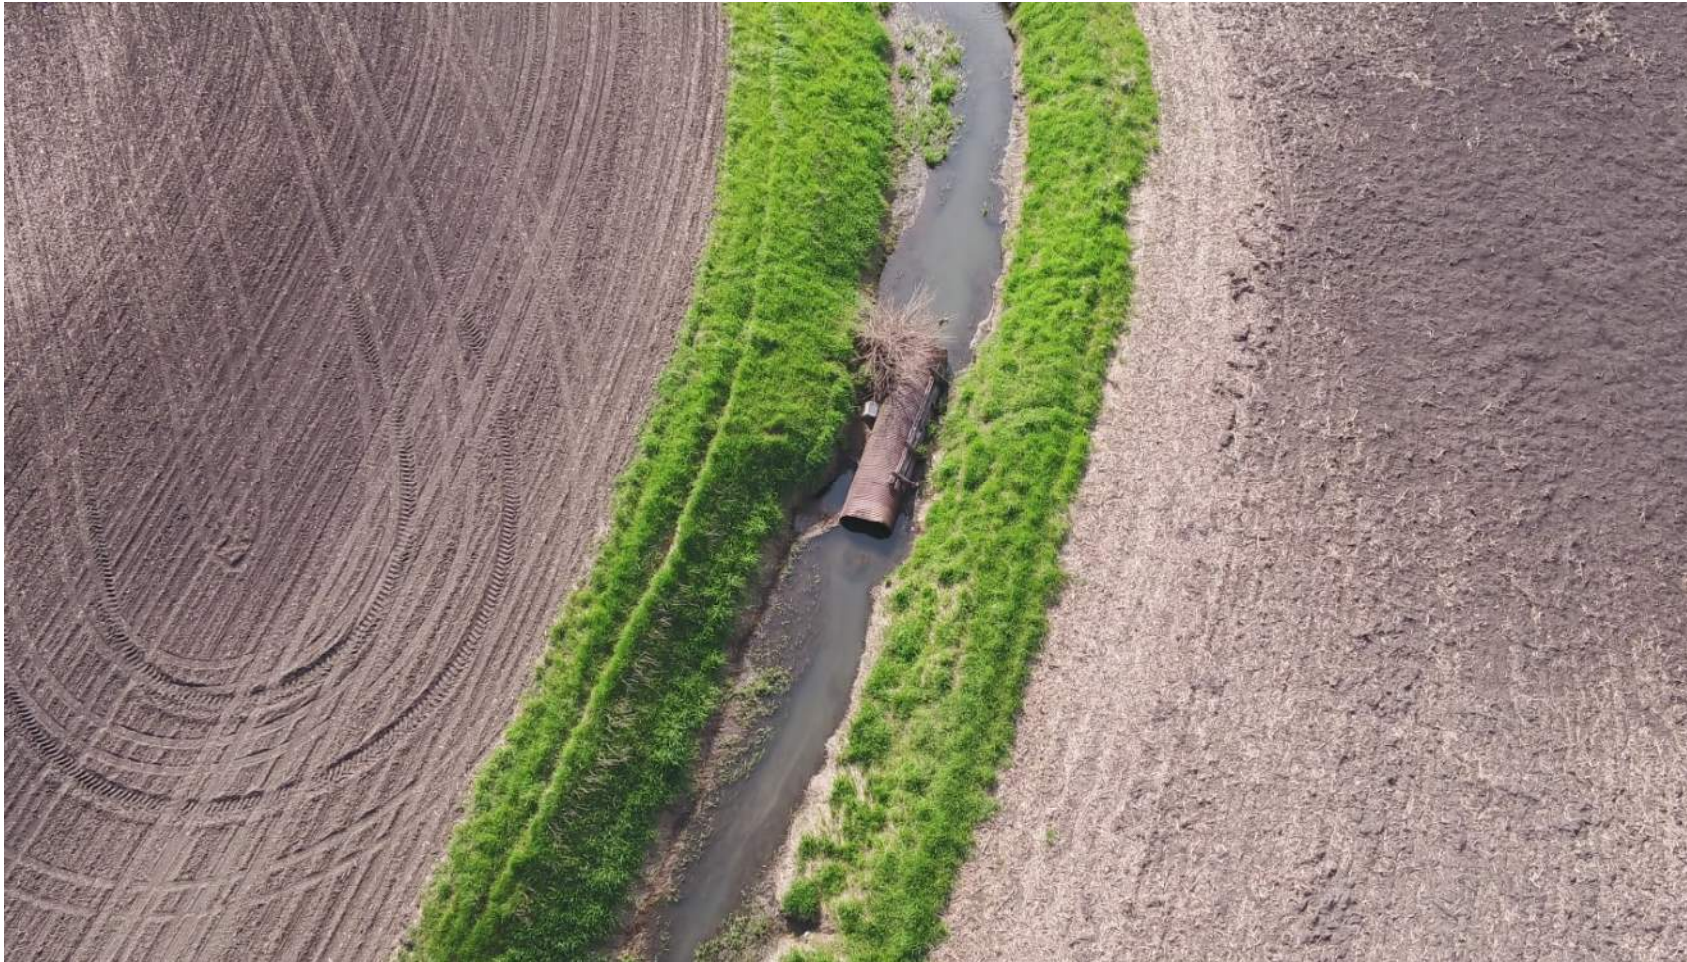
Drone Survey Photograph 4: Removed Field Crossing and Culvert Obstruction at Station 109+00
