Technical Memorandum

Subject: County Ditch 60 Repair Project

Date: July 12, 2019

Project: 6255-0011

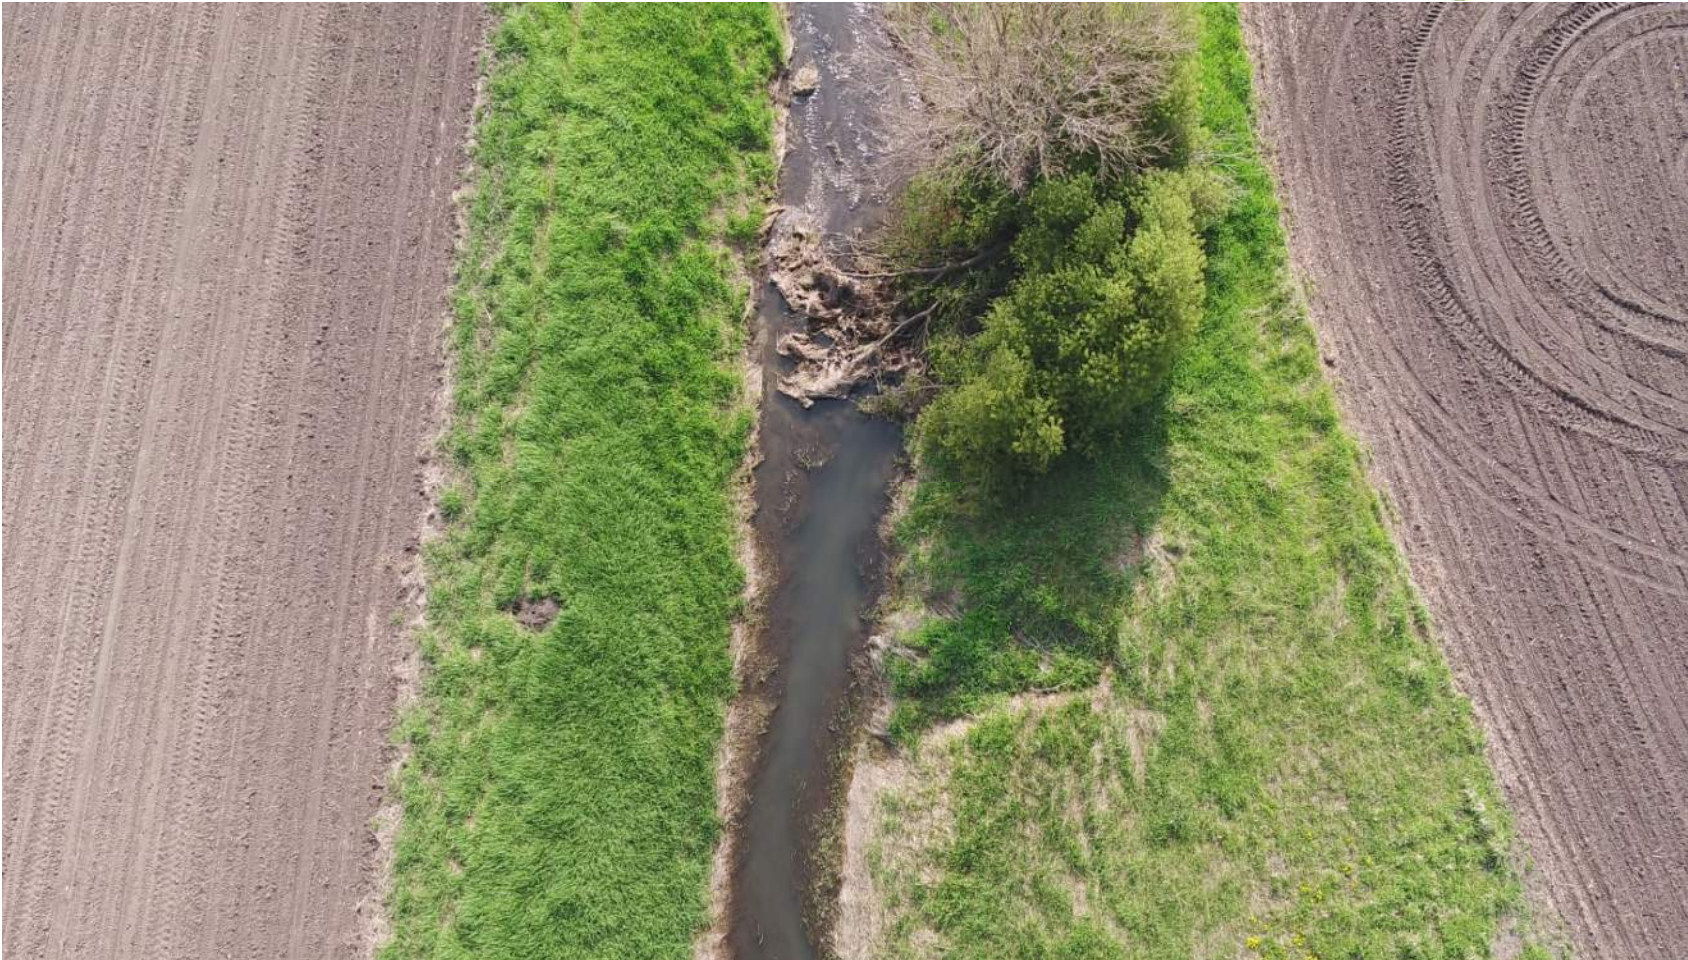
Drone Survey Photograph 5: Tree Obstruction at Station 121+00
