Faribault County, Minnesota

County Ditch #14

Repair Report

CD14 Open Ditch Repair Report

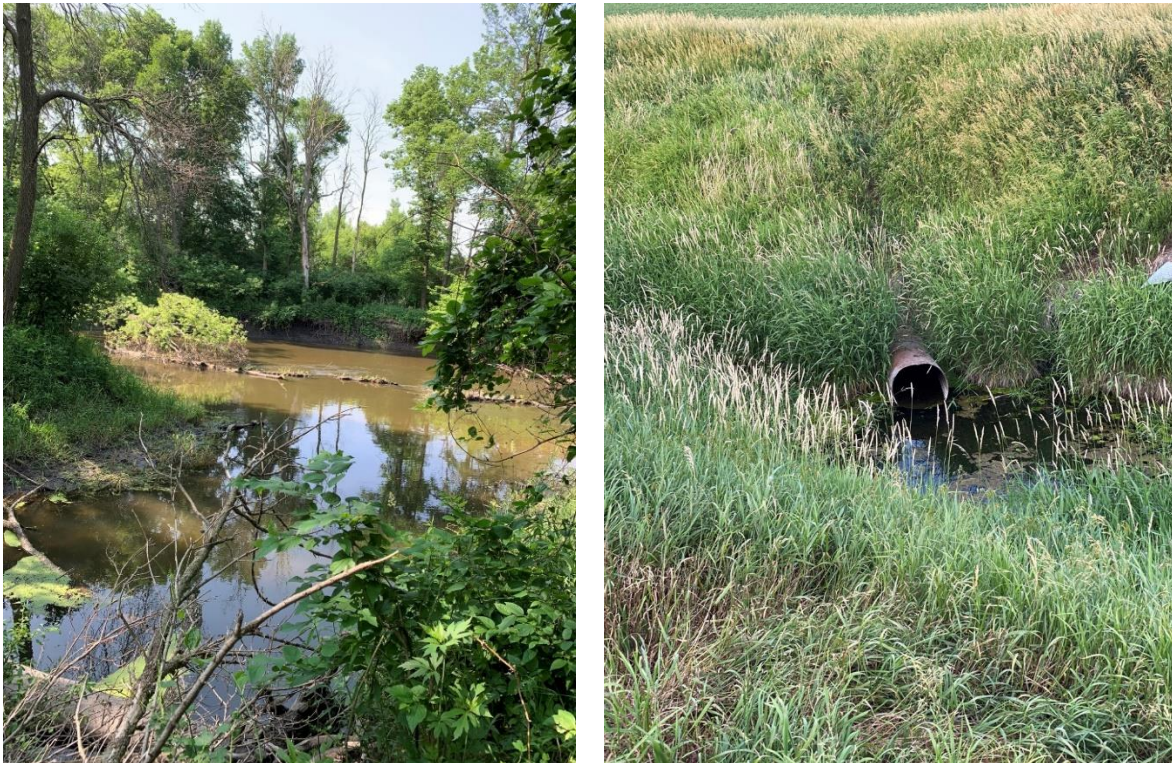
Figure 1. The outlet of CD14 to the East Branch Blue Earth River (left) and a branch of CD14 outlet into the expanded open ditch (right).

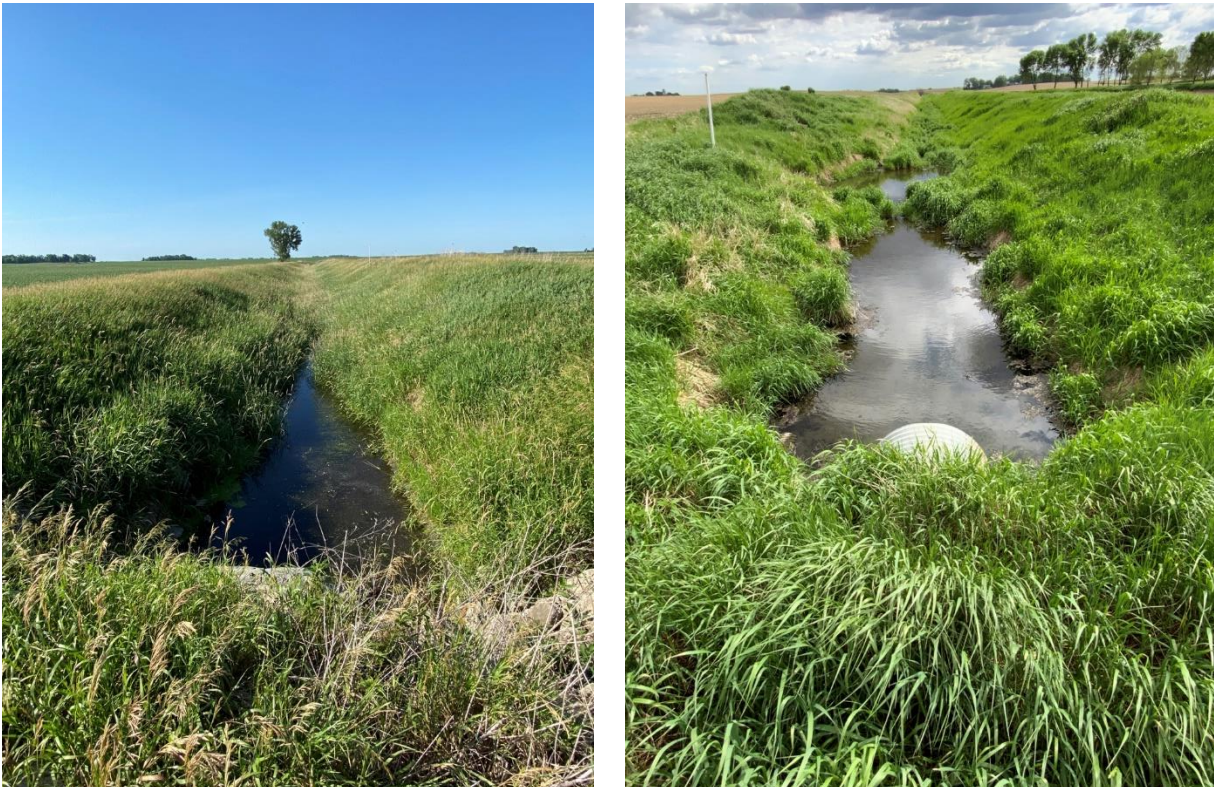
Figure 2. The channel condition of the top end of Branch A/B (left) and the Main (right) open ditch. Sediment has accumulated in the channel in the upper reaches of both branches, impacting drainage.

Open Ditch Cleaning: Remove sediment from the channel according to the open ditch profiles and level spoils. Seeding of buffer strips to be completed by a separate contractor, however buffer strips must fit for seeding.

1. Main Open Ditch Station 152+00 to 279+00
2. Branch A Station 13+00 to 94+00
