# REPAIR REPORT FOR:

## COUNTY DITCH NO. 24 REPAIR: FAIRBAULT COUNTY, MINNESOTA

JUNE 14, 2021

Project No. 19-23499

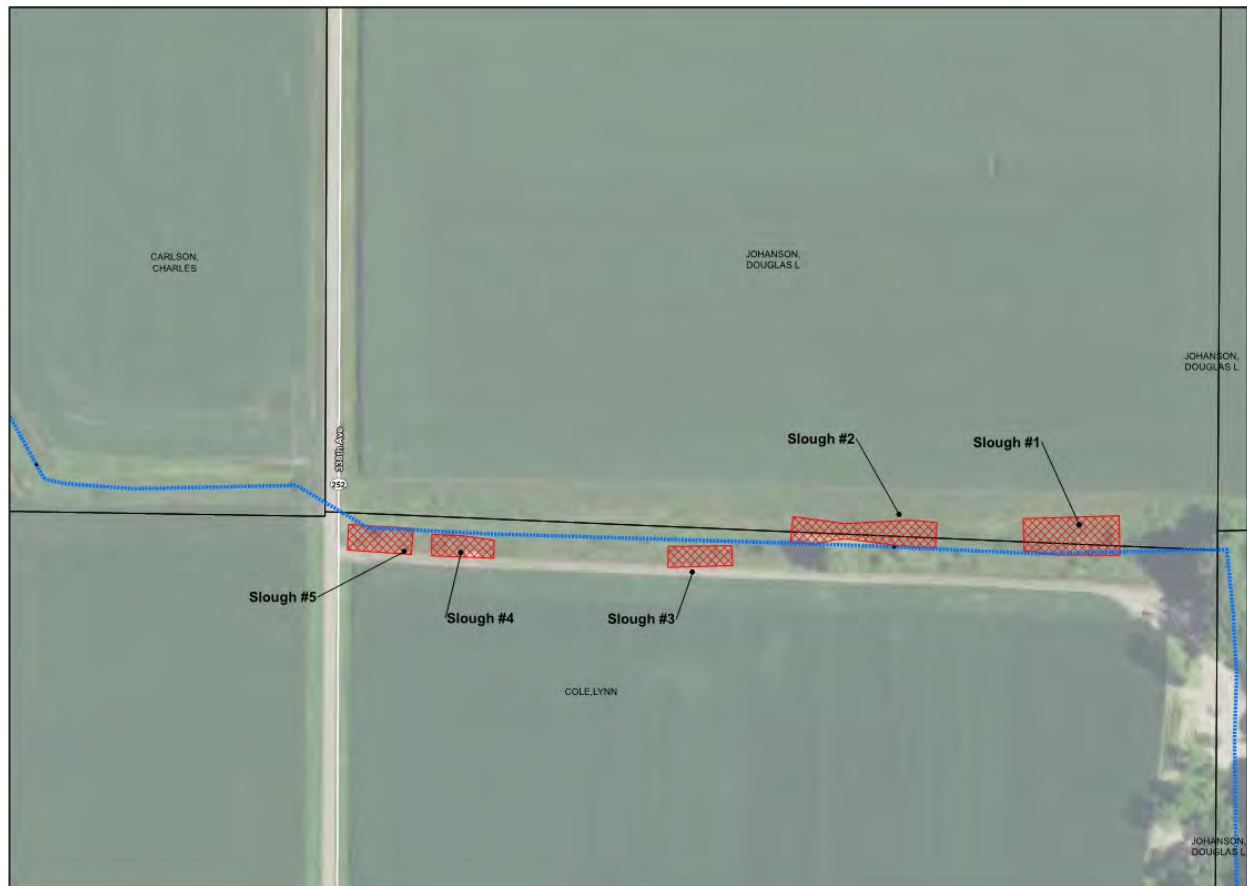
*Figure 1: Slough Locations*

The sloughs range in size and severity, and the repairs to each slough will be addressed individually. The sloughs recommended to be repair have been numbered 1 through 5. A Slough Location map in Appendix C displays the location and extent of each slough. The slough repair areas were identified as slough that have potential for causing major flow restrictions, sediment export to downstream waters, bank instability, or potential for loss of farmland adjacent to open ditch. Areas that have naturally stabilized will not be addressed in the repair as it may cause more harm than benefit to disturb stabilized areas.

Slough #5 is located on the south side of the ditch directly downstream of 338<sup>th</sup> Avenue. The landowner uses this area as a field access and due to sloughing is in jeopardy of damage. There is minor sloughing near the top of the ditch side slope. To be proactive in protecting the field access from erosive flows from the 338<sup>th</sup> Avenue, erosion control blanket will be installed near the top of the ditch and riprap will be installed at the toe. The riprap will help to stabilize and prevent any further sloughing into the open ditch.

Slough #1, #2, #3, and #4 will be repaired with a bench side slope slough repair where the bench will be near the toe of the ditch. The benched side slope slough repair will create a more stable design for the open ditch. The bench is placed at the toe for these repairs because the sloughed material has naturally formed a bench at this location. The existing edge of buffer will remain in the same location therefore no land acquisition is expected. However, excavation from the repair will expand out into the adjacent fields which will require temporary damages. The buffer will be lowered down to take pressure off of the side slope and toe of ditch. The slide slopes will be flattened to 2:1 or 3:1 side slope ratio depending on the existing side slope ratios. Once the naturally formed bench elevation is reached, the side slope will merge into it. The bench widths will differ throughout each slough repair. Riprap will be placed at the bench to ensure there isn't any additional sloughing in the future and protect the toes from the high velocity flows.

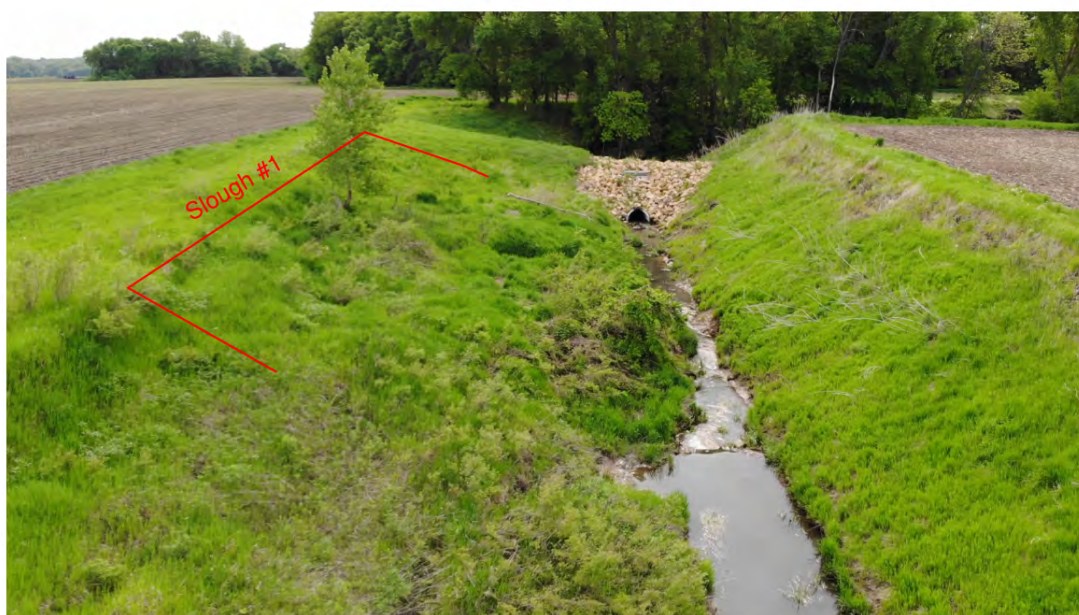
Figure 2: Slough #1 viewing downstream

There are multiple areas in the open ditch portion of CD24 on the east side of 338<sup>th</sup> Avenue that are having bank failures. There are several sloughed areas which are causing material to fall into the open ditch and are causing or may have the potential for flow restrictions. There has been natural widening of the ditch caused by high, erosive flows and some downcutting in the past; therefore, the landowners directly adjacent to the ditch have lost productive cropland due to erosion and bank failures.

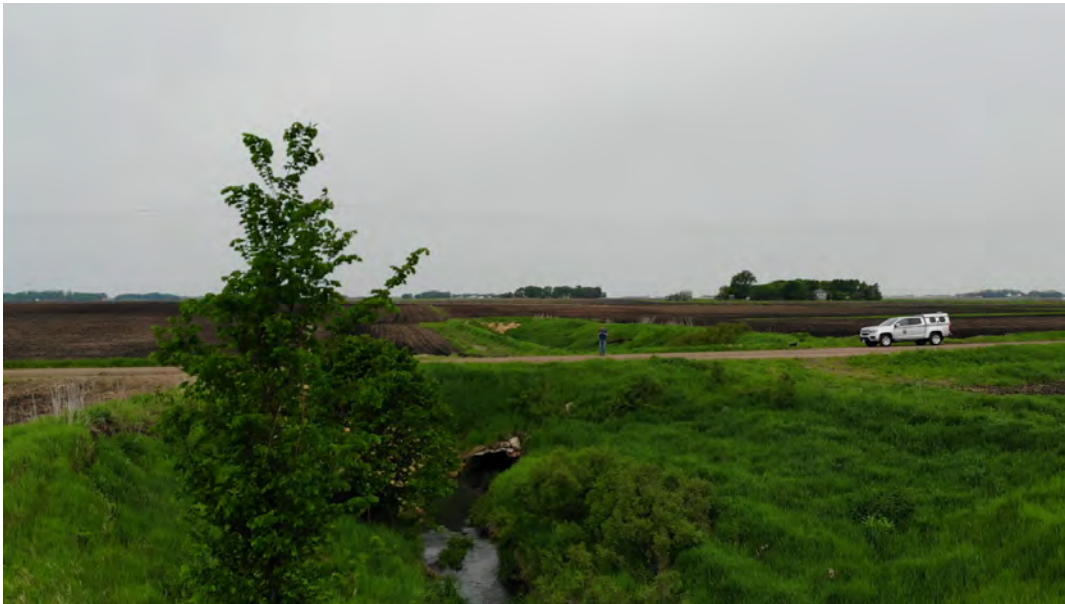
*Figure 12: 338th Avenue Culvert*

The existing 66-inch corrugated metal culvert under 338<sup>th</sup> Avenue connects the CD 24 open ditch diagonally across the road. Due to the angle in which the culvert crosses the road, the outlet on the east side of the culvert causes erosion along open ditch banks. The township has discussed independently to install a bend in the culvert to safely route water to the center of the open ditch and away from the ditch bank. However, this has not been completed to date. Extra rip rap has been added to the Slough #5 repair to add support to the bank and direct flow towards the center of the open ditch.
