Faribault County, Minnesota

County Ditch #37

Staff Repair Report

CD 37 Open Ditch Repair

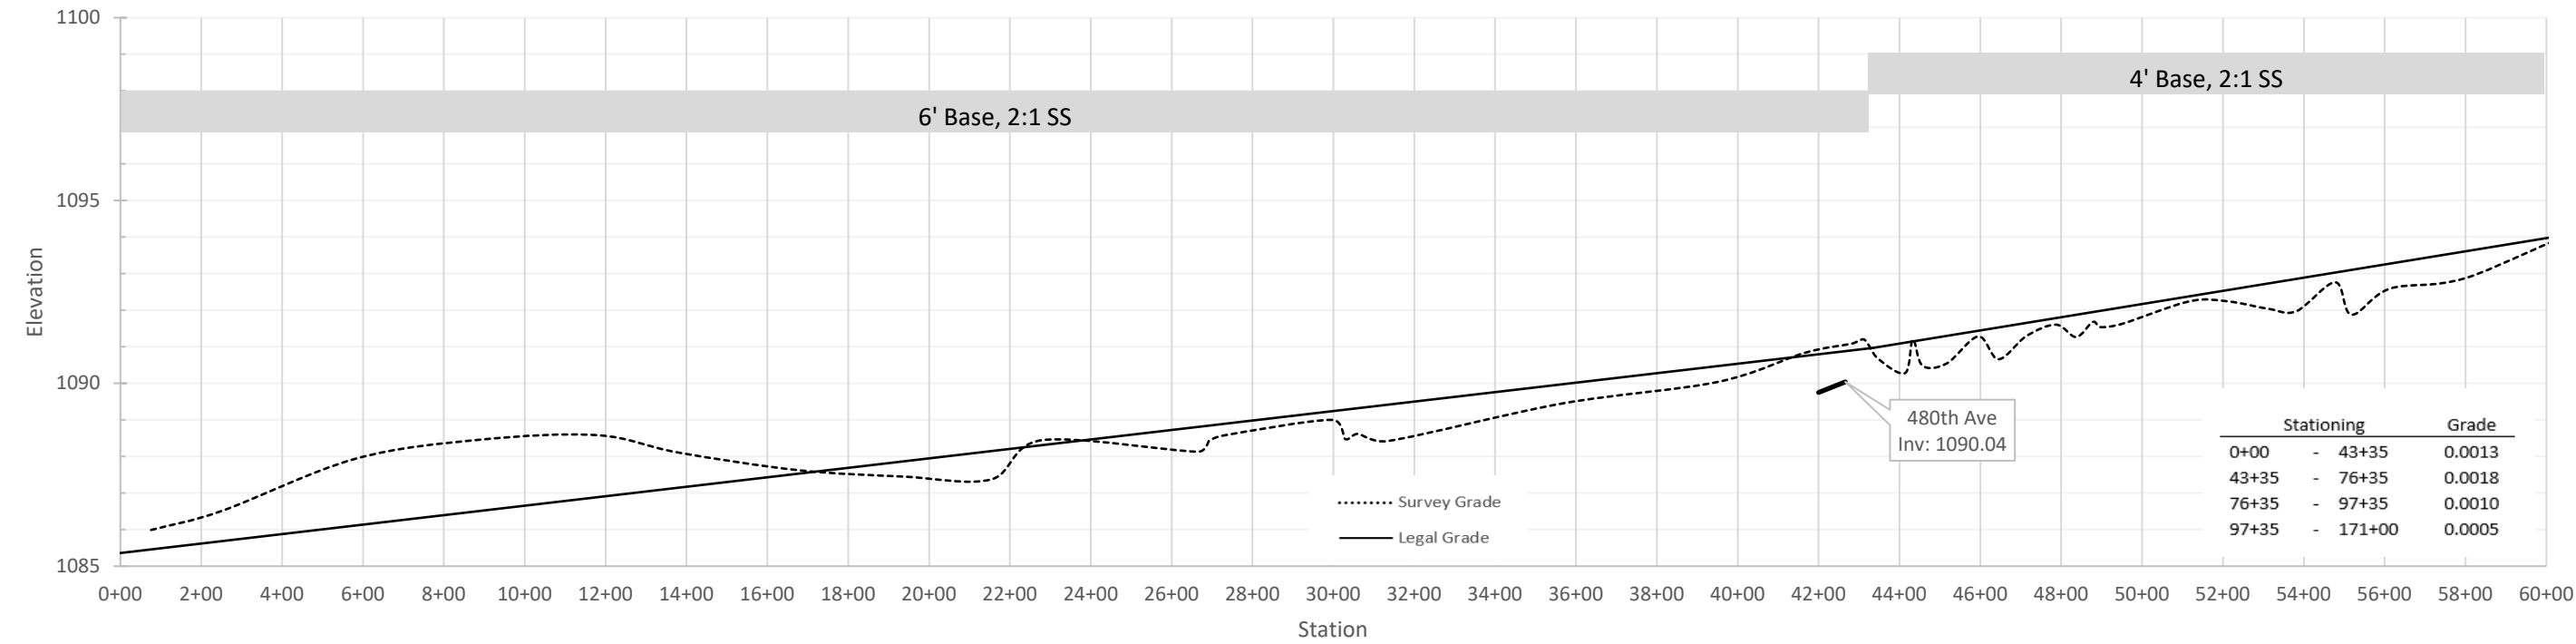
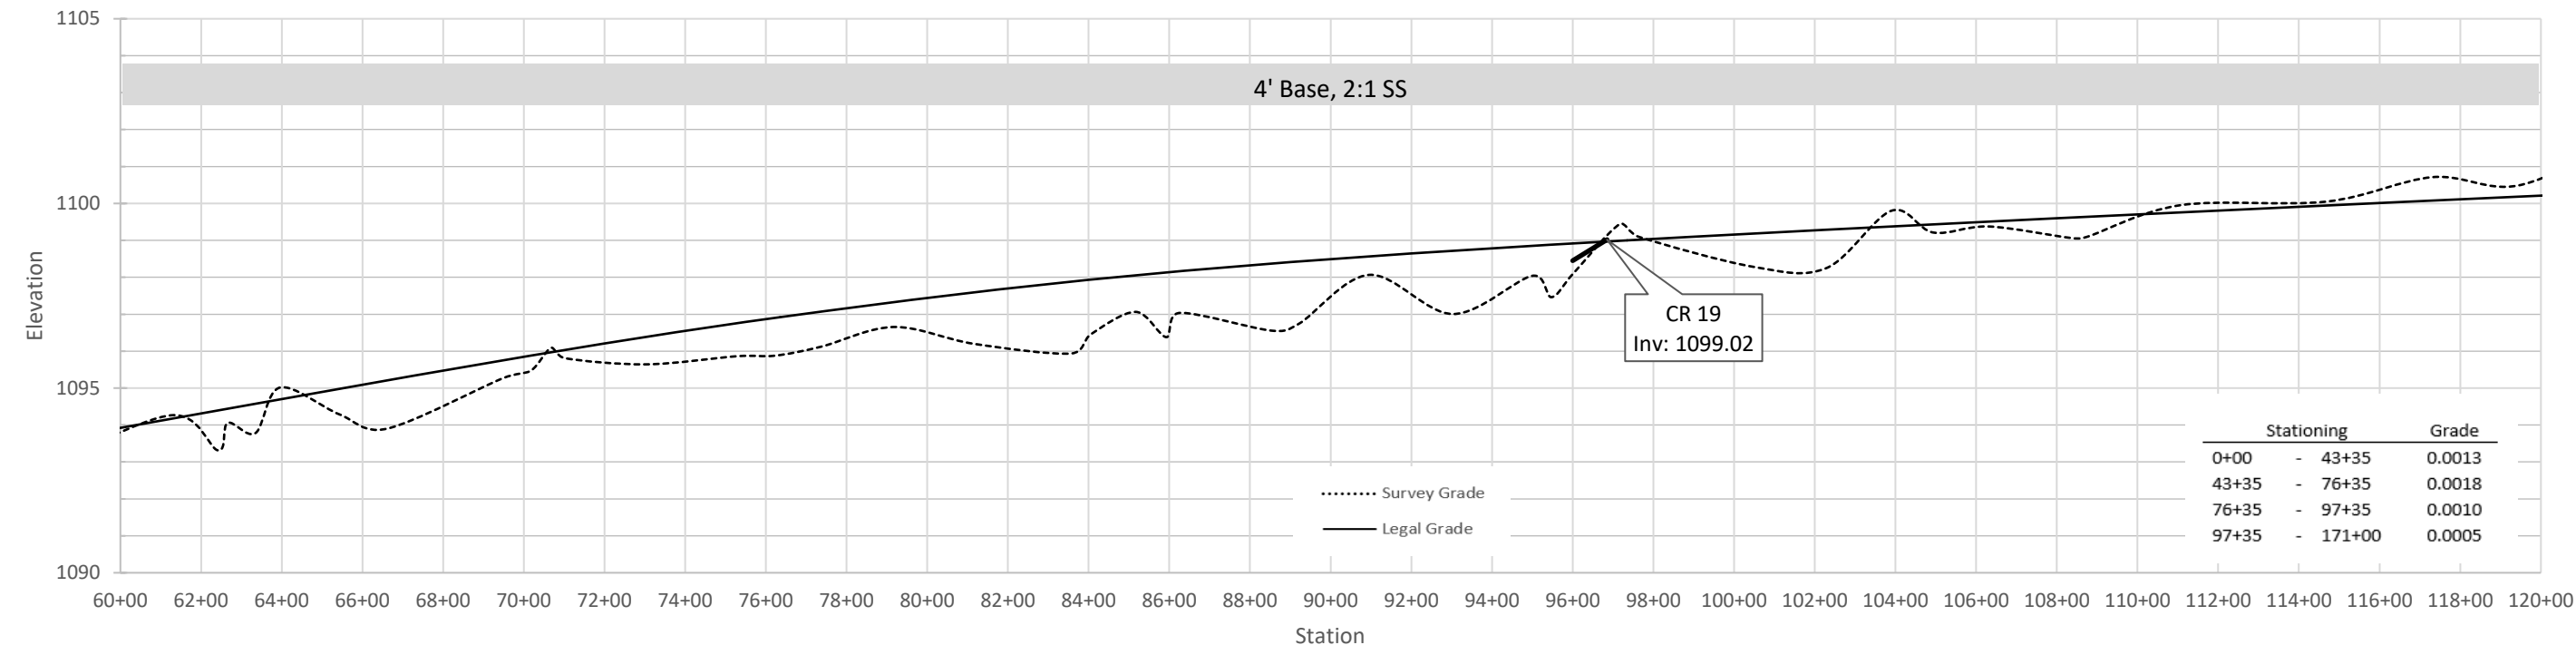
CD37 Main Trunk Profile

A survey of the open ditch channel was conducted. A repair report completed by Bolton & Menk in 1970s showed a repair grade extrapolated from the outlet elevation of the Main Tile. This report converted the local datum of the original establishment plans to mean sea level. The Bolton & Menk legal grade shows an invert elevation of 1104.0 of the Main tile outlet. This is consistent with the Drainage Department survey, with an error of 0.17'. There are three crossings in the centerline of the ditch and one bridge. Two of the crossings are roadways and one is a field crossing. Extrapolating the grade downstream from the Main Tile outlet shows that the invert of the field crossing at station 127+00 is 2' higher than legal grade. The perched elevation of this crossing is likely the main cause of the sediment accumulation and high water in the upper reaches of the open ditch. Lowering this crossing to legal grade and cleaning the upper reaches of the open ditch will restore drainage to the tile drainage system.

Open Ditch Cleaning: Approximately 7,500 feet of open ditch cleaning from Station 96+00 to 171+00 (see profiles).

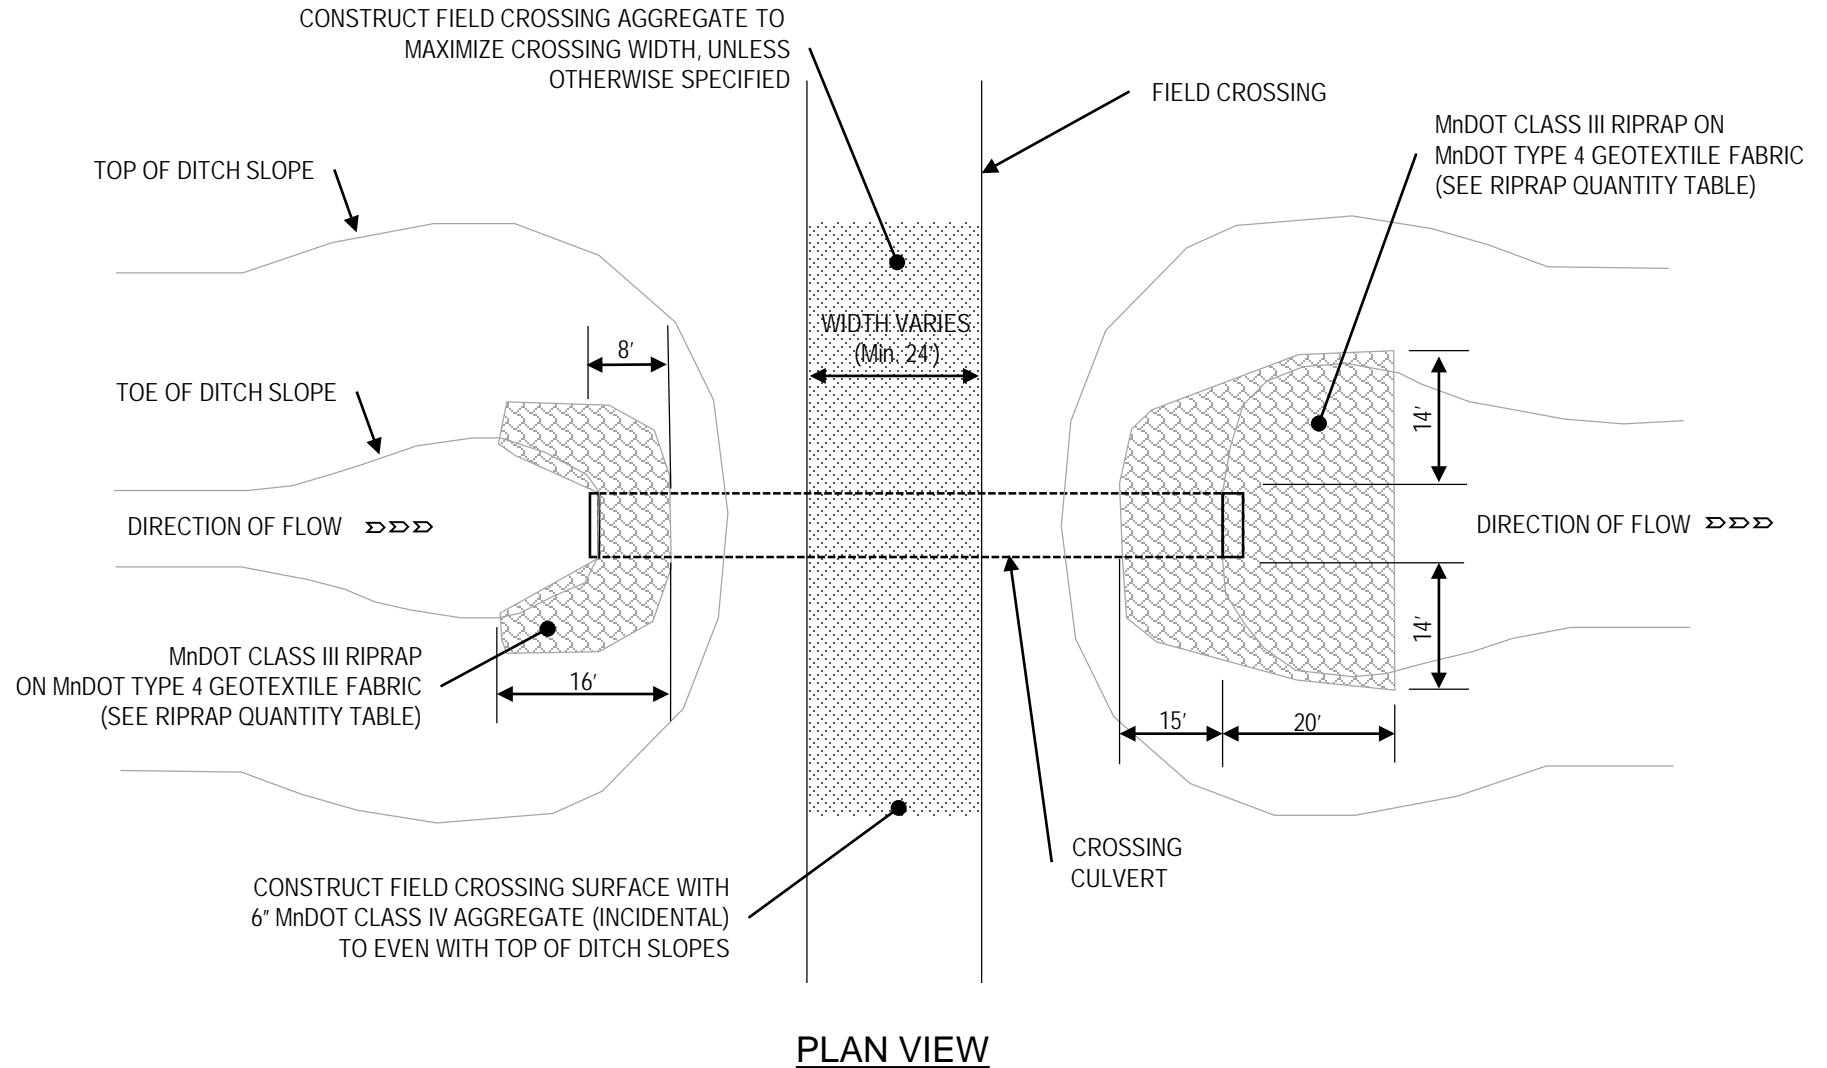
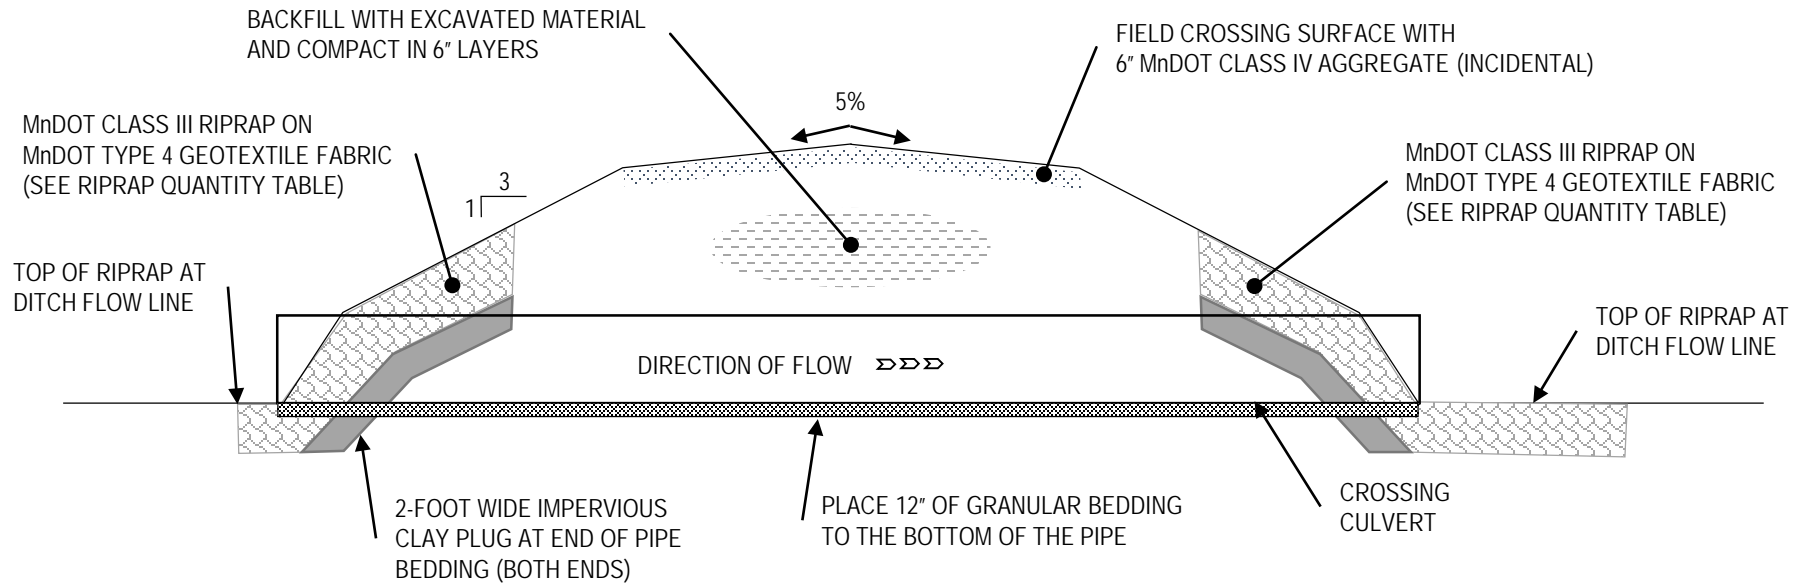
TYPICAL FIELD CROSSING

Crossing Replacement: The existing CMP crossing at Station 127+50 will be removed and a new crossing installed near the property line at Station 123+00. Joe Lewis from HEI was hired to run a hydrologic analysis to determine the size of culvert needed to attain a 1" drainage coefficient. The analysis showed that a 66" culvert would give us that capacity.
