# Faribault County, Minnesota County Ditch #44 East Main Staff Repair Report

November 2022

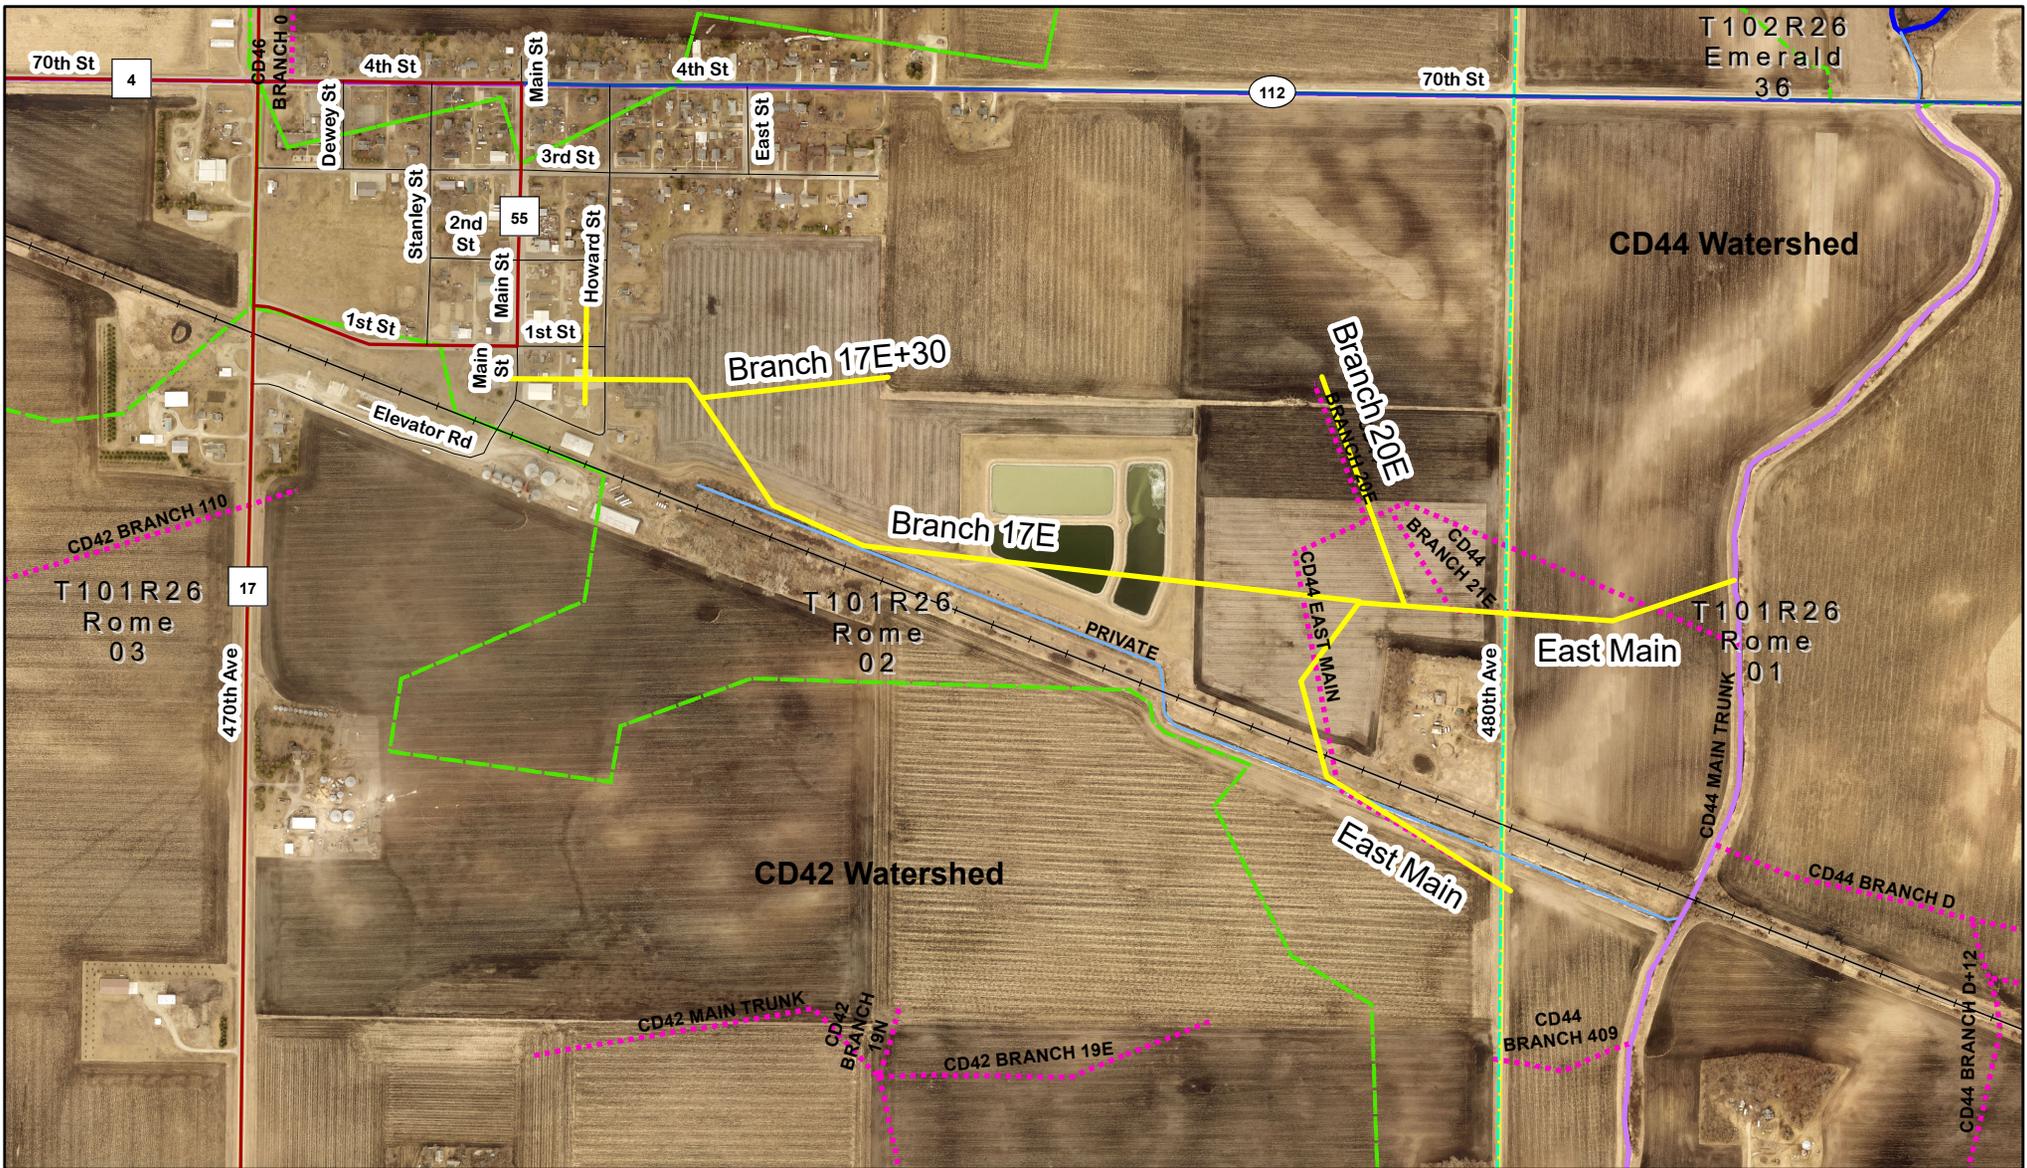
### Appendix A

## Mapped and Supposed Location Of East Main Tile

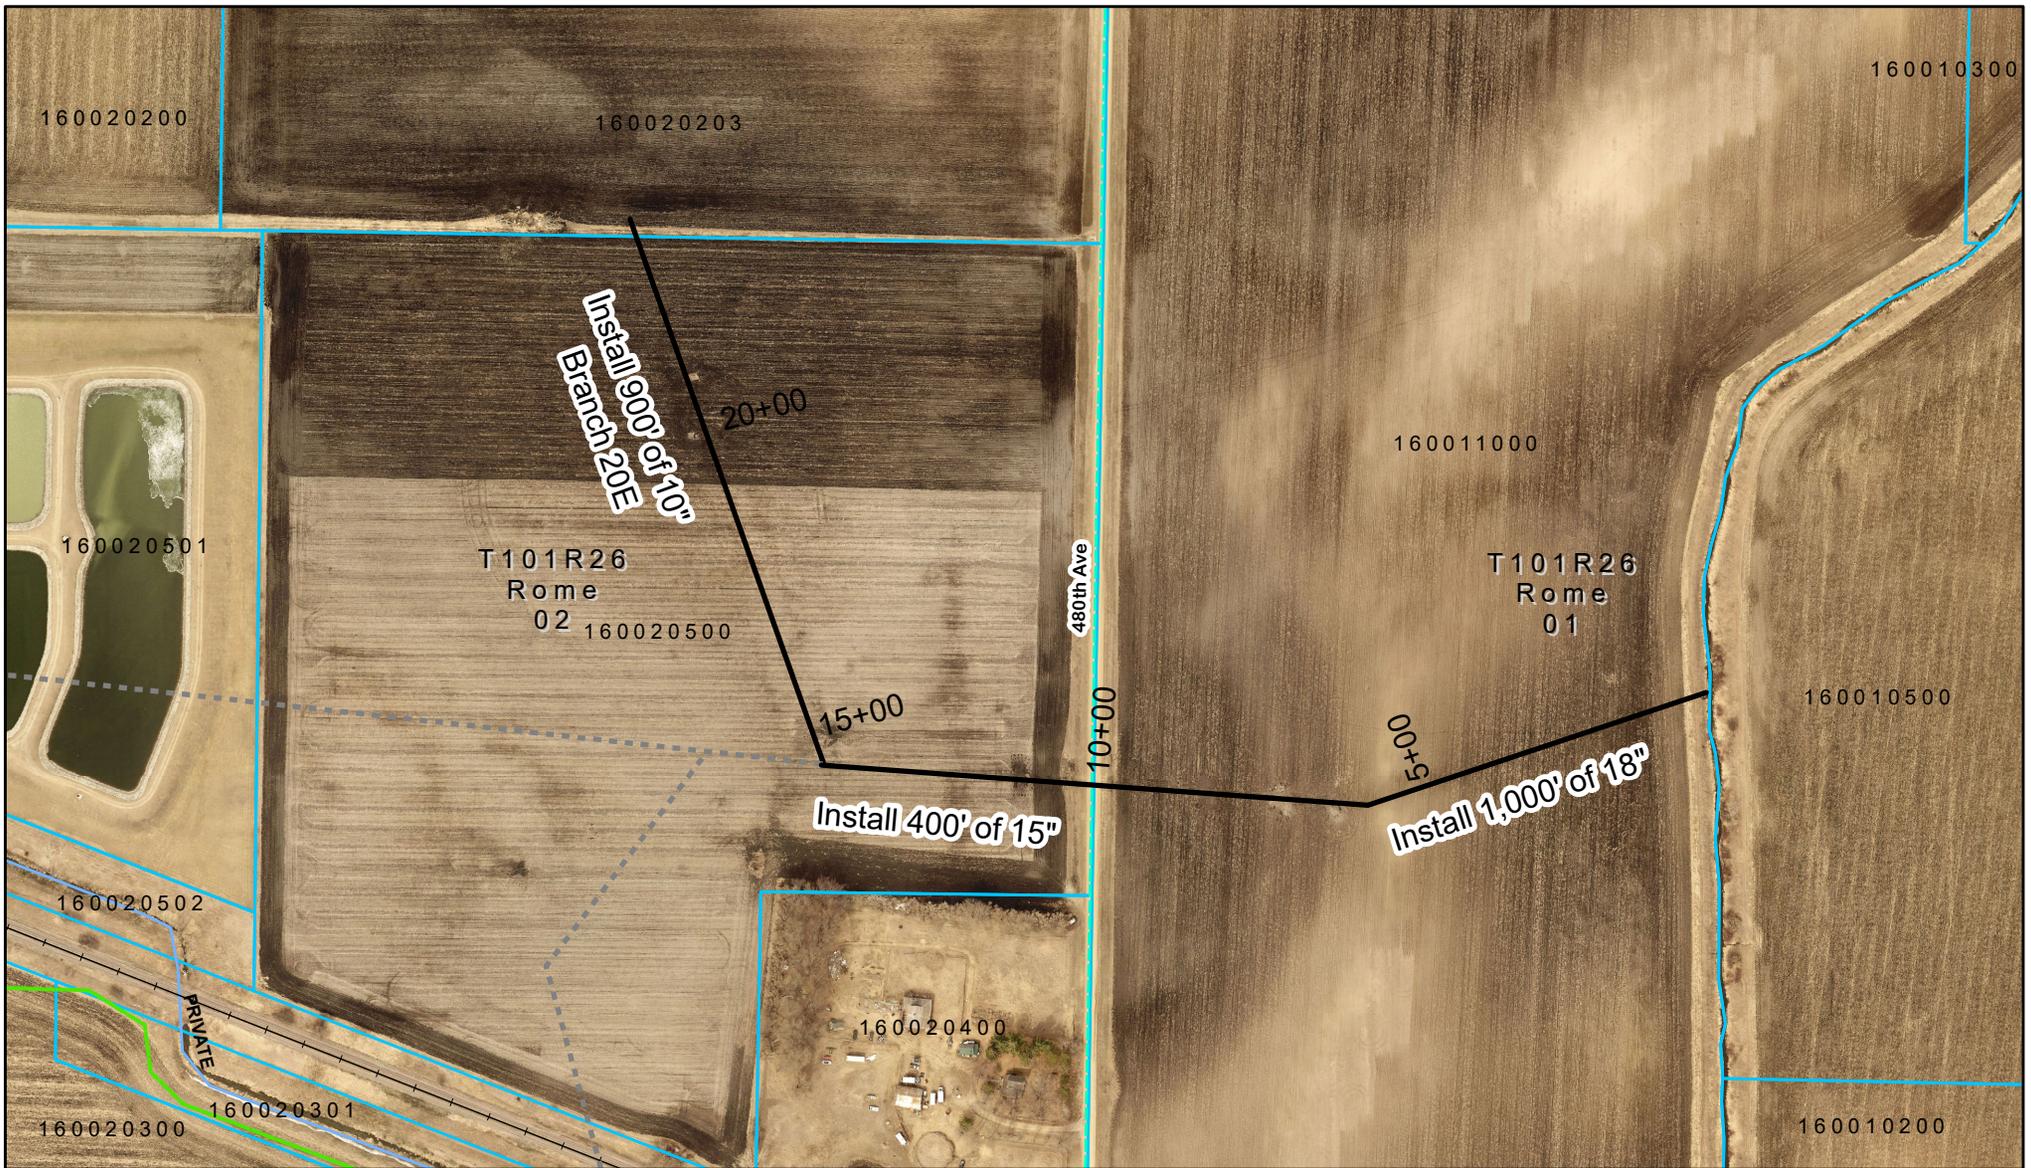
Appendix B

East Main  
Proposed Repair

The proposed repair focuses on the lower 1,400 linear feet of the East Main and Branch 20E. Survey of the East Main suggests that the East Main tile had a grade of 0.29%, giving it a drainage coefficient of well over 0.5 inches per day. The proposed repair will re-design the system to a lower drainage coefficient to gain cover over the tile. The target drainage coefficient will be 0.5 inches per day for the East Main (Table 1). Branch 20E will be installed at a grade of 0.10% to maintain as much cover as possible. The proposed drainage coefficient for Branch 20E is significantly less than 0.5 inches per day.

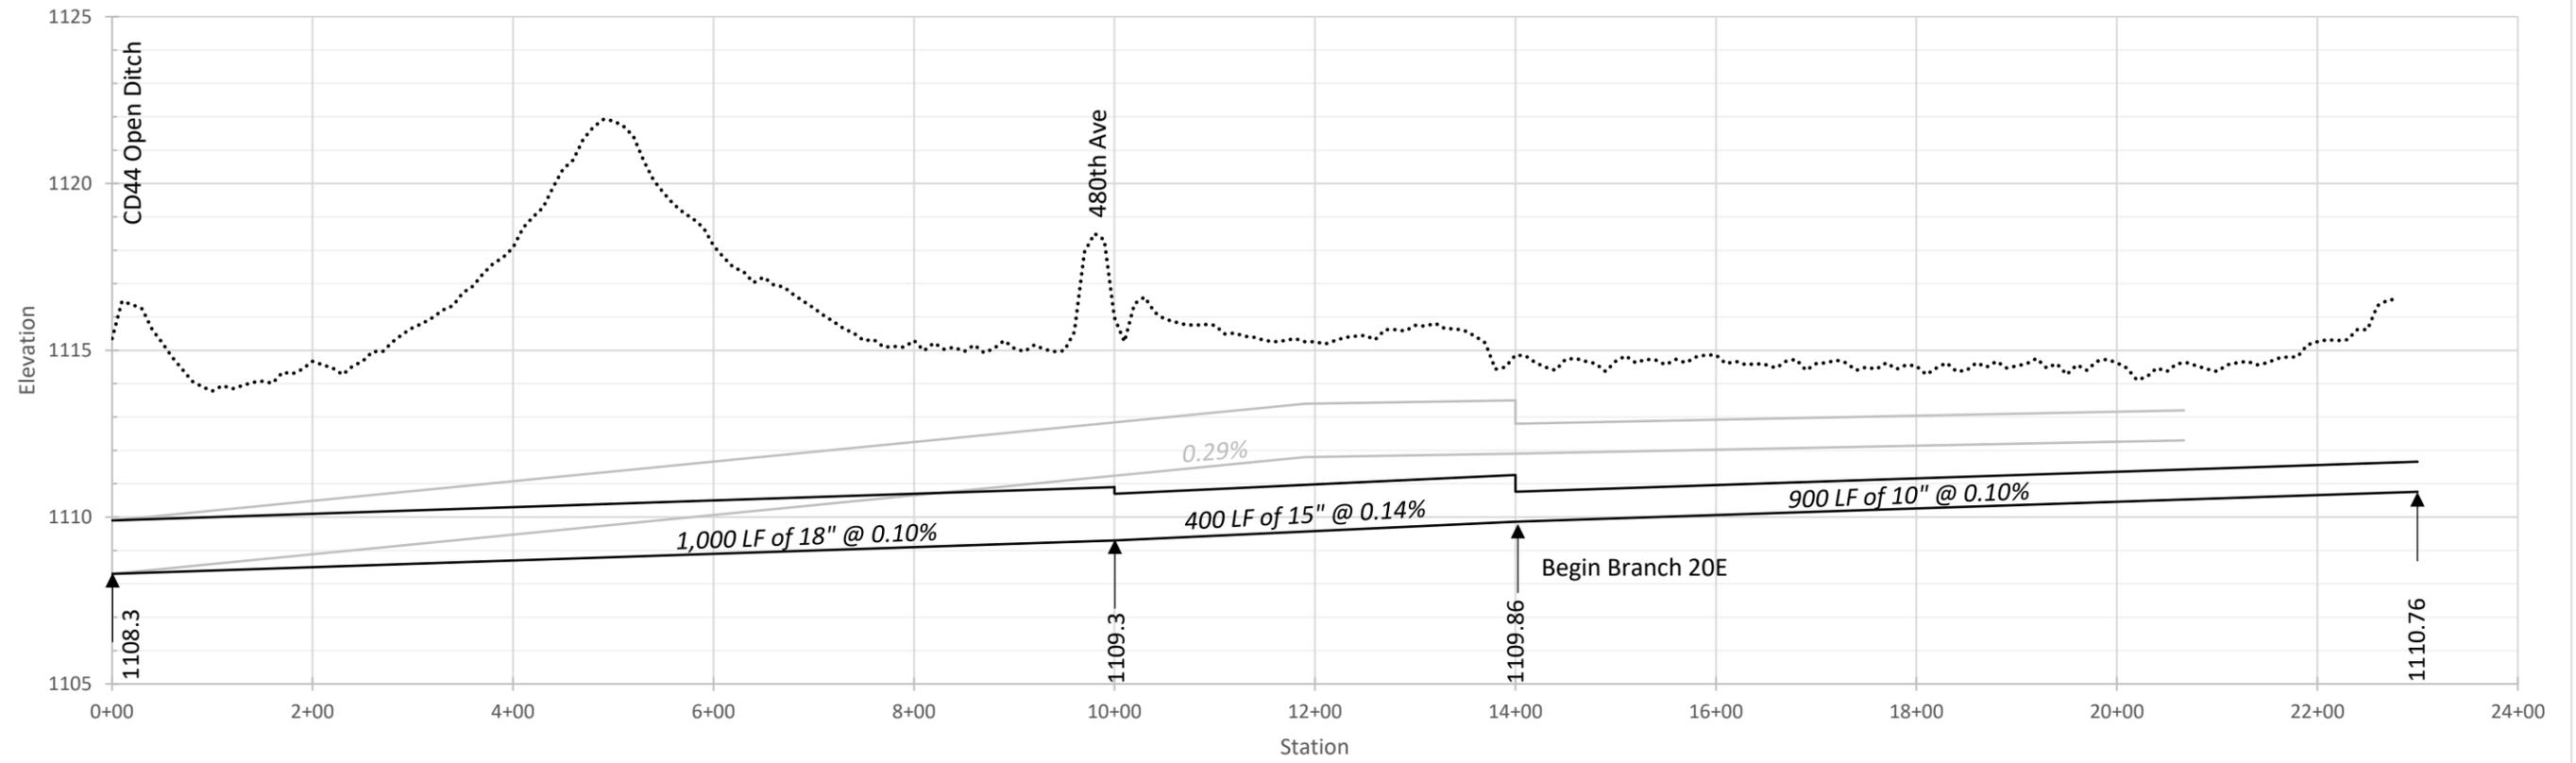
Appendix C

East Main Profile
