# REPAIR REPORT FOR:

## COUNTY DITCH NO. 55 REPAIR: FARIBAULT COUNTY, MINNESOTA

December, 2019

Project No. 18-22272

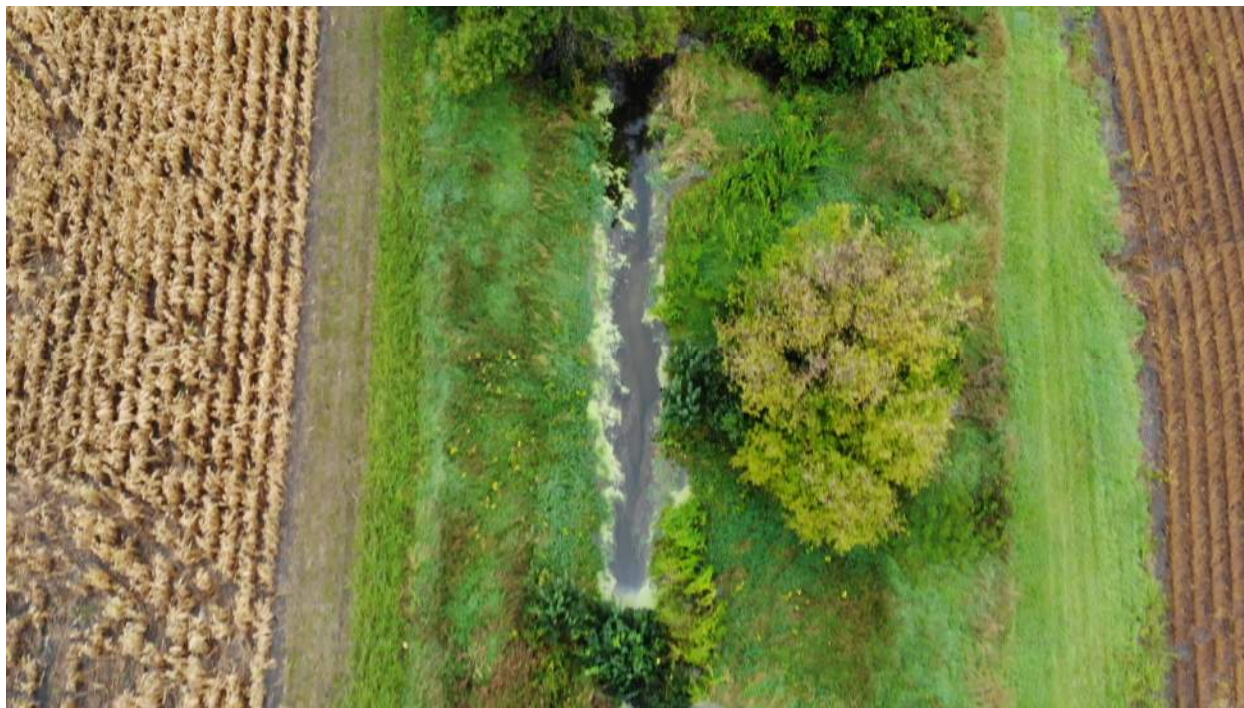
After an analysis of soil borings and topographic survey, it was determined that CD 55 has accumulated sediment in the open ditch. The average depth of sediment over legal grade throughout the petition area is approximately 1.5 feet. Accumulated sediment restricts flow and can lead to vegetative growth. A stretch of ditch with accumulated sediment in the channel can be seen in Figure 4.

*Figure 4. Sediment accumulation in NW ¼ of Section 29 of Brush Creek Township*

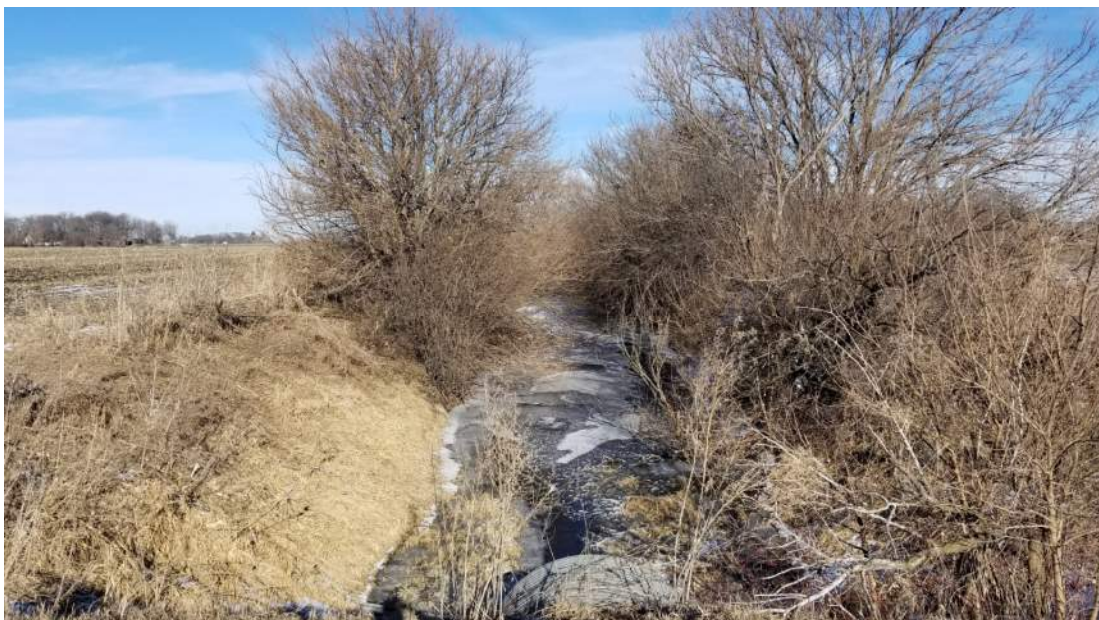
Tree and shrub growth along the open ditch contributes to erosion, sediment deposition, and flow restrictions. Trees and shrub in the open ditch create flow restrictions. Trees and shrub in the open ditch create flow restrictions and once vegetation is established can become overgrown and difficult to maintain quickly. Trees along the ditch banks at any time can lose limbs or even fall into the ditch causing flow restrictions. The trees also provide a canopy across the open ditch banks creating poor conditions for grasses and vegetation within the buffer to grow. This causes instabilities and is more susceptible to erosion. Perennial grasses along the ditch bank are more suitable as it provides dense root growth, which creates stable banks less susceptible to erosion. Figure 5 show an example of trees and shrubs in the open ditch and within the 16.5-foot buffer.

*Figure 5. Trees within Open Ditch Upstream of Field Culvert Crossing #8 in the SW ¼ of Section 20 of Brush Creek Township*

Well established trees, brush and shrubs were identified along the banks of the open ditch throughout the watershed. The repair will include removing these obstructions to prevent future erosion of the ditch banks. The amount of tree clearing was estimated using aerial photos, topographic survey, and drone footage. Major tree clearing and grubbing is recommended in Section 30 of Brush Creek Township where well developed trees are fully grown on both sides of the ditch bank. Beaver dams are very likely in this area with the trees and have been a nuisance throughout the years.

Tree removals are also recommended in Section 24 of Emerald Township and Section 20 of Brush Creek Township. While the trees are not as dense as in Section 30, heavy tree growth is still observed and can lead to bank instabilities. Heavy vegetation is also well developed in Section 23 of Emerald Township, however does not pose a major flow restriction or erosion at this point and are not required to be removed.

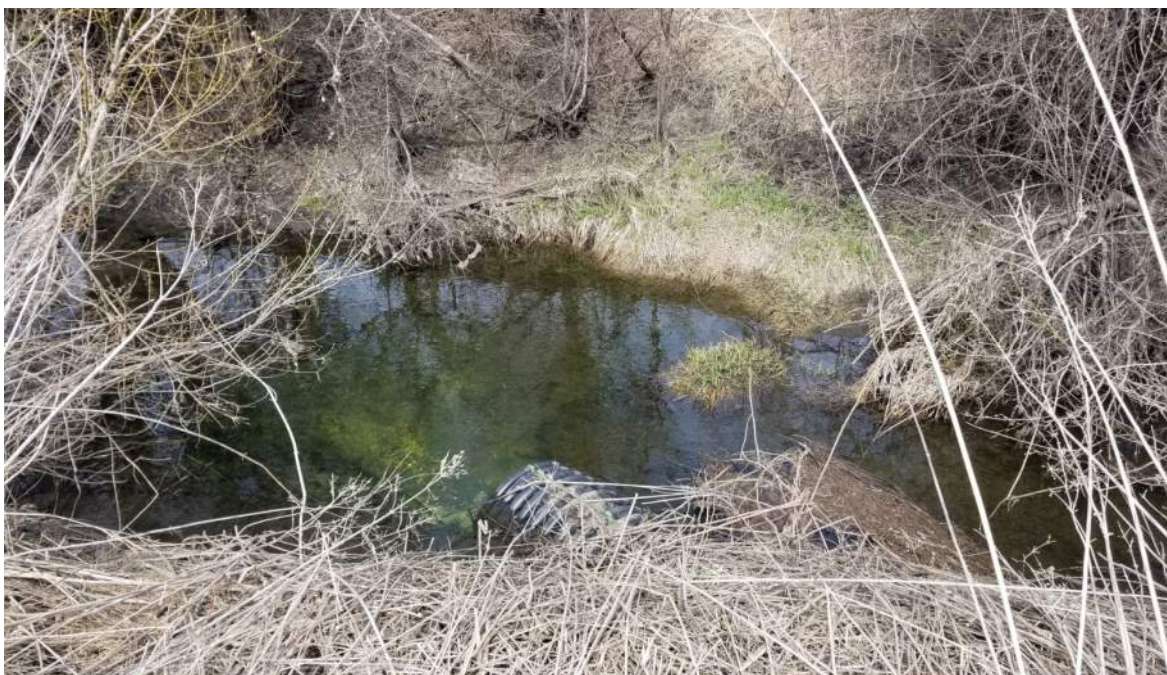
Many tile outlets within the open ditch are failing and causing or have the potential to cause erosion. Examples of failing tile outlets would include bent, broken, covered, crushed, or completely washed away tile outlets. Almost all tile outlets do not have riprap to protect the ditch banks. Figure 6 shows an example of the many tile outlets that are in poor condition and do not have riprap protection.

*Figure 6. Unprotected Tile Outlet in the SW ¼ of SE ¼ of Section 20 of Brush Creek Township*

All tile outlets into the open ditch will be replaced or repaired as part of this project where construction occurs. Some of the tile outlets are in good shape and only require riprap protection on geotextile fabric; however some tiles are bent, broken, or completely washed away causing erosion to the ditch banks. The repair of damaged tiles will consist of replacing the damaged outlets into the ditch with a section of new tile and protecting the tile from erosion.

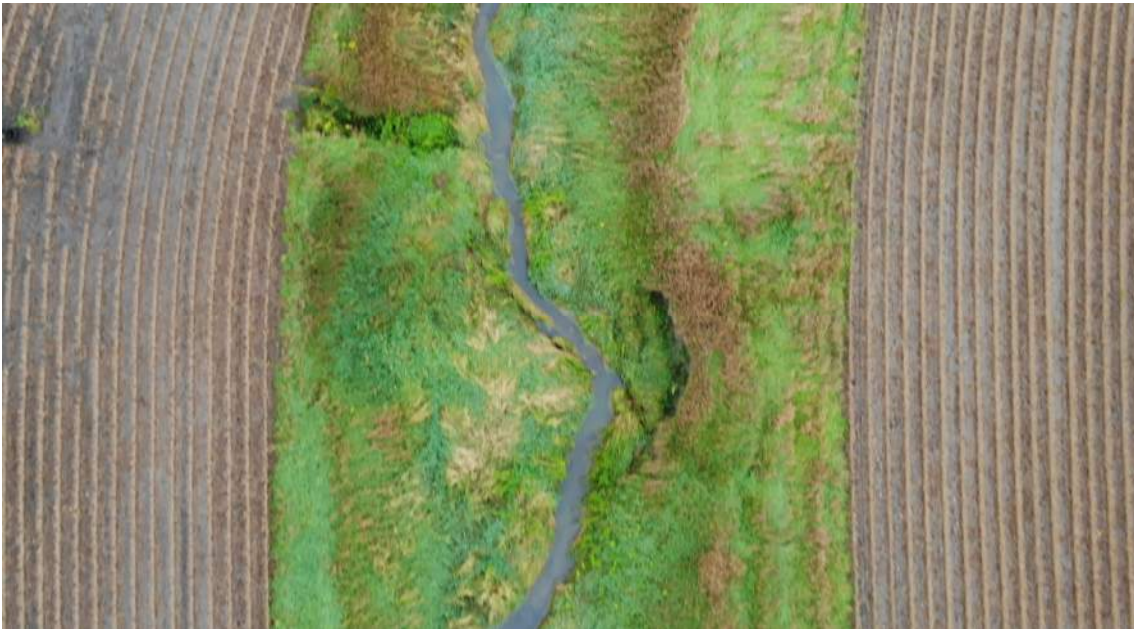
Sloughing was identified at various locations along the ditch. Sloughing occurs when the bank of the open ditch shears and collapses into the open ditch. The main causes of sloughing include overland flow overtopping the ditch bank, lack of buffer vegetation, steep side slopes, and meandering alignment of the open ditch. The sloughing deposits sediment into the CD 55 open ditch which restricts flow and requires maintenance. Figure 7 shows a bank slough on the Main open ditch.

*Figure 7. Bank Slough in the NW ¼ of SW ¼ of Section 24 of Emerald Township*

The drone and topographic survey revealed ditch bank sloughing and erosion throughout CD 55. Slough repairs will include re-establishing a stable ditch bank where a slough or erosion is occurring and will also include seeding the repaired area. Further slough repairs may be necessary based on the condition of the banks when construction is occurring.

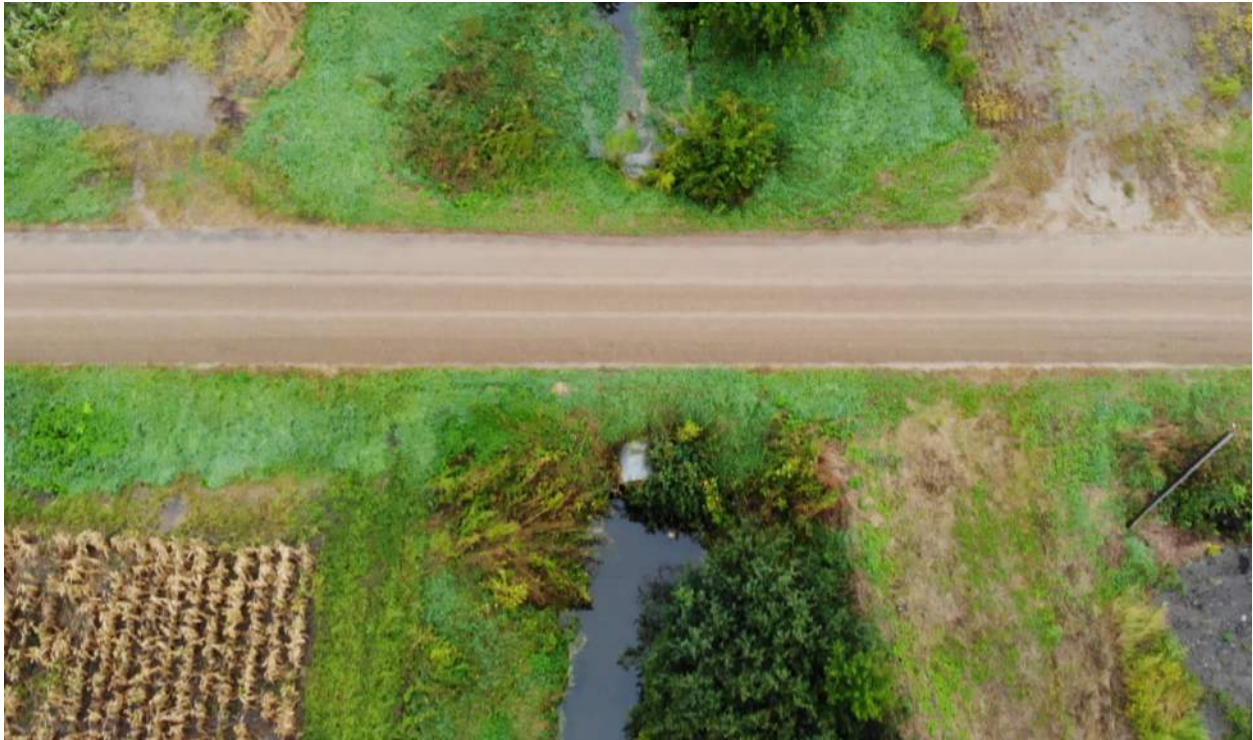
*Figure 8. Culvert Crossing #8 at 90<sup>th</sup> Street in Section 20*

There are three culvert crossings recommended to be replaced as part of this repair. Culverts that are significantly above legal grade are proposed to be replaced. Culverts that are not planned to be replaced will still be addressed with maintenance items. Riprap protection will be placed on the upstream and downstream ends of the culvert to protect ditch banks from erosion such as scouring and downcutting. For culverts with accumulated sediment within, cleaning and sediment removal will take place.

In lieu of corrugated metal pipe (CMP) crossings, crossings are recommended to be replaced with reinforced concrete pipe (RCP) or otherwise decided by the Drainage Authority for long term durability. Figure 15 shows the locations of the culverts to be replaced. Table 2 summarizes the proposed crossing capacities for open ditch crossings. Culvert crossings 3 and 9 are proposed to be replaced and lowered to legal grade. Culvert crossings 6 is recommended to be removed as it is in poor condition and is no longer utilized for crossing the ditch with farm equipment.

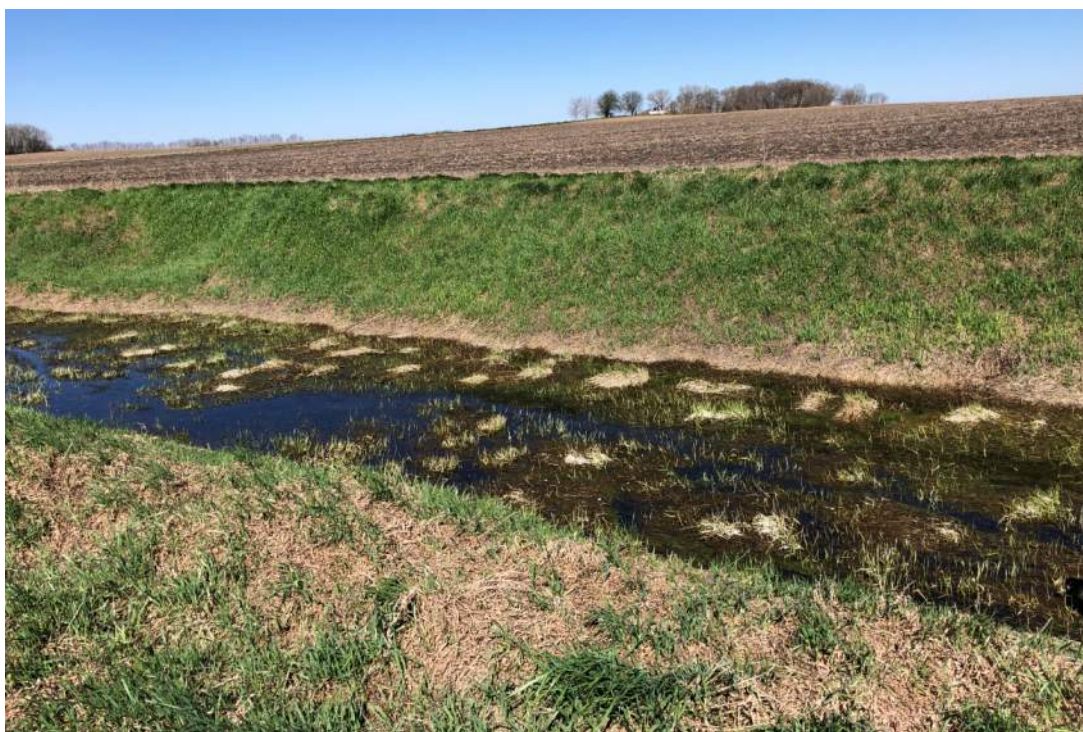
An alternative to standard open ditch cleaning was reviewed in Section 20 and 29 given the characteristics of the open ditch. This stretch of open ditch has an existing channel bottom significantly wider than the legal channel bottom. In lieu of a standard ditch repair, a two-stage repair alternative is reviewed for better long term maintenance while still providing adequate drainage.

*Figure 11. Proposed two-stage ditch segment in SE ¼ of SW ¼ of Section 20 of Brush Creek Township*

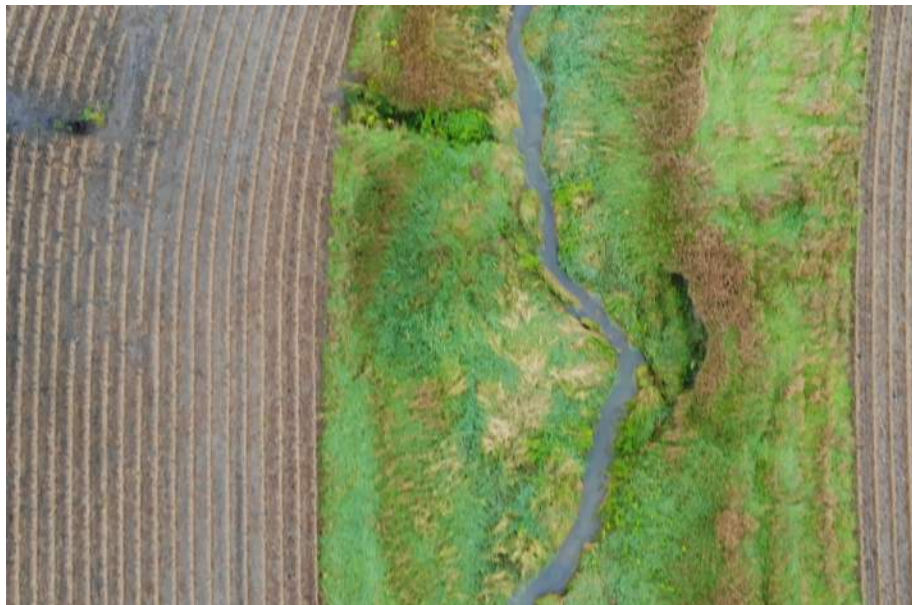
Picture #4: Bank Sloughing in NW  $\frac{1}{4}$  of SW  $\frac{1}{4}$  of Section 24 of Emerald Township
