# Repair Report

## County Ditch No. 64

Faribault County, Minnesota

ISG Project No.: 17-21098

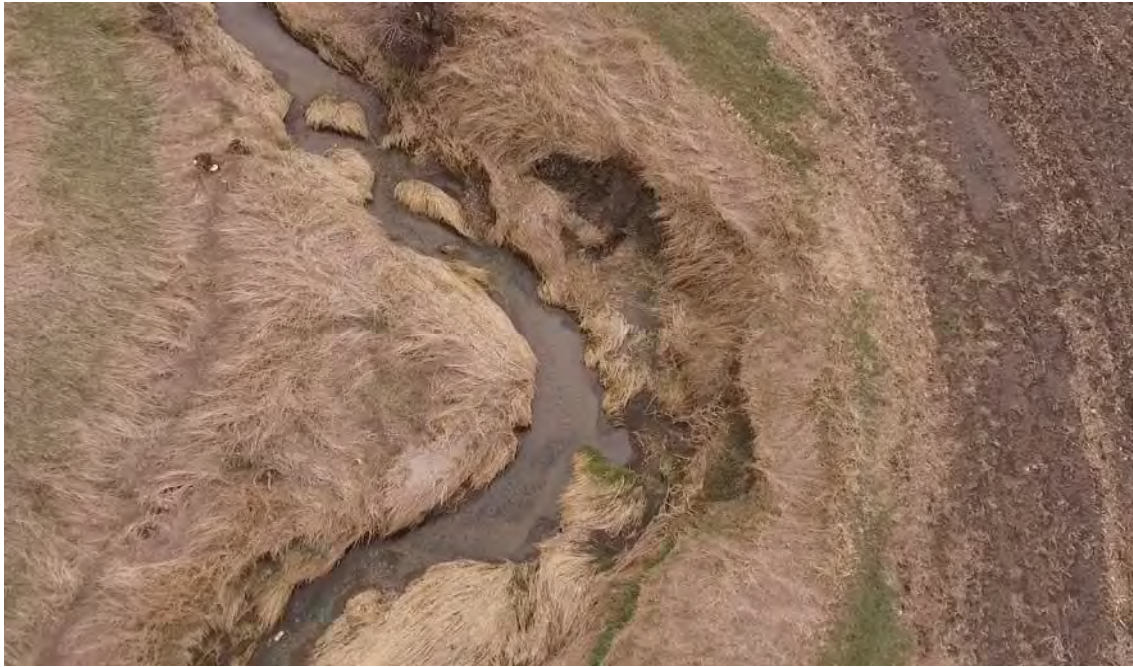
As discussed previously in the History section of this report, the system as it currently stands exhibits ditch side slope erosion throughout the majority of the system and downcutting which is resulting in increasingly steep grades and therefore increased velocities during major flooding events. The watershed is also known to be very flashy with high peak flow rates draining through the system in a short duration of time. These issues combined with one another contribute to increased sediment and nutrient transport for downstream users, as well as failing ditch integrity which could result in major ditch failures. Some images of the current condition of the ditch can be seen in the figures added below. Figures 1 through 4 depict some of the issues seen through the length of the ditch, while this is not a cumulative inventory, it provides insight into the failures the majority of the ditch is facing. Several drone aerial videos have been submitted to the Faribault County Drainage Staff and are available for viewing.

*Figure 1. Streambank Failure at Bend in Open Ditch (Section 7, Kiester Township)*

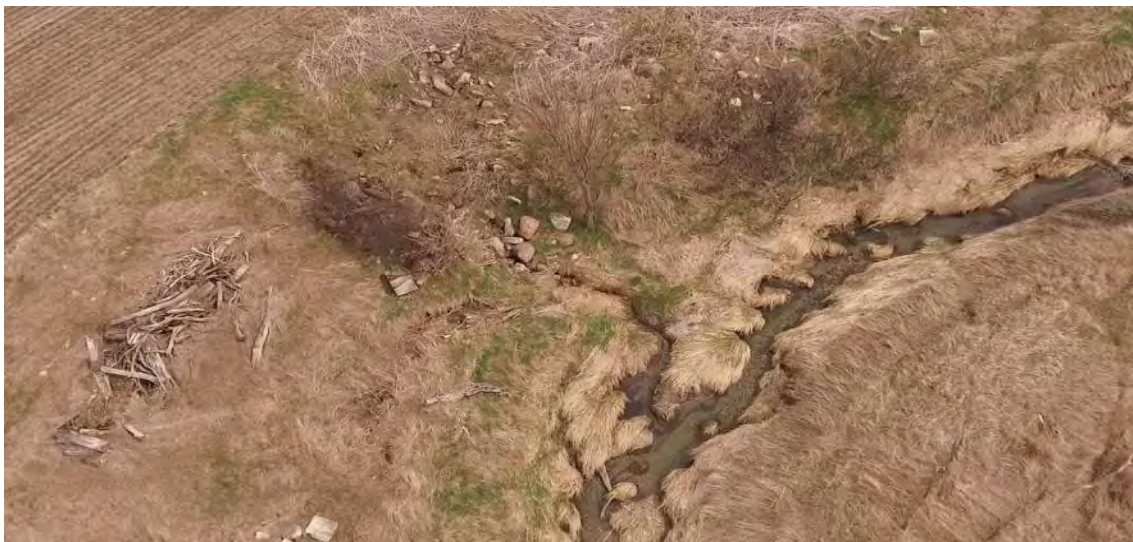
*Figure 2. Streambank Erosion (East Half of Section 7, Kiester Township)*

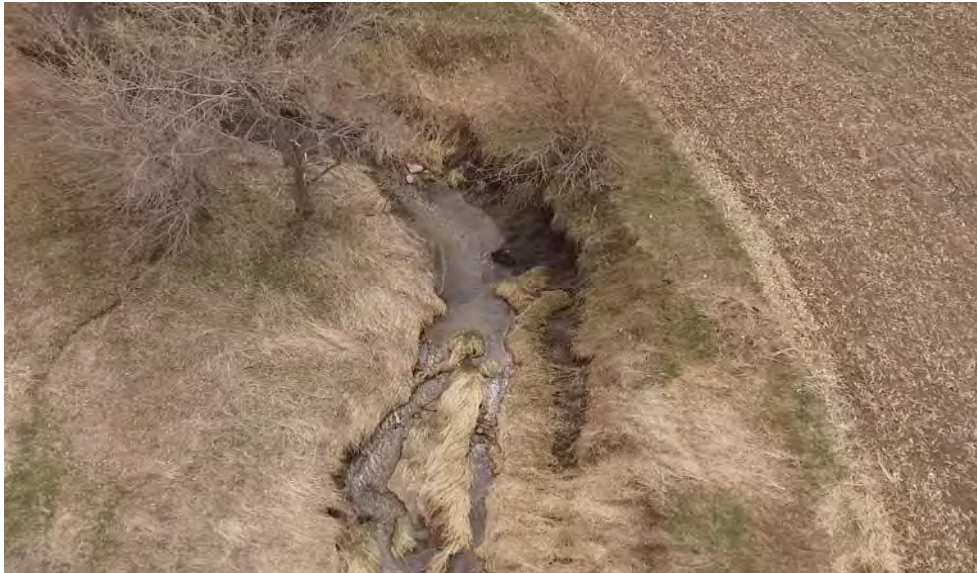
*Figure 3. Sediment Delta Formation and Streambank Failure (East Half of Section 7, Kiester Township)*

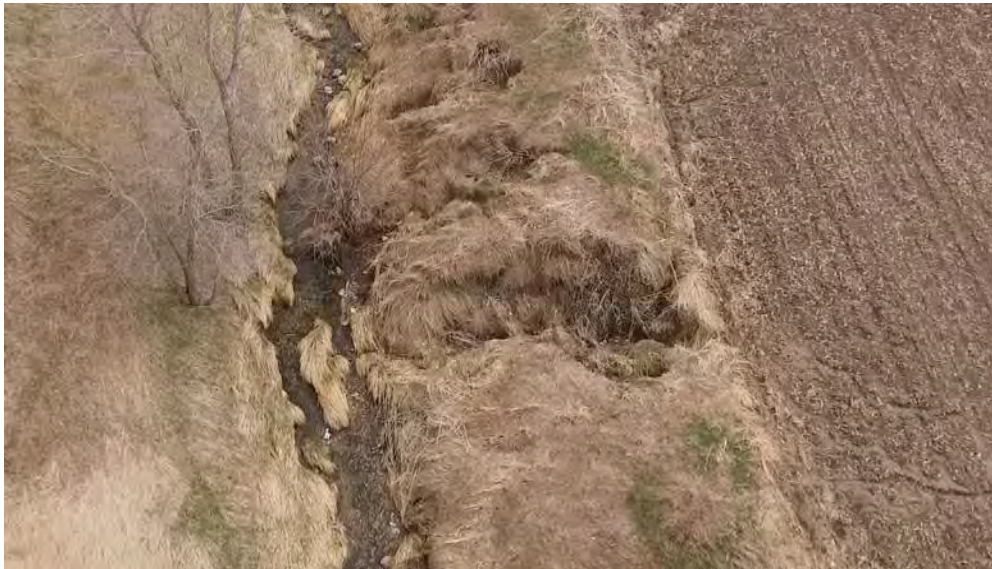
*Figure 4. Streambank Gully from Overland Flow (West of CR 21)*

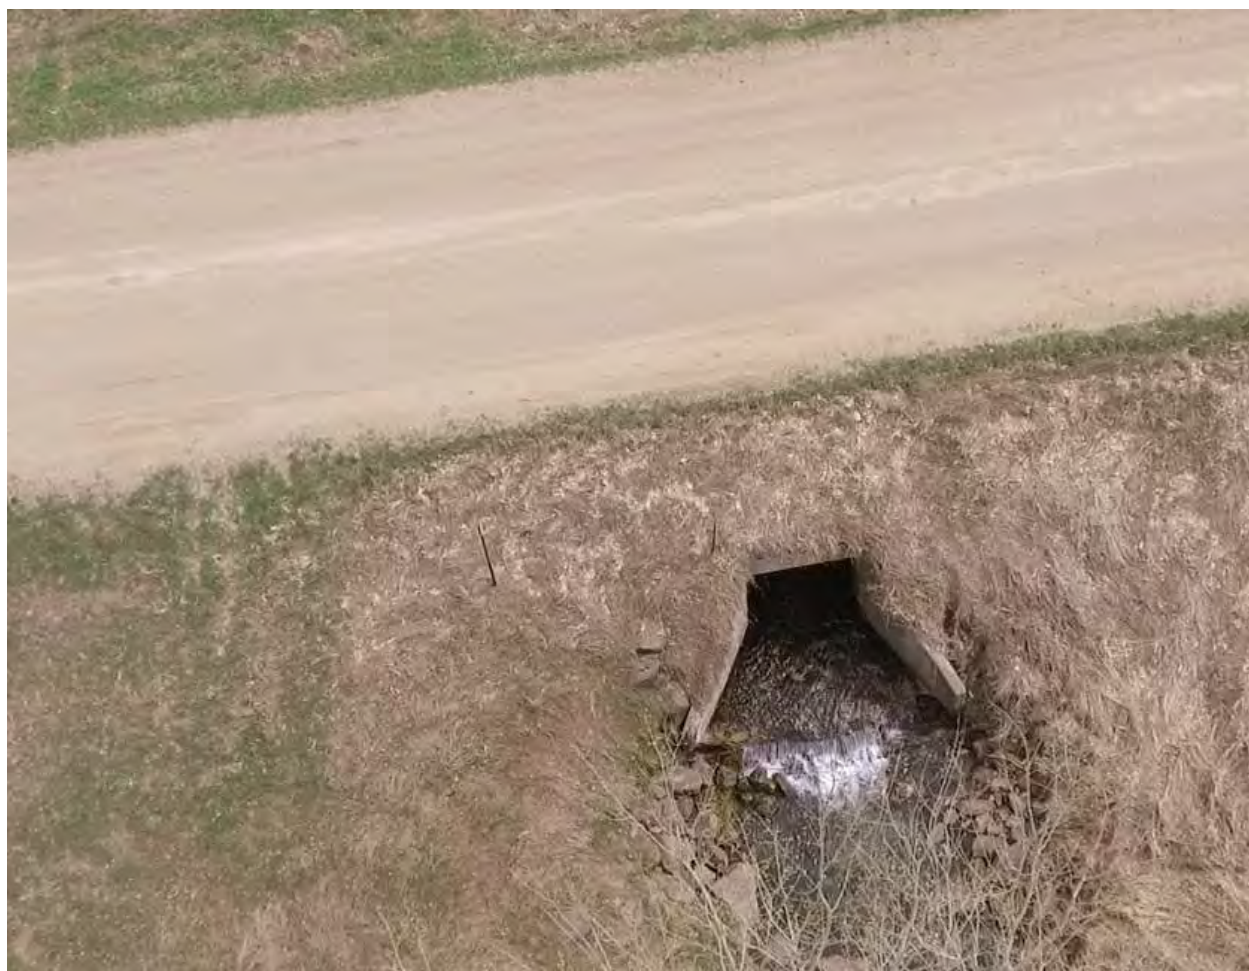
The cast in place box culvert under County Road 21 is well above the adjacent upstream and downstream channel grades. This is referred to as a perched culvert that can occur by a misplacement of the structure or from channel downcutting overtime. Since this structure appears to be in place for a significant time period, it is unlikely it was incorrectly placed and the perched culvert is a result of channel downcutting. The elevation difference from the upstream side to the downstream side of the culvert is nearly 3 feet. Since there are no major drainage issues upstream of the crossing, it is recommended to leave the structure at the same elevation moving forward to prevent further channel downcutting. An image showing the drop-off after the culvert outlet can be seen below in Figure 1.

Figure 1: Perched Culvert under County Road 25 (560th Avenue)

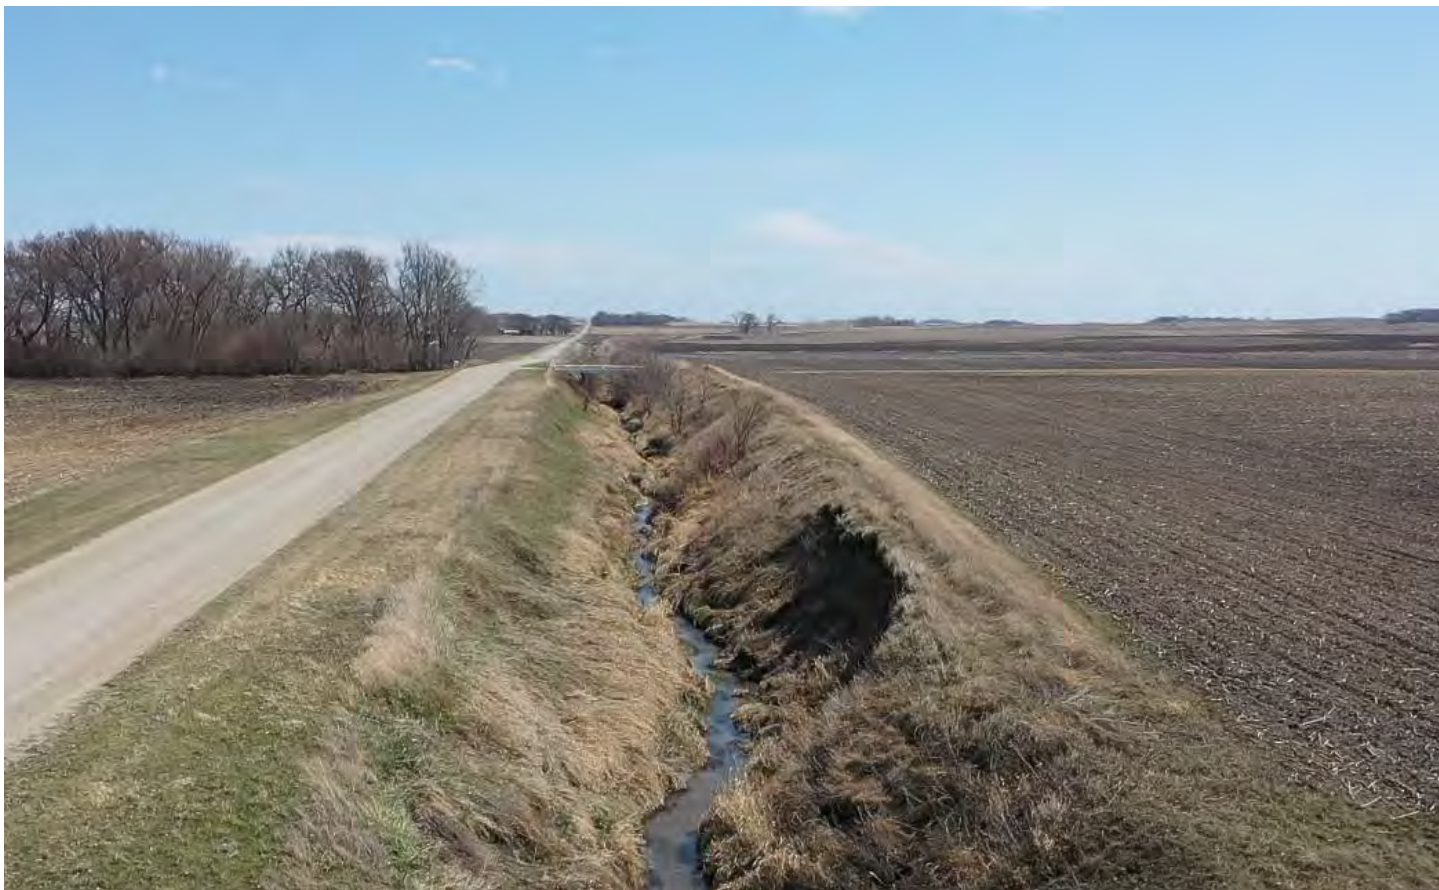
The outlet portion of the open ditch downstream of the private bridge crossing is experiencing significant bank sloughing that is causing erosion and downstream sedimentation. The existing bank slopes range between 1:1 and 1.5:1 which is very steep for open ditches. After reviewing the flow elevations and velocities with the permissible velocity method, the current channel geometry is at risk for further bank failures. In order to have a stable geometry in this stretch, the south bank side slope should have a minimum 3:1 backslope from Station 1+25 to 6+00 to achieve a 3.5 feet/second velocity. If the side slopes were flattened out to 4:1, the velocities of the channel would be 3.38 feet per second, slightly lower than a 3:1 side slope. Shown below shows a drone aerial of the outlet portion ditch while Figure 3 shows a cross section of this stretch.

Figure 2: Bank Sloughing at Open Ditch Outlet (Section 12, Seely Township)

This repair will include peeling back the existing sloughed material, flattening of the ditch bank, leveling of spoils adjacent to the ditch, and reseeding the bank and buffer area. Erosion control blanket is recommended for the seeding as it provides more stability for the flashy ditch system and also provides cover for the seed bed so the seeds stay in place. For this stretch, there are an estimated 0.4 acres of permanent damages for widening of the ditch easement and 1.5 acres of temporary damages for topsoil stripping and spoil placement. Since this repair area avoids the area next to the outlet and next to the bridge, the permanent easement is recommended to extend in a straight line across the entire stretch as this will make farming practices more practical.

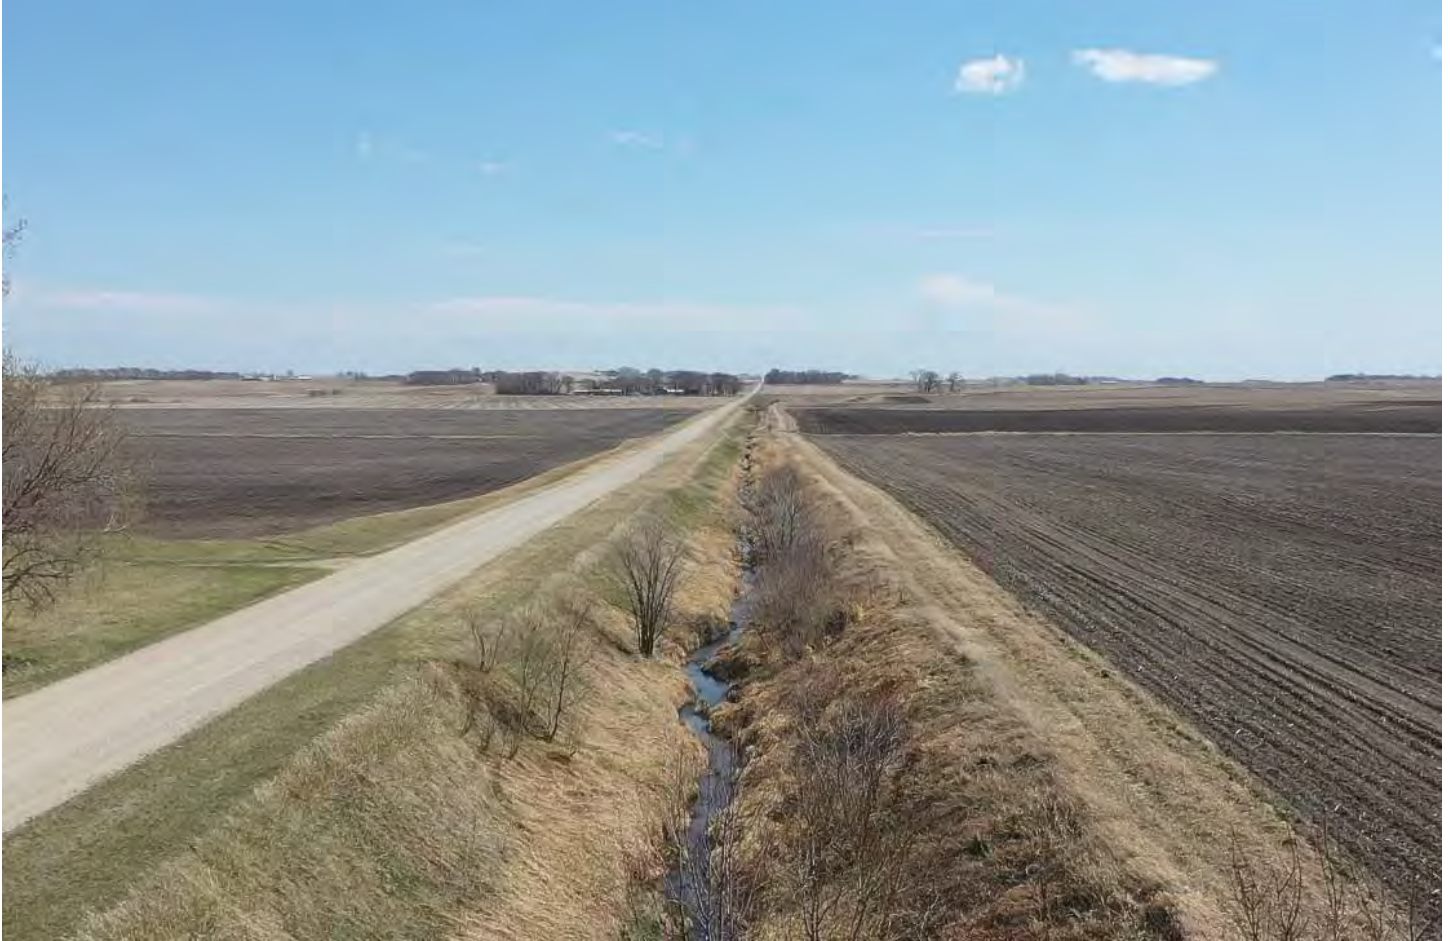
The midway open ditch along 60<sup>th</sup> Street from the private driveway to a point roughly 550 feet upstream (Figure 4) contains a deeper ditch with steep banks. Currently there are minor slough areas, however the channel itself appears to be stable, likely due to the crossing structure underneath the bridge holding the channel grade. The existing side slopes range between 1:1 and 2:1 which is steep for the channel in this area. A review of the channel velocities in this area suggests that the slope should be closer to 3.5:1 which could be achieved by flattening to 3:1 side slopes, however the immediate need for side slope flattening is not there. This area should be monitored in the future for potential side slope flattening. A cost estimate has been generated for reference to this repair.

*Figure 4: Drone Aerial Along 60th Street (Section 12, Seely Township)*

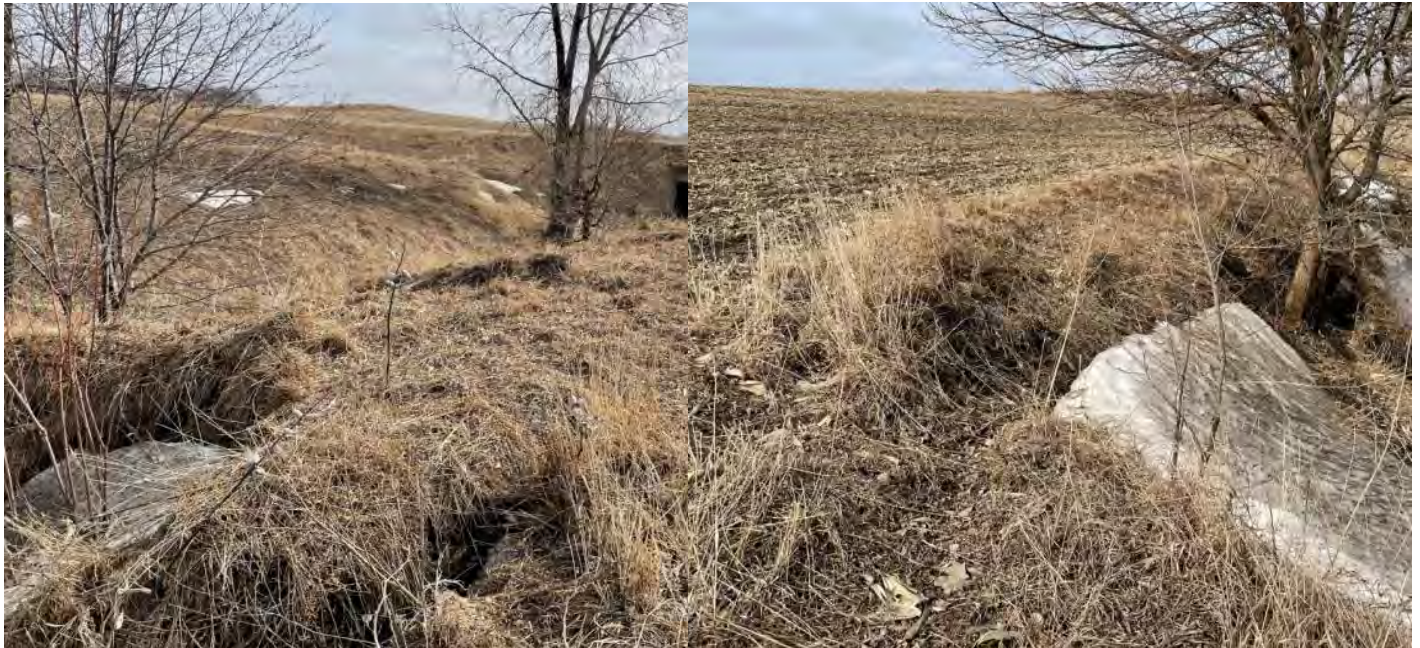
An area approximately 1,000 feet downstream of County Road 25 (560<sup>th</sup> Avenue) has multiple extreme bank failures caused by surface flow from the adjacent hillside (Figure 11). Given the steep topography and surface flow, a small berm could be built up along this stretch to reduced surface flow over the ditch bank. Two alternative side inlets are proposed be added to carry the surface flow through a pipe into the open ditch as part of the grade stabilization repairs. Approximately 600 cubic yards of material would be required to build the berm up in this area and the clay could be borrowed from the two-stage ditch excavation to reduce overall earthwork costs.

*Figure 11: Gully's through Ditch Bank (Downstream of CR 25, Section 7 Kiester Township)*

Other options for this area would be to look for upland BMPs such as cover crops, WASCOBs, reduced tillage, or other buffer easements to reduces the amount of surface flow.

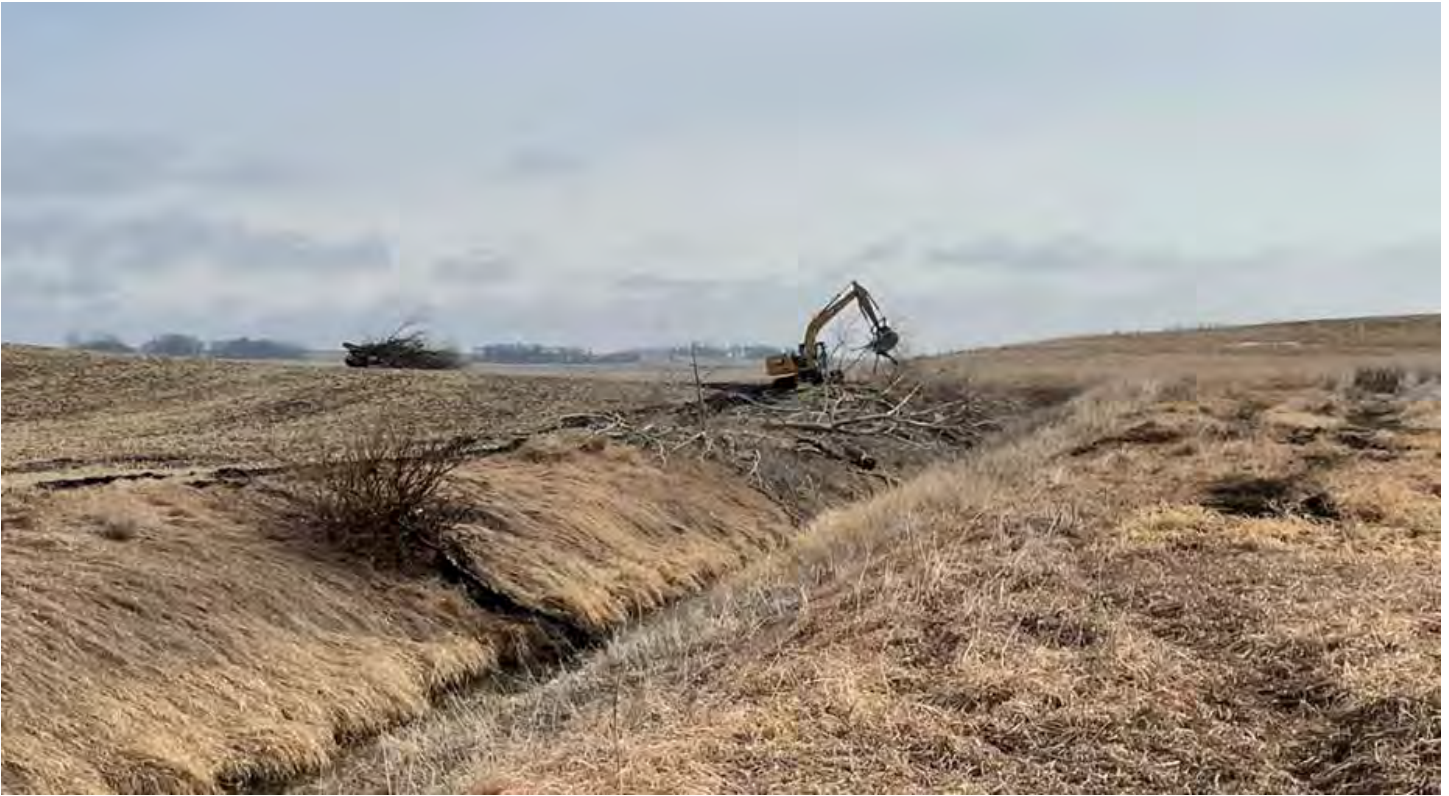
Many areas within the east half of Section 7 and west half of Section 8 in Kiester Township have full grown trees within the ditch bank and buffer strip. These trees can cause surface erosion and block bank vegetation from establishment. As of March of 2022, these large trees are being removed on a separate contract through the drainage authority. Other tree removals along the rest of the ditch are smaller and will be removed as needed with other ditch repairs as incidentals.

*Figure 15: Tree Removals along CD 64 (Section 8, Kiester Township)*

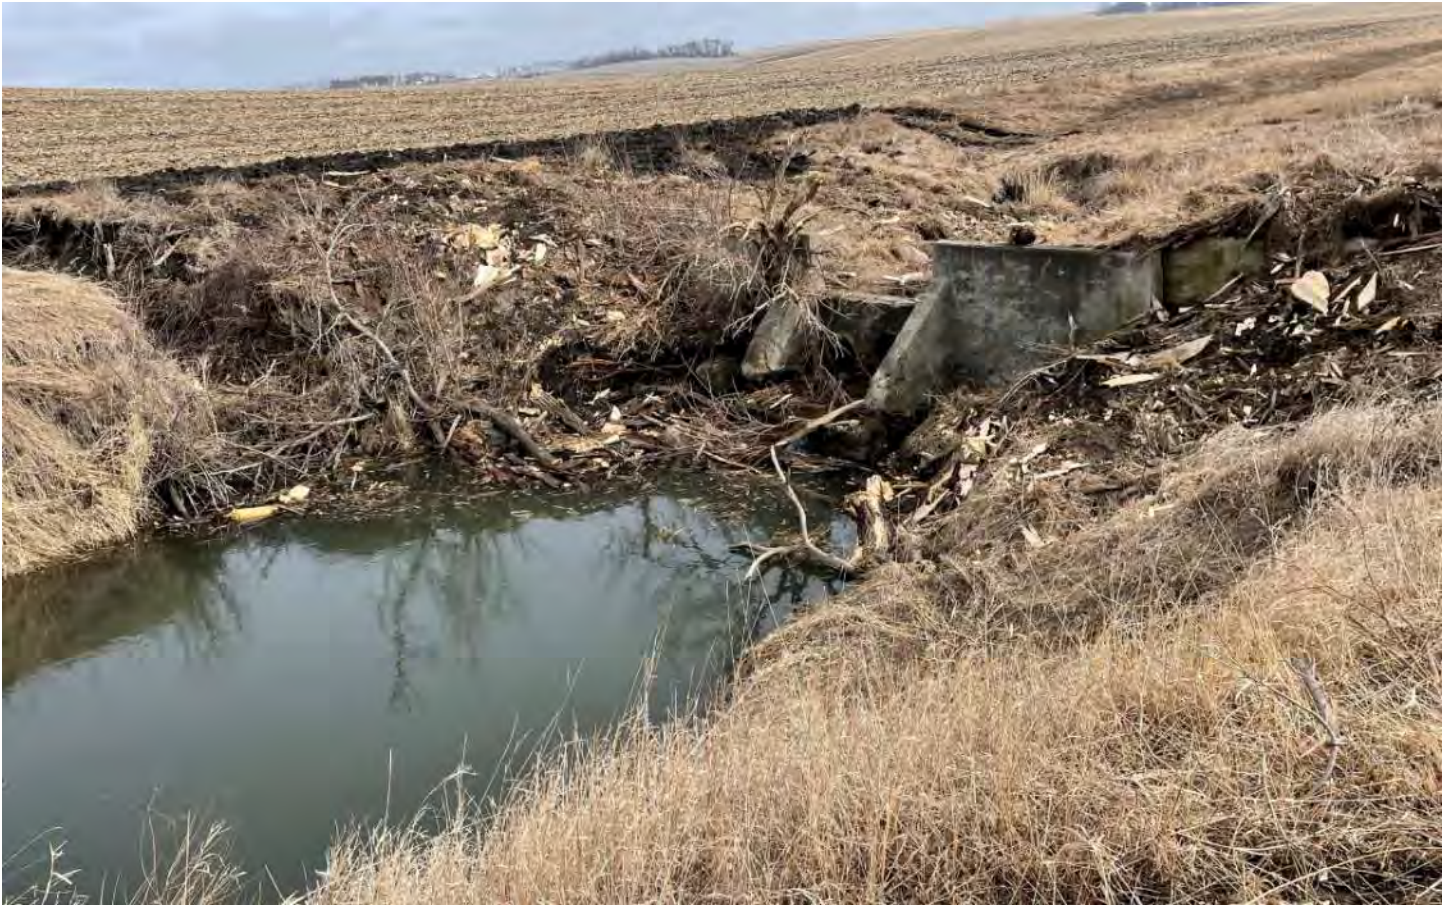
The existing headwall at the beginning of the open ditch in Section 8 of Kiester Township is in failing condition. Upstream of the headwall, the grassed waterway has eroded down to the existing tiles that drain into the open ditch. Along the sides, there are two gulley's that have carved large holes in the ditch banks. The concrete headwall itself is deteriorated, with the bottom portion no longer fully attached and the wing walls eroded and no longer connected. The channel itself has carved a large plunge pool due to the high flows, velocities, and erosion through the years. The age of the structure is approximately 100-years which is likely over the expected lifespan. Figure 17 through Figure 19 show photos of the headwall structure.

*Figure 17: Failed Headwall at Beginning of Open Ditch (Section 8, Kiester Township)*

The existing headwall is in need of major repairs that may be costly. There are two options to consider for repairing the headwall, adjacent waterway, and gully erosion through the ditch bank. In both options, it is proposed to build a berm around the perimeter of the plunge pool to direct surface flow into the pool at 1 location. Also in both options, it is proposed to fill in the large gullies, add rip rap for stabilization, and add alternative side intake to take some immediately adjacent surface water into the pool. Sections of the tiles outletting inlet to plunge pool under the waterway will also need to be replaced in the waterway erosion areas. Both options would need further surveying and design moving forward depending on which option is preferred.

Option 1 includes replacing the concrete headwall with either a concrete structure or sheet pile weir. The weir wall would be installed just upstream of the existing structure to allow for rip rap to be placed on the downstream side to prevent future erosion and enlargement of the plunge pool. Both of the existing tiles outletting through the weir wall would be replaced with watertight tiles and connected through the new weir. Upstream of the new weir wall, additional rip rap would be added to dissipate velocities and to protect the backfill from downcutting. The grassed waterway would be repaired by filling the erosion holes and reseeded. Additional rip rap would be added on the perimeter of the plunge pool to prevent it from expanding and eroding further.

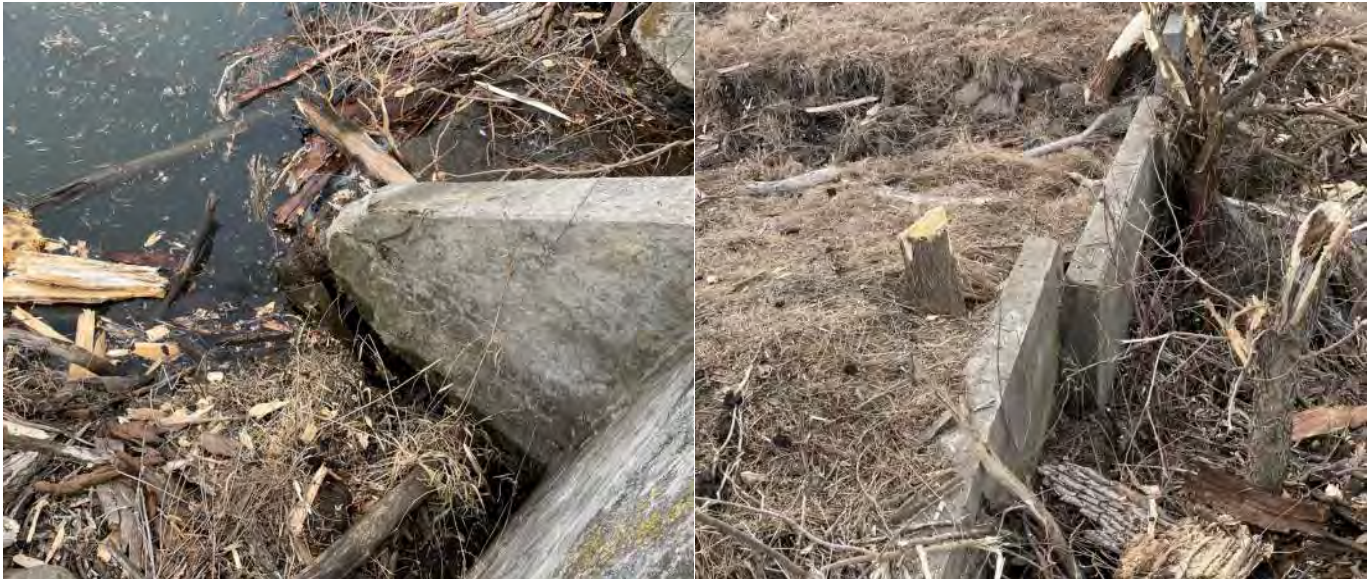
*Figure 18: Headwall Failures*

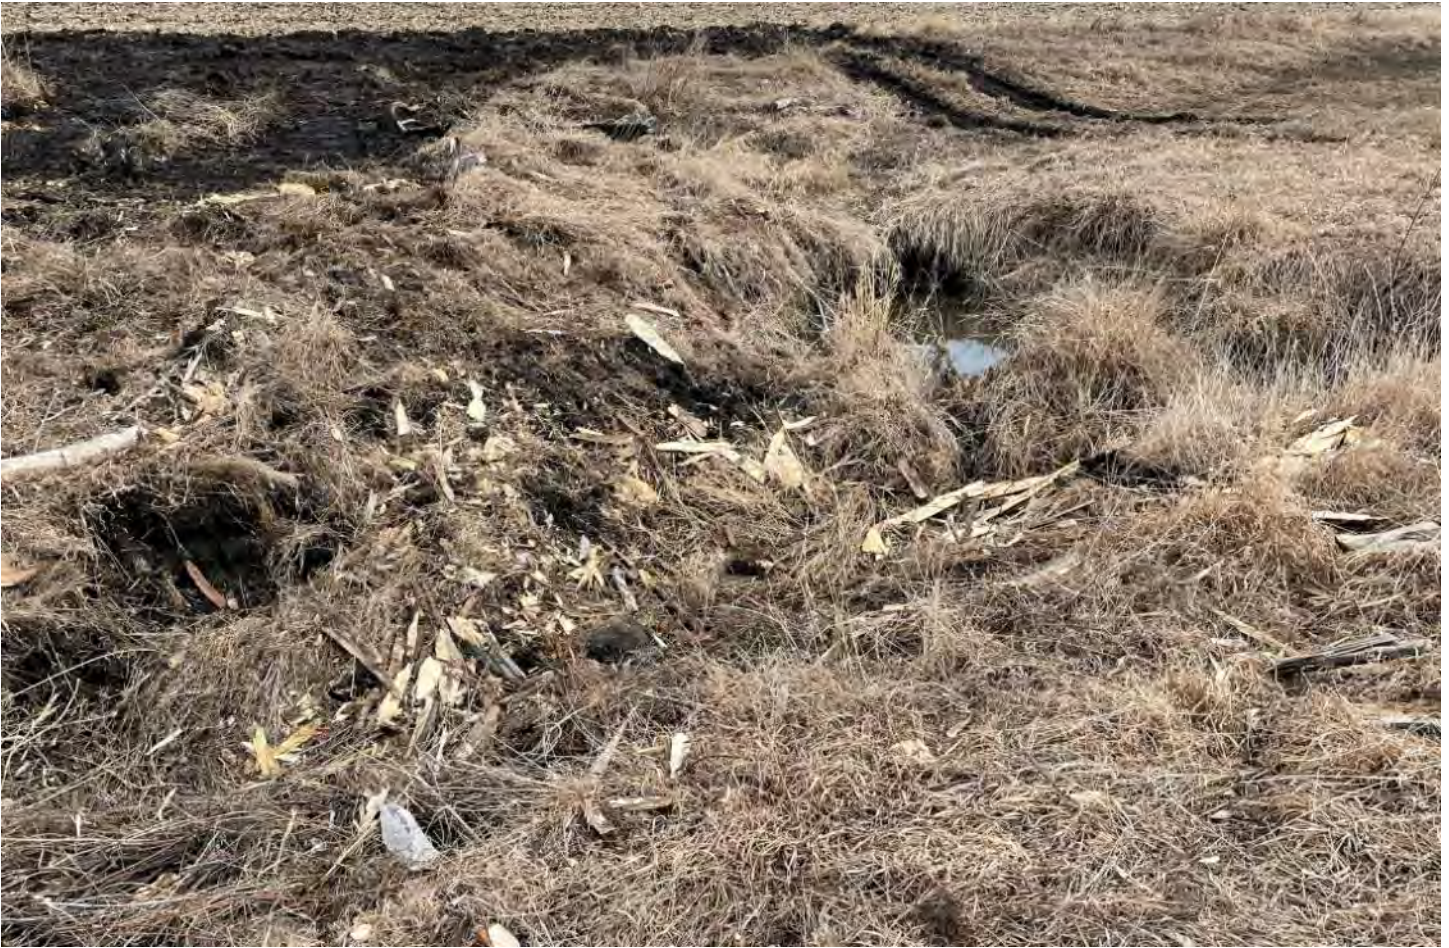
*Figure 19: Grassed Waterway Erosion and Downcuts*
