Faribault County, Minnesota

County Ditch #86

Staff Repair Report

August 2021

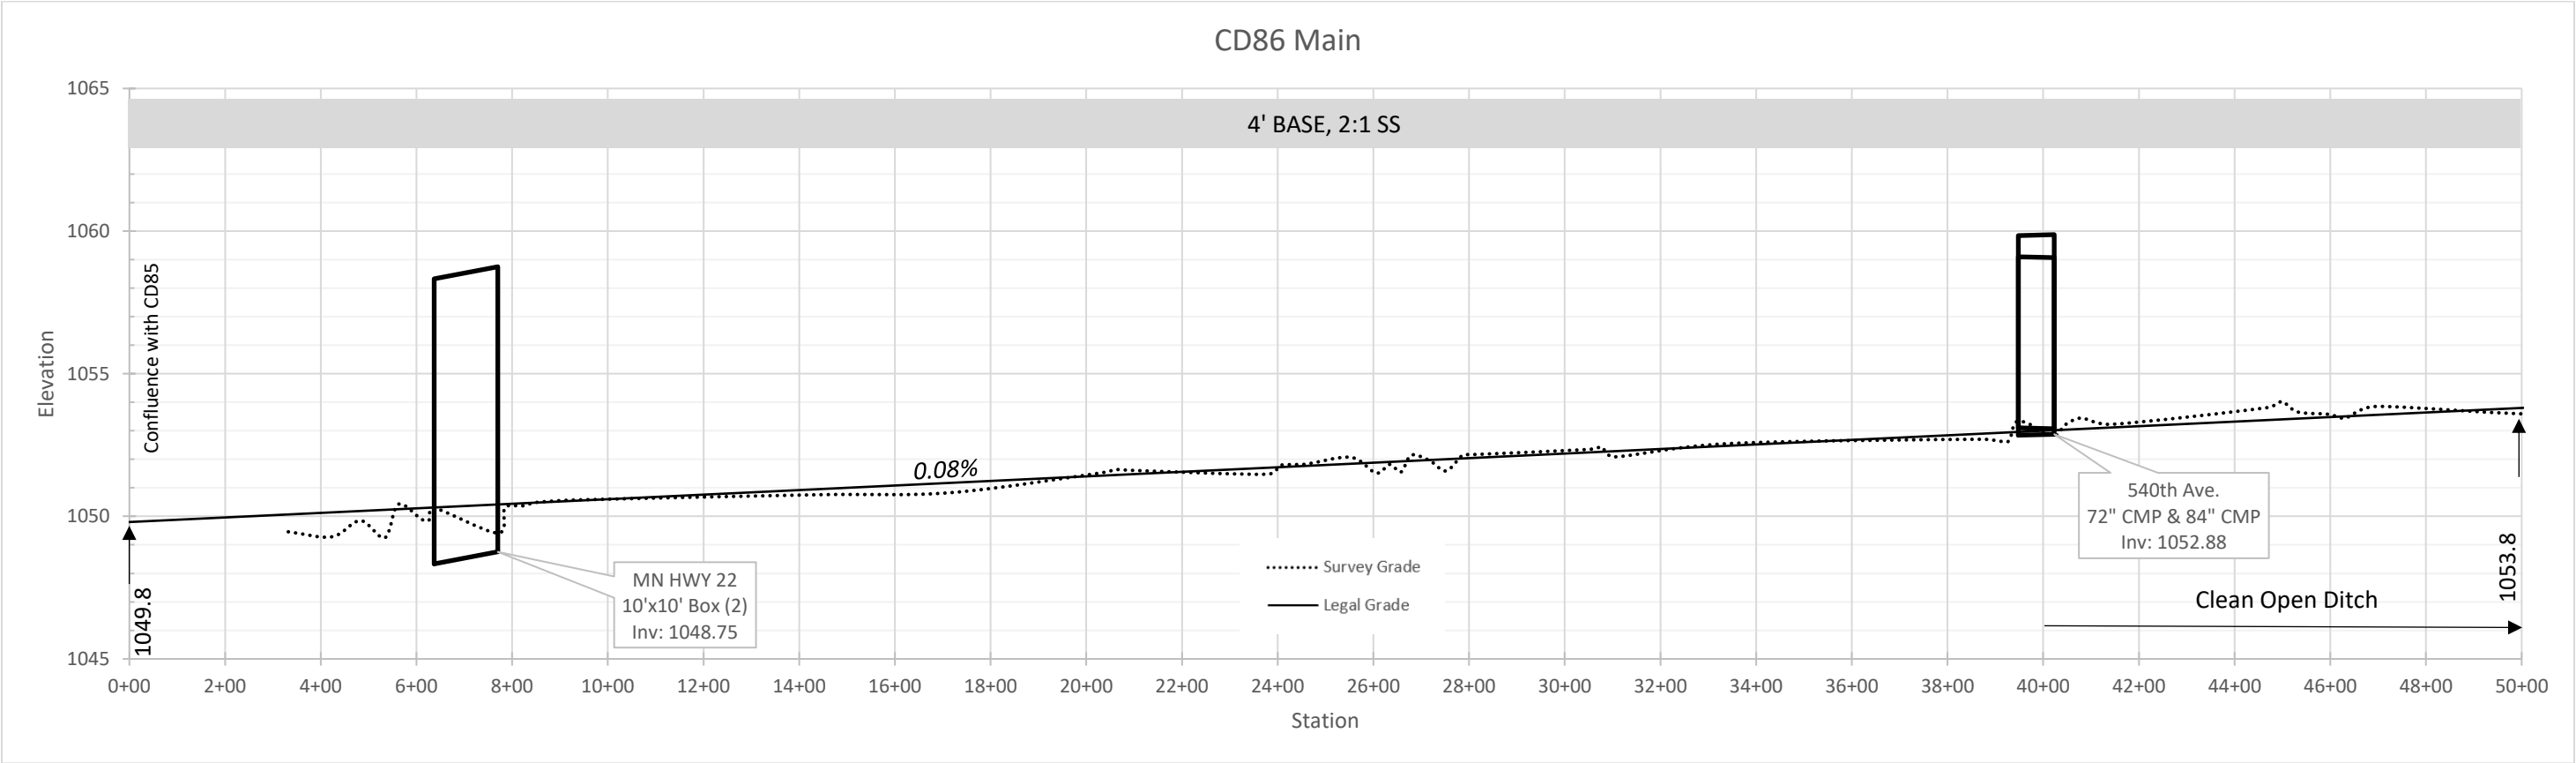
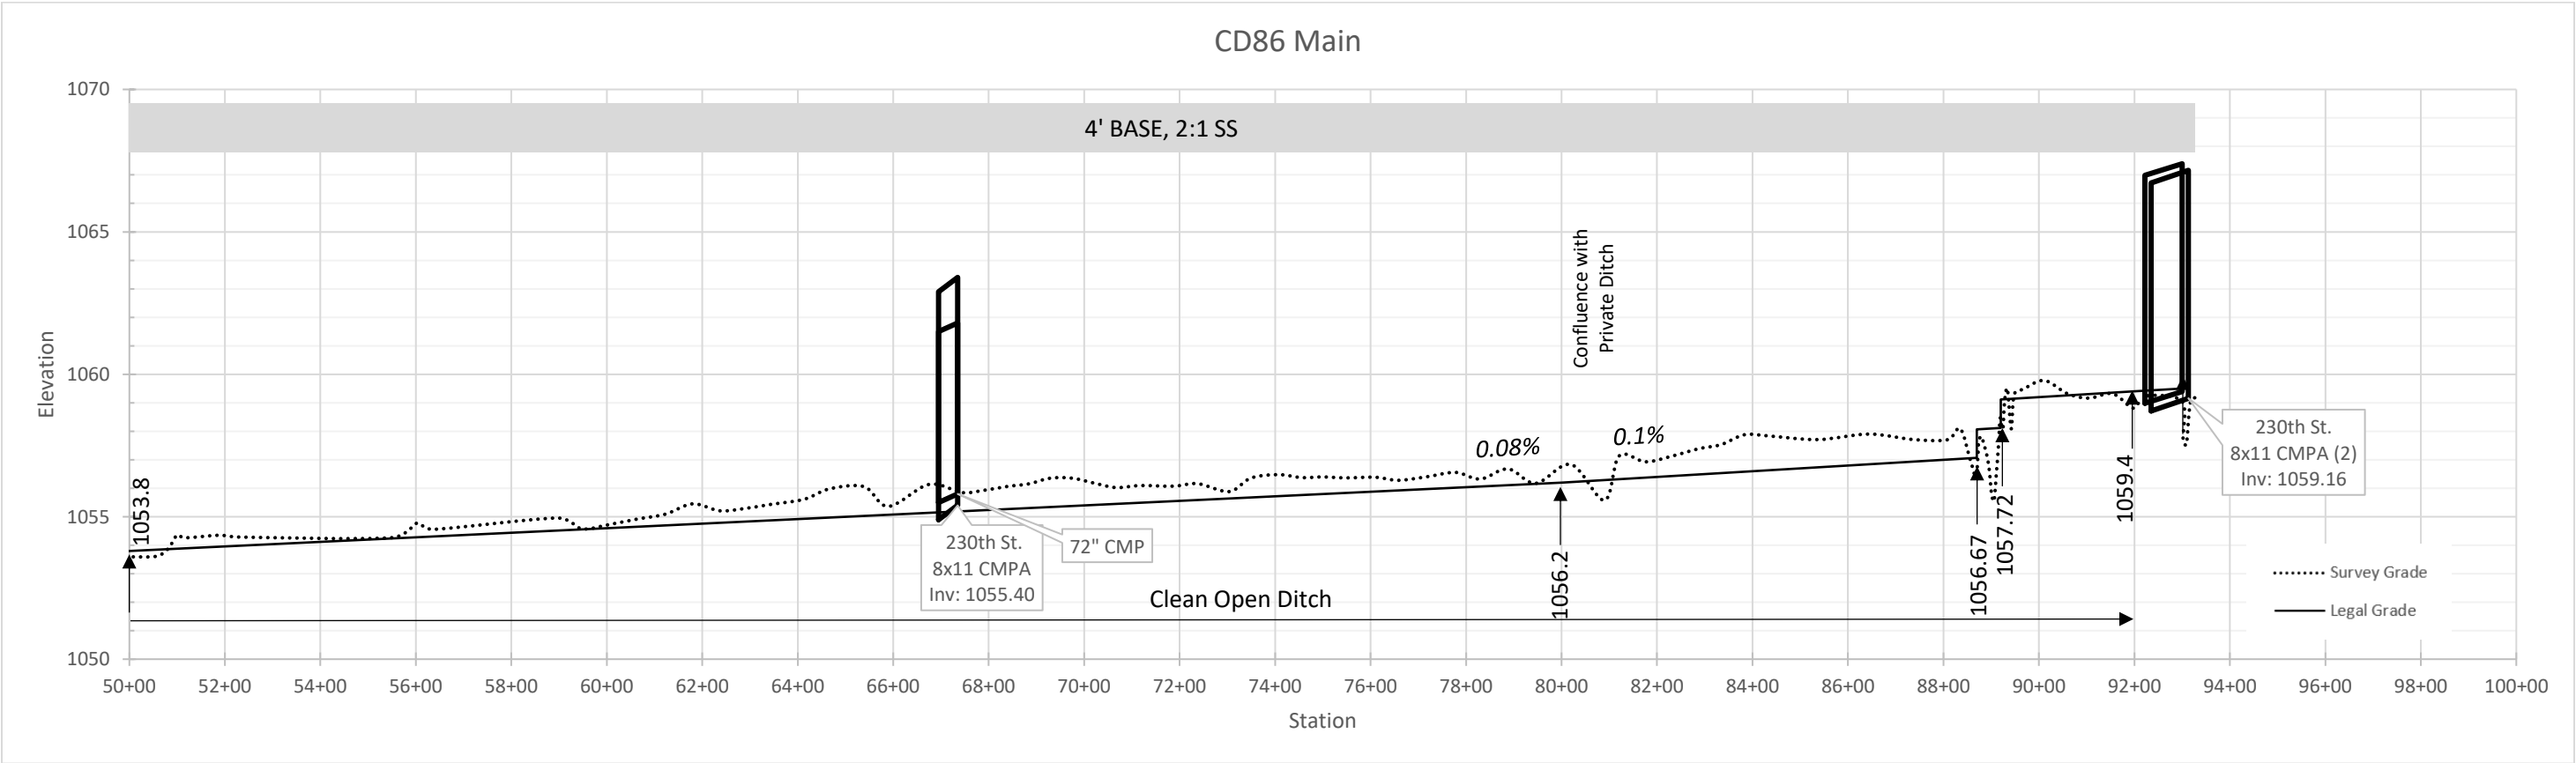
According to the profiles, some areas upstream of 540th Ave have accumulated sediment at depths ranging from 0 to 1 foot. All roadway crossings consisted of two culverts. In each instance, at least one of the roadway culverts had an invert elevation at or near the legal grade of the ditch.

Open Ditch Cleaning: Sediment in the channel bottom should be excavated from Station 40+00 to 92+00. Sediment accumulation depth ranges from 0.5 – 1 foot. Levelling of berms may be required to clean the ditch north of 230th St. The berms will need to be restored to their current elevation after repair activities have been completed.
