# Faribault County, Minnesota

## Joint County Ditch #202FM

### Staff Repair Report

February 2021

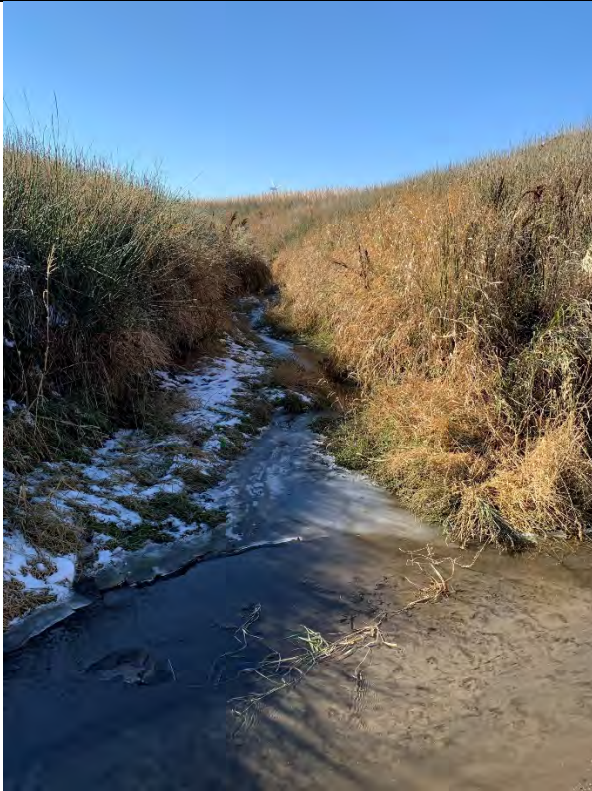
Confluence of JCD202FM with JD2FM

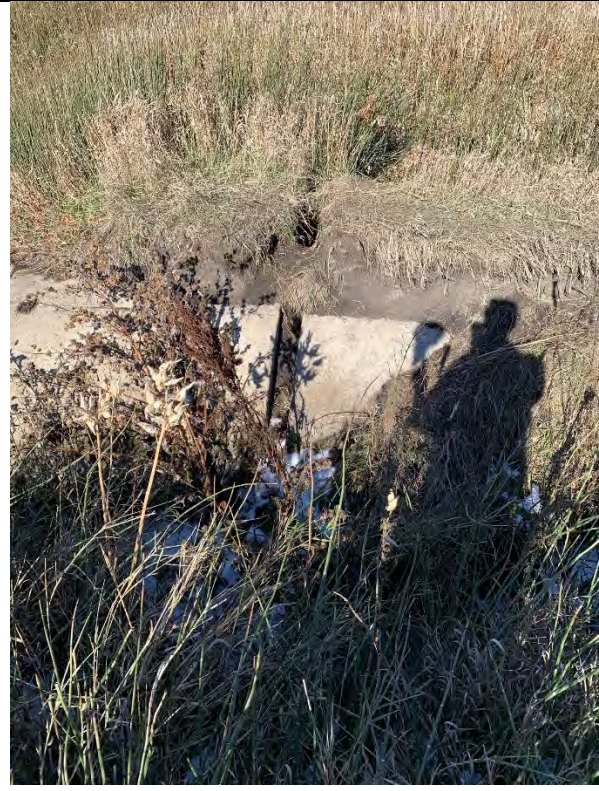
96" RCP Field Crossing at Station 7+00 on Main.

Remove and Dispose of Field Crossing: The 96" RCP Field Crossing on the Main Trunk at station 7+00 should be removed and disposed of. The ditch slopes should be seeded and blanketed.

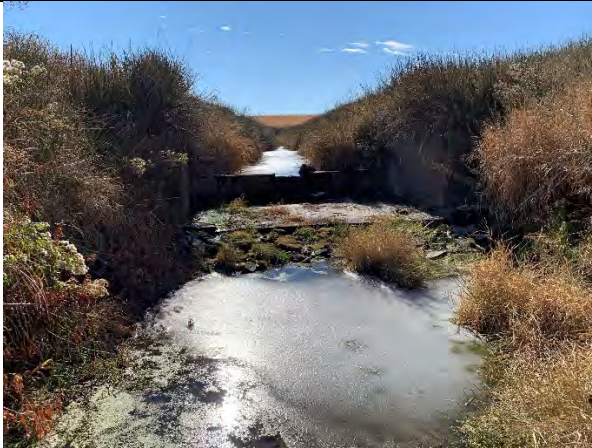
Control structure at Station 2+00.

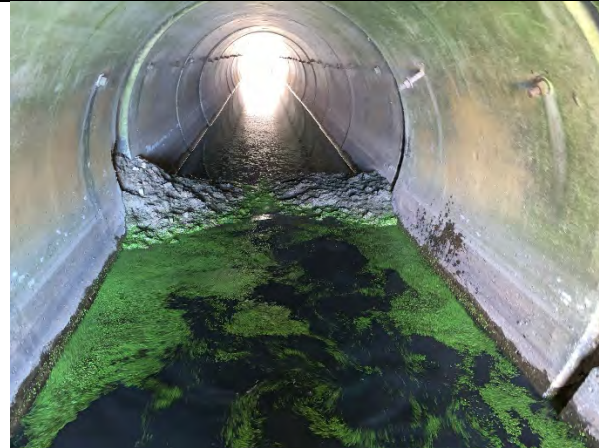
310<sup>th</sup> Ave Township Road Crossing. Sediment is being deposited in the pipe from a wide joint.

Repair 310<sup>th</sup> Ave. Ditch Crossing: The 72" RCP 310<sup>th</sup> Ave Township Road Crossing (Faribault-Martin County Line) has a joint that is depositing gravel and sediment into the pipe. Three RCP sections of this crossing need to be removed, re-set, and tied together. The gravel road shall be restored with Class V gravel.

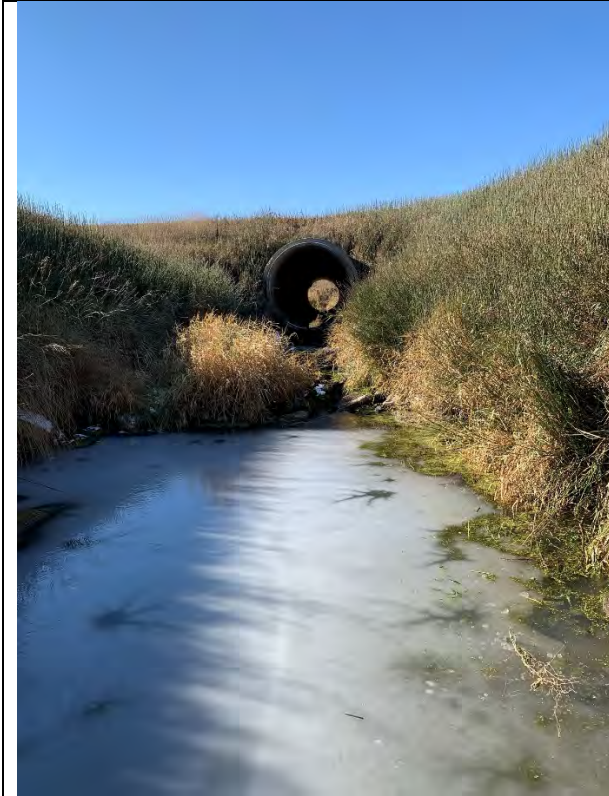
Field crossings, road crossings, and headwall elevation were largely found to be on grade. Two of the three original concrete headwalls from 1979 were in place, however the concrete headwall on the Main Trunk at station 18+00 has been destroyed. The destruction of this headwall caused the ditch bottom to down-cut up to the CR1 Road Crossing, making the CR1 Road Crossing the new grade control point.

96" RCP County Road 1 Crossing. This crossing is acting as a grade control point.

Armor Existing Open Ditch Crossings: It is recommended that each open ditch crossing on the Main Trunk and Branch 9 be protected with rock riprap armoring. This is especially true for the 96" RCP CR1 Road Crossing on the Main Trunk at station 20+00.

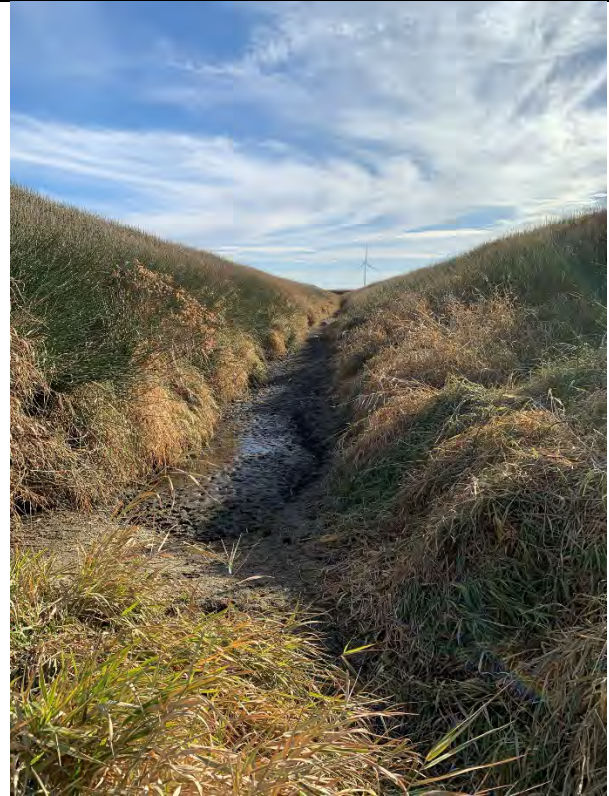
Main Trunk channel condition.

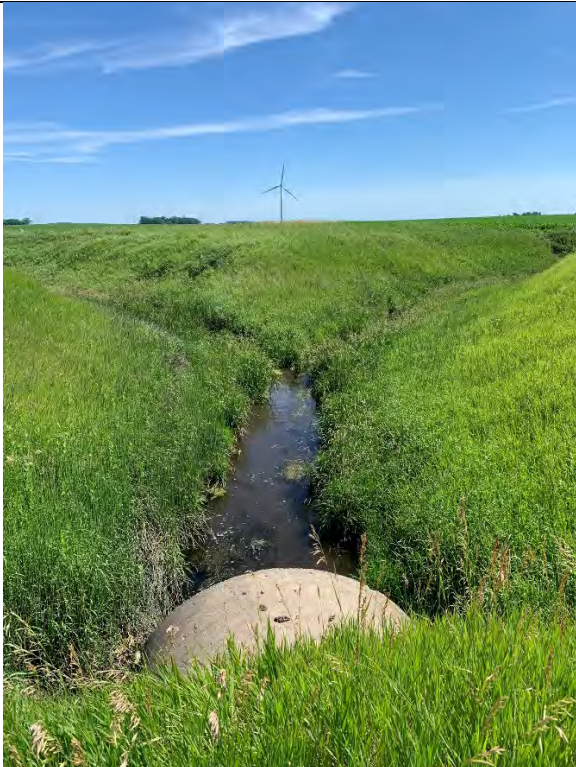
Confluence of Branch 9 with Main Trunk

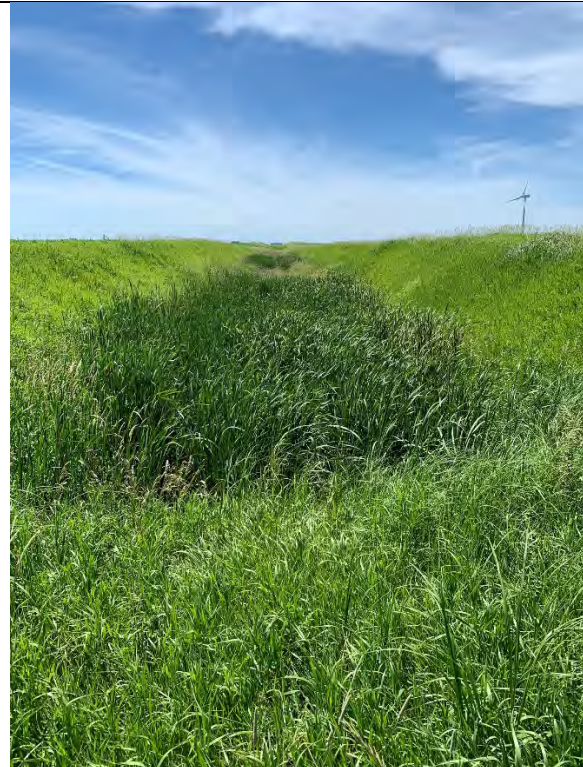
The JCD202FM Main Truck Open Ditch system is in relatively good condition except for required repairs to two ditch crossings and spot cleaning of the open ditch. It is clear from the profiles that Branch 9 is impacted by sediment accumulation in the ditch bottom. On average, 1 to 2 feet of sediment is impacting the entire length of Branch 9, approximately 7,400 linear feet.

Branch 9 channel condition.

Open Ditch Excavation: The entire 7,400 linear feet of Branch 9 channel needs to be restored to legal grade, whereas 8,350 linear feet of spot cleaning is required on the Main Trunk (see profiles).
