# Faribault County, Minnesota Joint County Ditch #301FF Staff Repair Report

February 2021

## JCD301FF Hueper Branch Repair

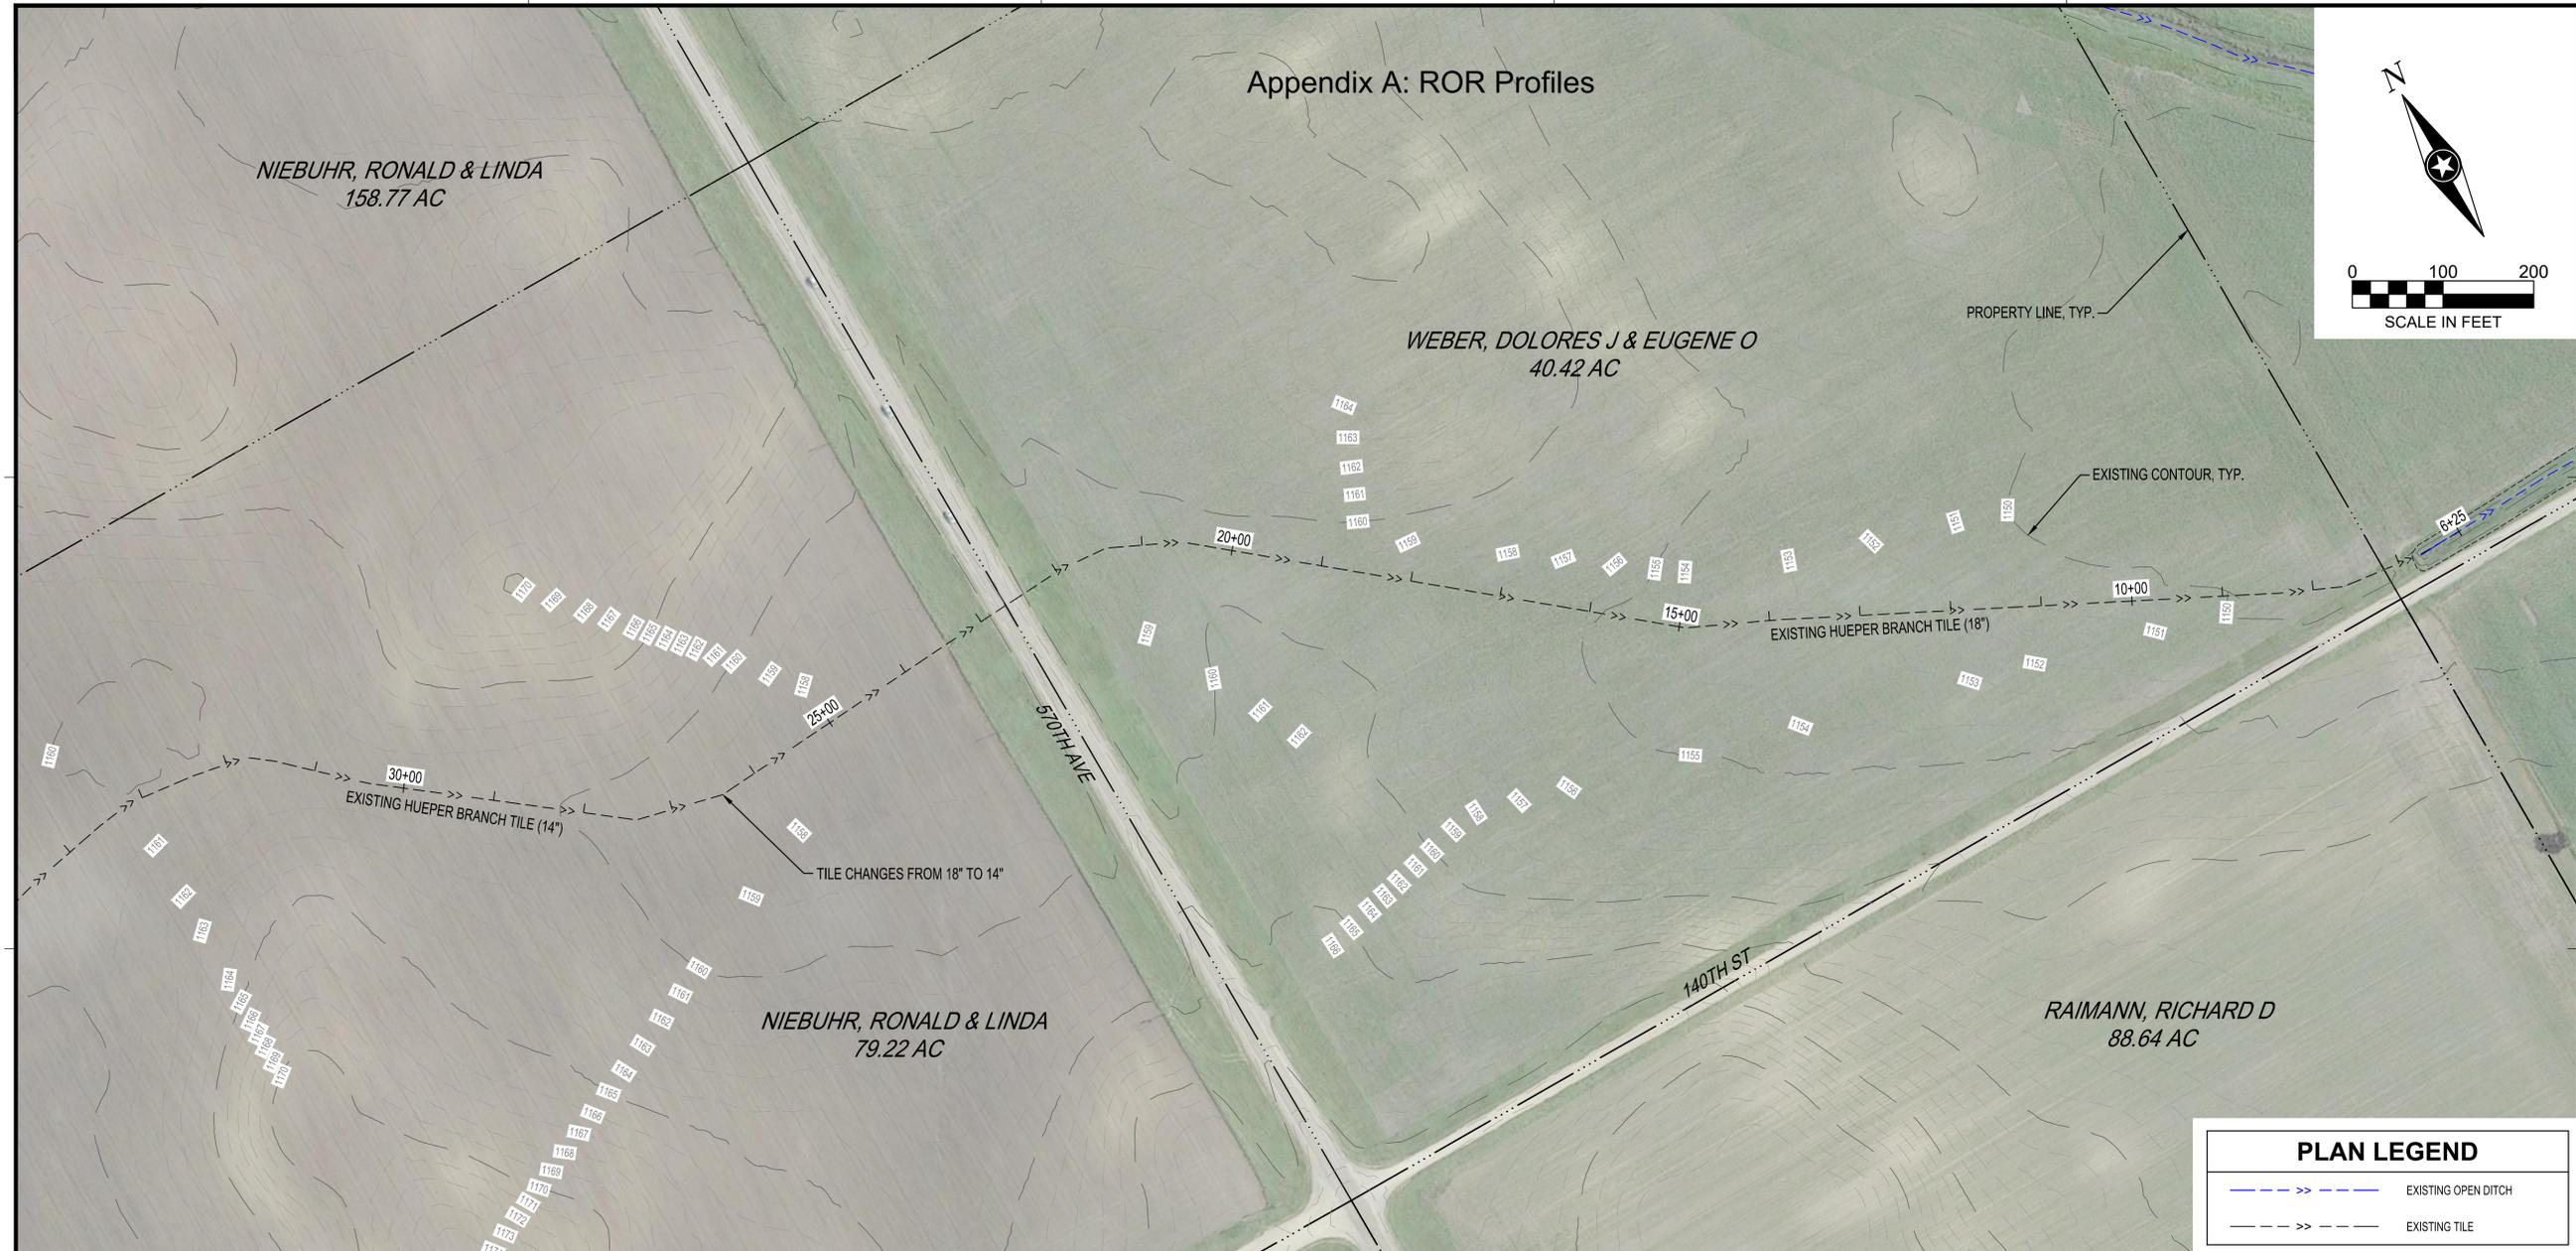
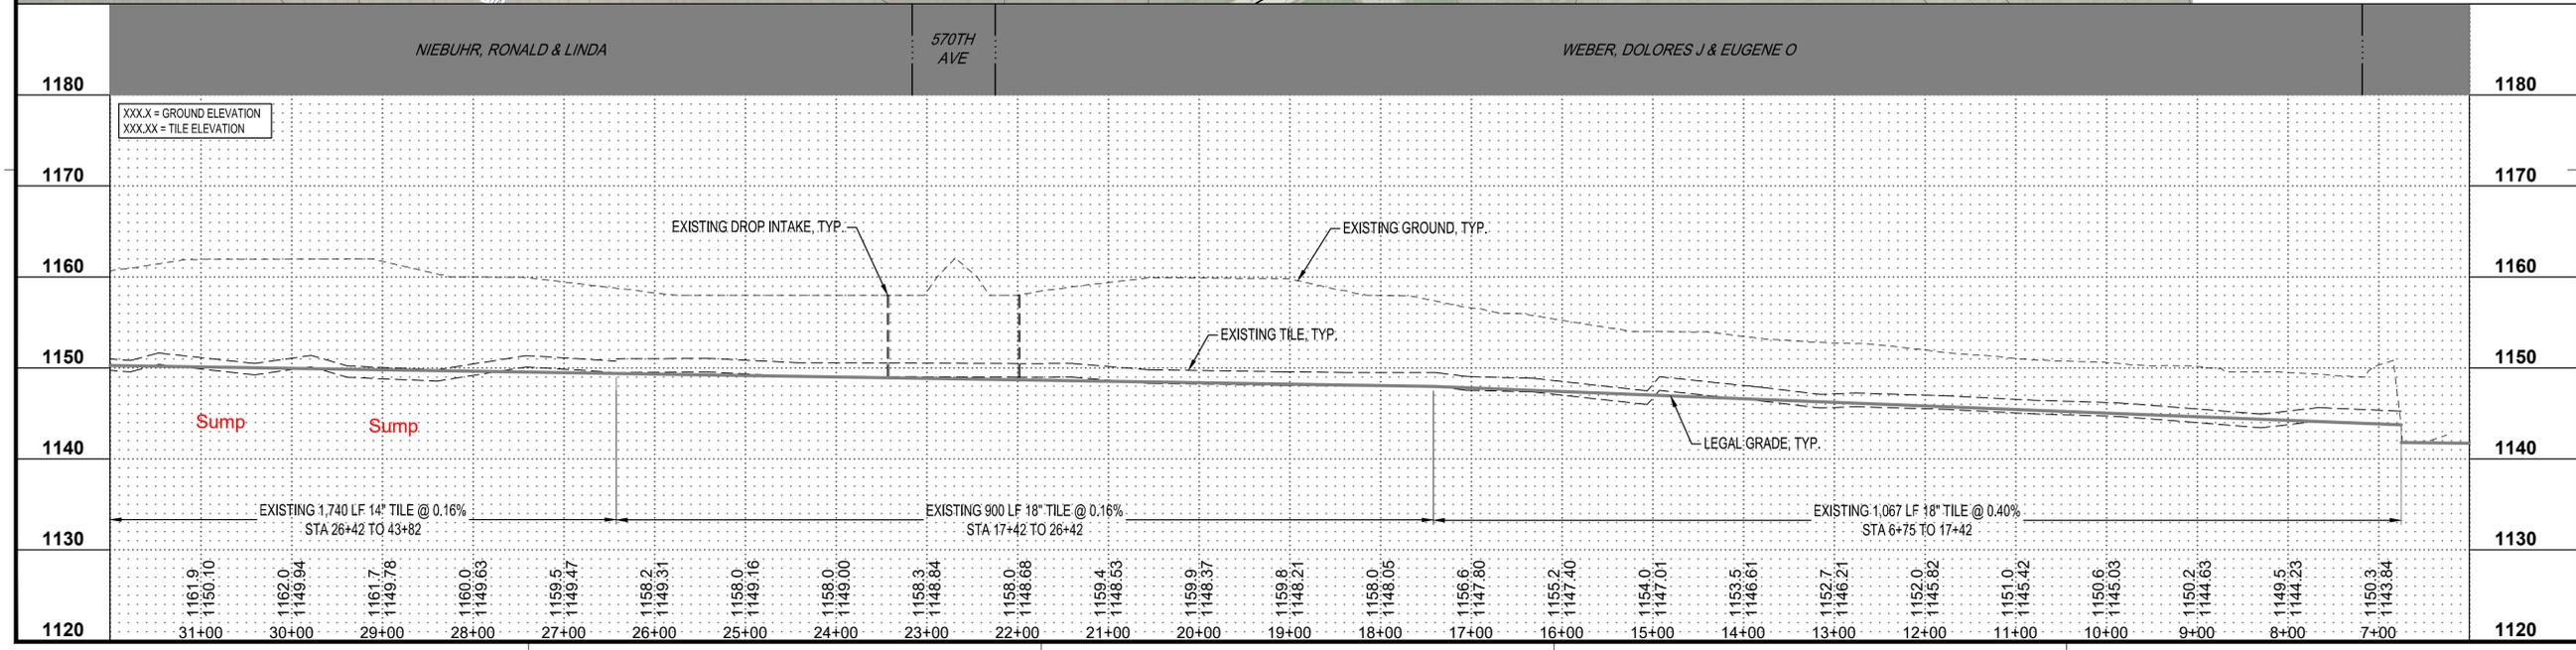
TITLE  
**TILE PLAN AND PROFILE**

The televising footage showed numerous areas of cracking, offset joints, debris in the flowline, and off-grade sections. However, the proposed spot repairs only include portions of the Hueper Branch that are severely inhibiting drainage capacity and/or are likely to fail in the near future. The main cost for this option are the two sump replacements of 15" tile, 235 feet and 275 feet, in the deepest cut of the system (see profiles).
