REESTABLISHMENT OF RECORDS JCD 301-HUEPER BRANCH

Faribault County, Minnesota

Date: November 19, 2020

ISG Project No.: 17-20487

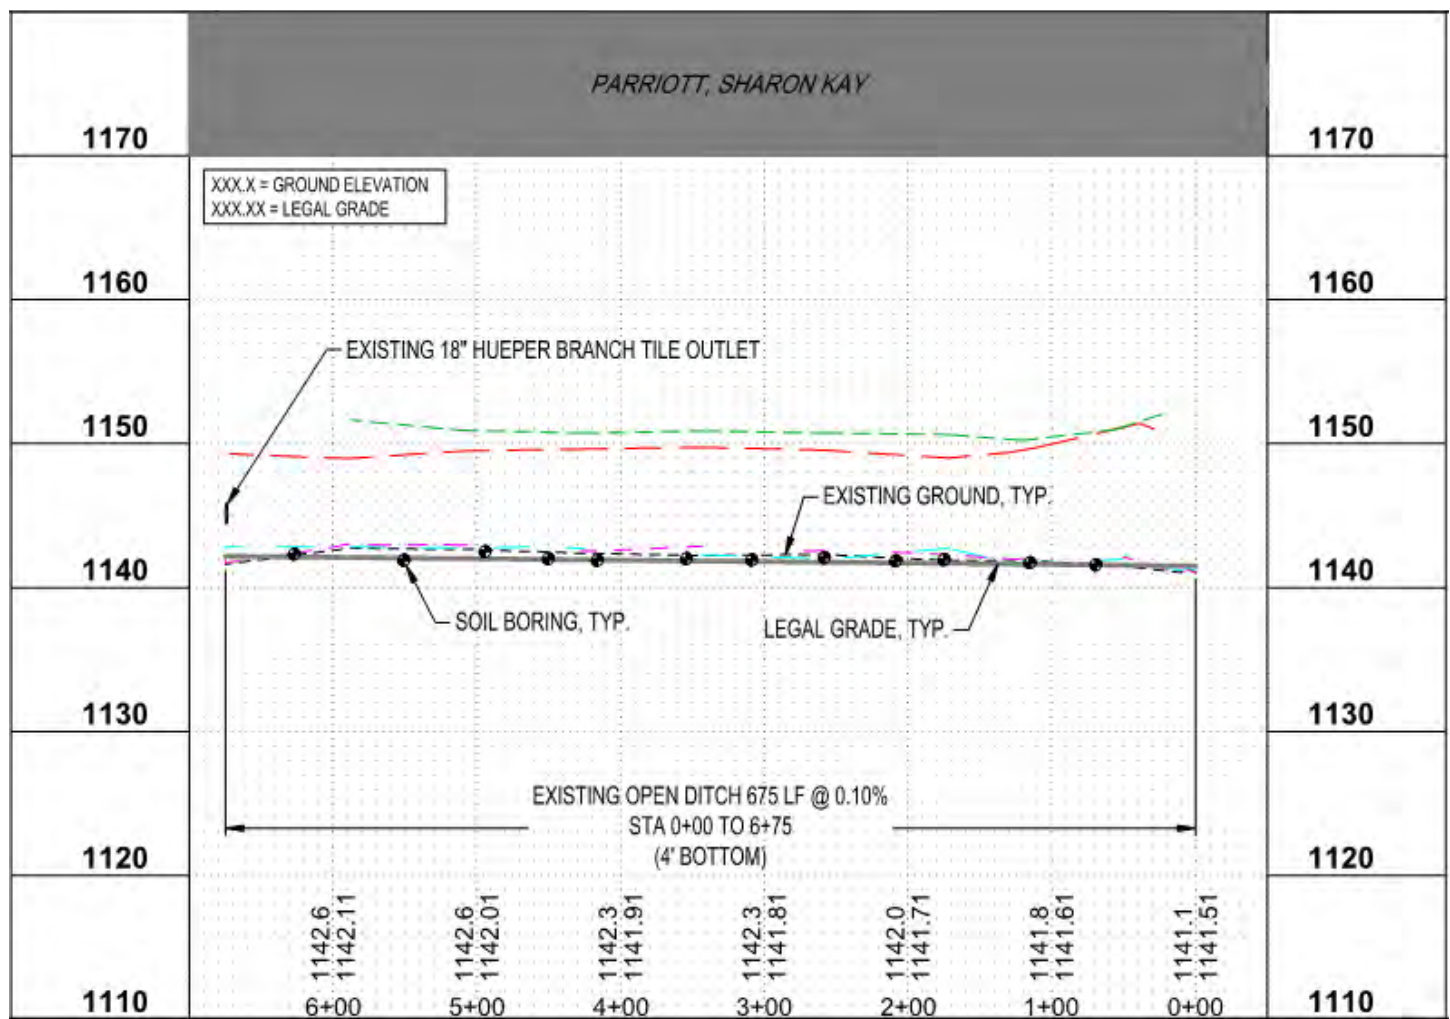
Figure 11: Open Ditch Profile of Hueper Branch

The only records indicating a legal grade of the Hueper Branch are from 1950 where the grade was shown at 0.10%. A profile plot of the open ditch and the soil borings was created to determine the legal ditch grade. The historical 0.10% open ditch grade was brought into the profile and a line of best fit was created to match as many soil borings as possible. Figure 11 shows the open ditch profile of Hueper Branch, indicating the reestablished grade based on soil borings and historical ditch repairs.

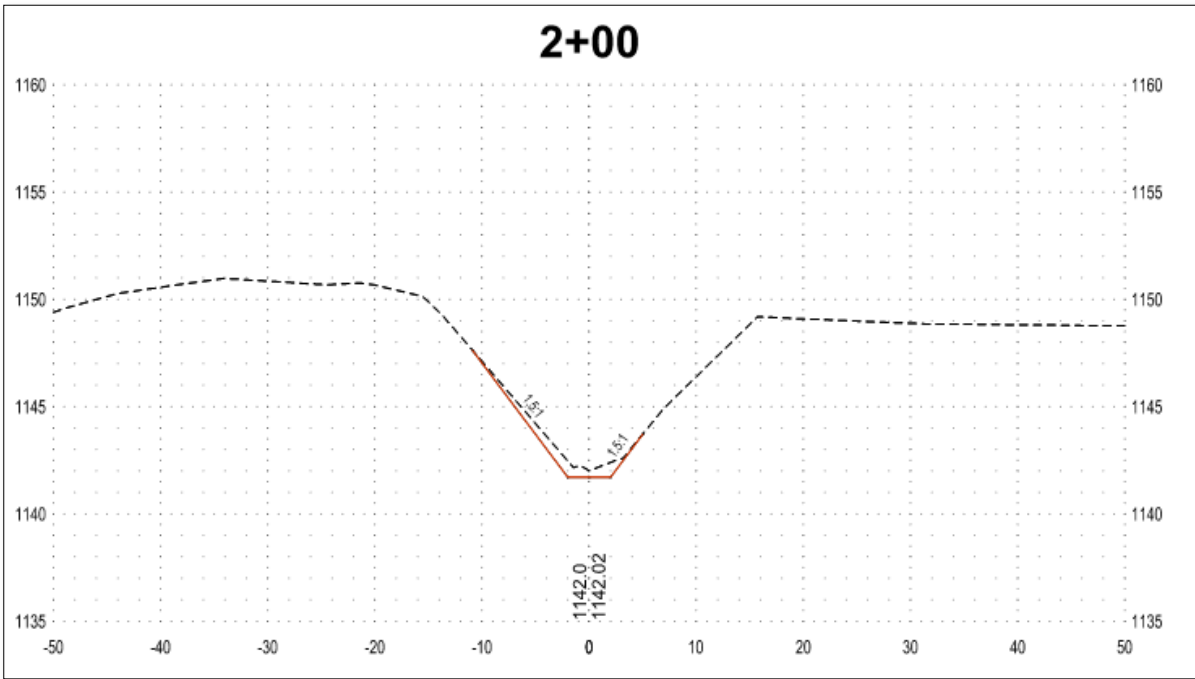
Figure 12: Cross Section of Hueper Branch Open Ditch

Historic records from the 1950 repairs indicate a ditch geometry of a 4-foot bottom width with 1:1 side slopes. The survey revealed consistency with a 4-foot bottom width; however the side slopes line up closer to a 1.5:1. Figure 12 shows an example cross section of the open ditch.

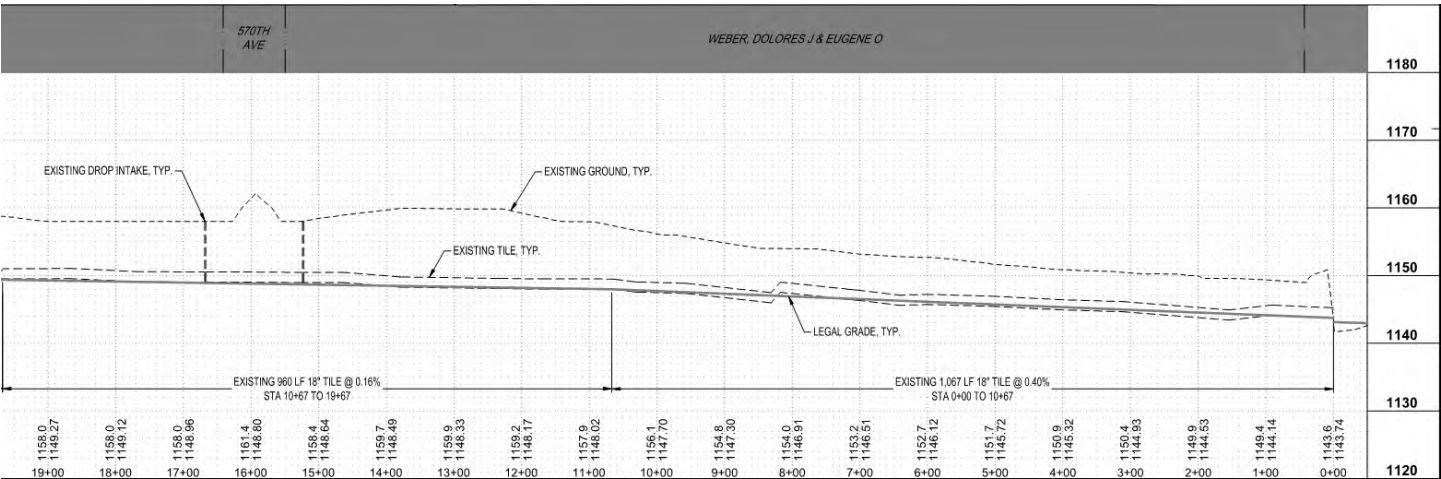
Figure 13: Profile of Buried Tile from Open Ditch to 570th Ave

Profiles of the tile data were created to develop a legal grade profile of the Hueper Branch tile. Figure 13 below shows a portion of the profile of the buried tile. The data from the televising camera does not show smooth grades of the existing tile. This is likely due to several factors. The condition of the tile varies based on age. Some portions of the tile are over 80 years old and in poor conditions. As the open ditch was filled in, it is likely that the buried tile was placed in the open ditch without proper bedding. This would allow for shifting of the pipes and not a smooth grade. The televising confirmed that the tile does not flow at smooth and consistent grade lines.

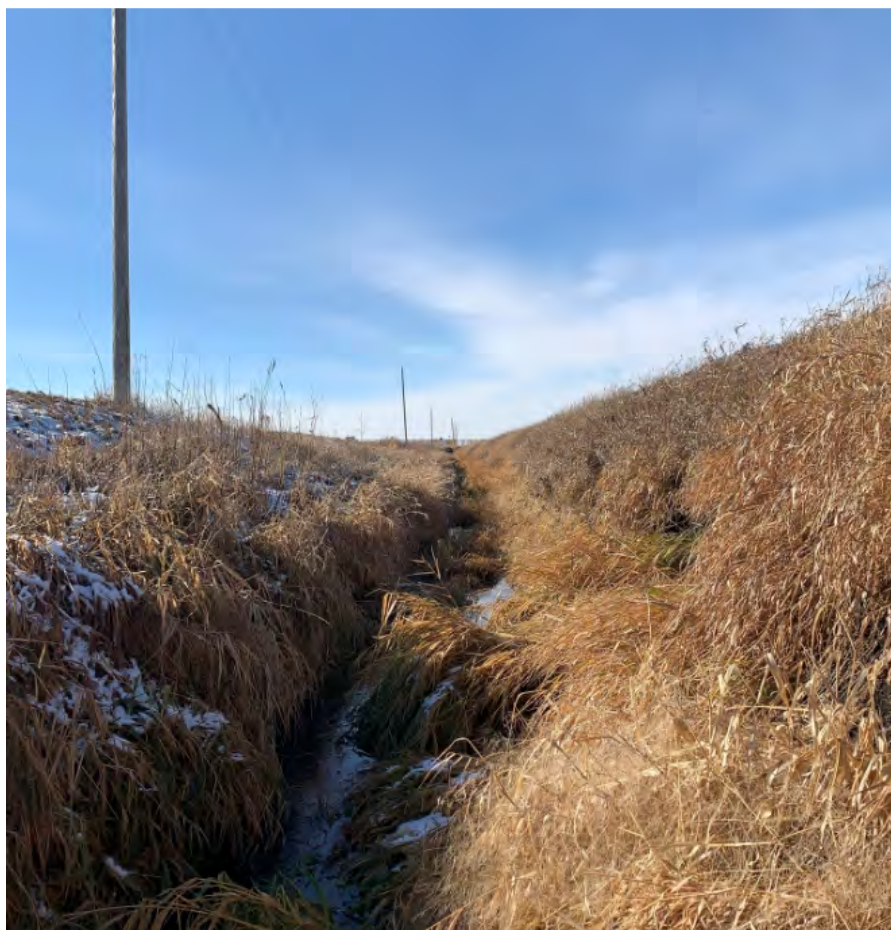
Figure 14: Hueper Branch Open Ditch Looking West from CD 301 Mainline

During the open ditch surveying, soil borings, and tile investigation; the existing conditions of the drainage infrastructure were noted. The open ditch portion of Hueper Branch is in fair condition with sediment and vegetation growth within the open ditch and minor sloughing. Buffer strips were not in place at the time of the survey. Figure 14 and Figure 15 show the existing conditions of the open ditch.

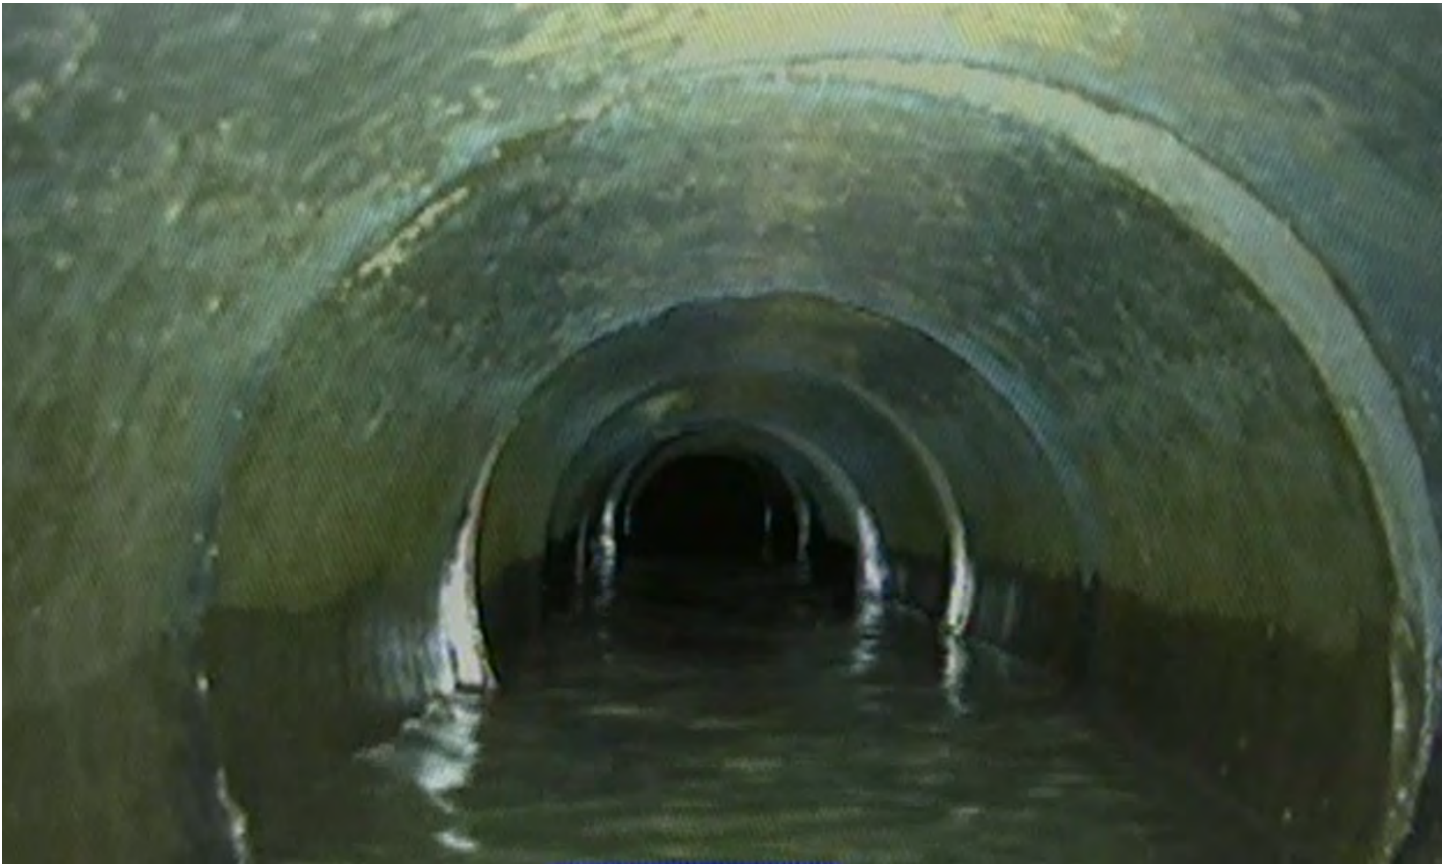
Figure 16: Televising at the Tile Outlet into Open Ditch

The condition of the buried tile was also documented during the televising. Overall, the existing tile is in poor condition with offset joints, cracking in the pipe sections, bellies in the pipe where the pipe has sunk, and other blockages. A full televising report is included in Appendix D while Figure 16 through Figure 20 show images of the televising throughout the Hueper Branch.

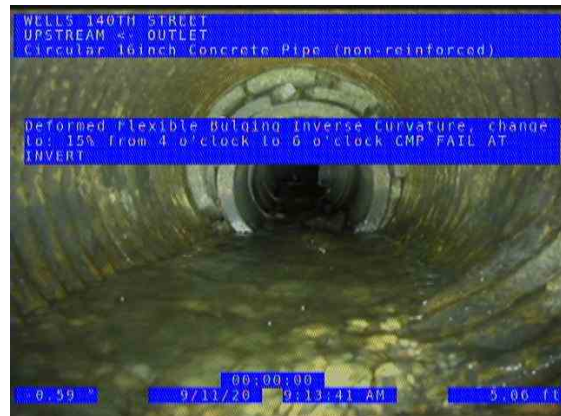
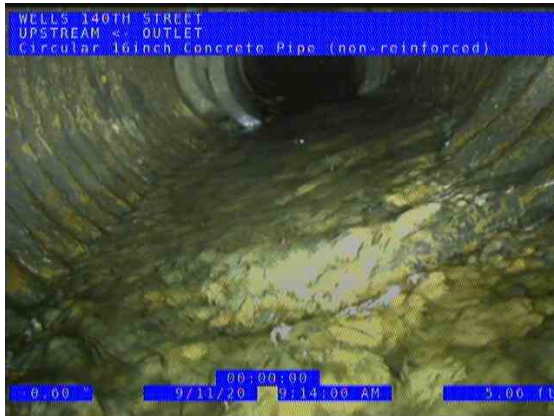
HUEPER BRANCH OUTLET (US)
UPSTREAM_4c48e0ef-33d7-4455-a360-c3de5c30cc74_2020
0911_093408_971.jpg, 00:00:17, 5.06ft
Deformed Flexible Bulging Inverse Curvature, change to: 15%
from 4 o'clock to 6 o'clock / CMP FAIL AT INVERT

HUEPER BRANCH OUTLET (US)
UPSTREAM_3c1e7256-2f41-4754-b1b6-1944c65ee355_2020
0911_093427_845.jpg, 00:00:17, 5.06ft
Deformed Flexible Bulging Inverse Curvature, change to: 15%
from 4 o'clock to 6 o'clock / CMP FAIL AT INVERT

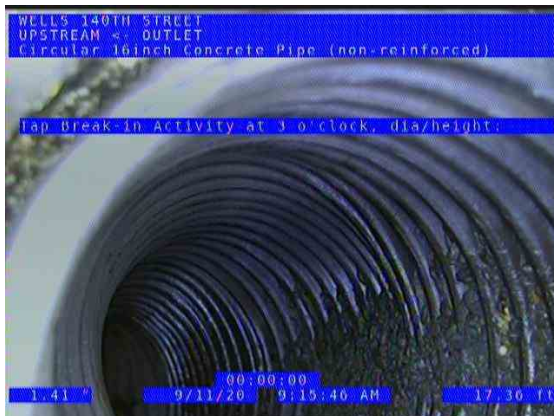
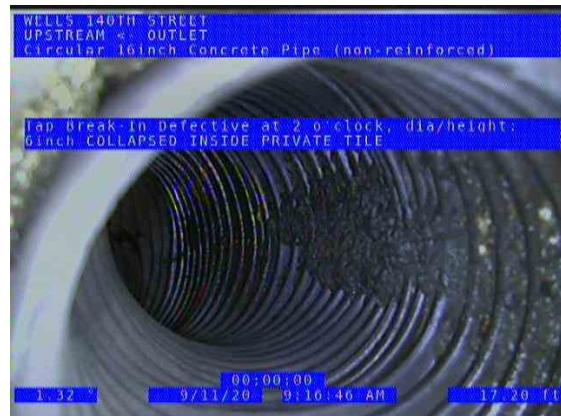
HUEPER BRANCH OUTLET (US)
UPSTREAM_501d19e1-907c-490a-a78d-7d8bd28d6a86_202
00911_093614_123.jpg, 00:01:35, 17.36ft
Tap Break-In Defective at 2 o'clock, dia/height: 6inch /
COLLAPSED INSIDE PRIVATE TILE

HUEPER BRANCH OUTLET (US)
UPSTREAM_ce0e5e53-6a12-49ac-a67c-c8c695227b42_2020
0911_093713_691.jpg, 00:01:35, 17.36ft
Tap Break-In Defective at 2 o'clock, dia/height: 6inch /
COLLAPSED INSIDE PRIVATE TILE

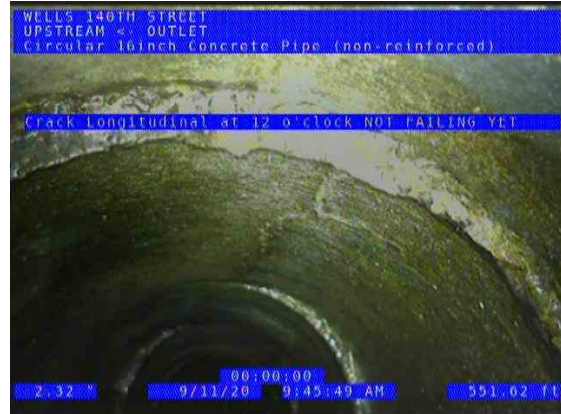
HUEPER BRANCH OUTLET (US)
UPSTREAM_e6ab26fa-49b3-489f-97b9-0b05a3cfd5c_20200911_100617_103.jpg, 00:18:46, 551.62ft
Crack Longitudinal at 12 o'clock / NOT FAILING YET

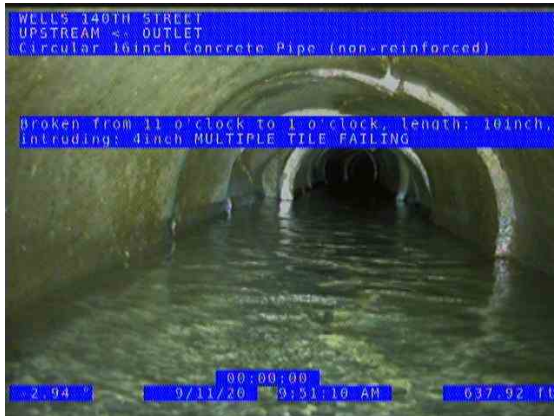
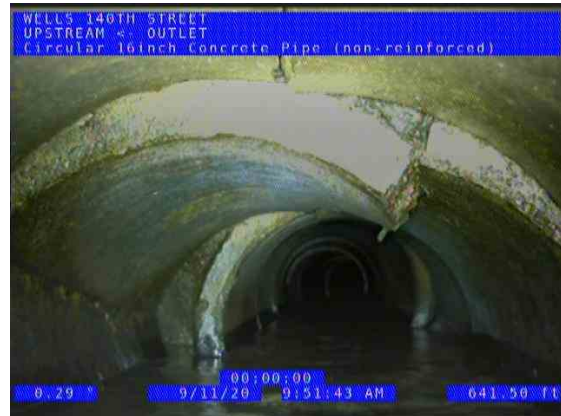
HUEPER BRANCH OUTLET (US)
UPSTREAM_23cf957b-cf6b-479f-abcd-5523457cbf2c_202009
11_101137_455.jpg, 00:21:16, 637.92ft
Broken from 11 o'clock to 1 o'clock, length: 10inch,
intruding: 4inch / MULTIPLE TILE FAILING

HUEPER BRANCH OUTLET (US)
UPSTREAM_ff8b467a-fca3-4e00-b752-e3d13ae92a85_20200
911_101210_495.jpg, 00:21:16, 637.92ft
Broken from 11 o'clock to 1 o'clock, length: 10inch, intruding:
4inch / MULTIPLE TILE FAILING

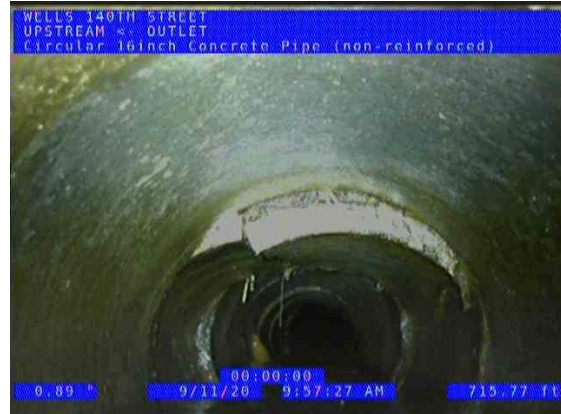
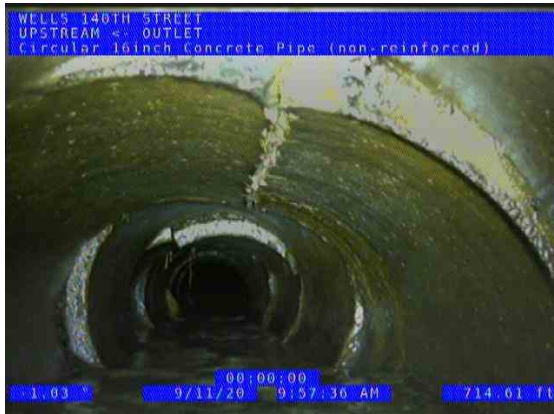
HUEPER BRANCH OUTLET (US)
UPSTREAM_120b2eca-5ce9-4ee4-b1d5-d46d0b1c7bf3_2020
0911_101754_365.jpg, 00:24:59, 713.21ft
Broken from 11 o'clock to 1 o'clock, length: 10inch, intruding:
4inch / COLLAPSING

HUEPER BRANCH OUTLET (US)
UPSTREAM_d92daa52-41f5-40c7-a997-ffe8c7b5df8_202009
11_101804_347.jpg, 00:24:59, 713.21ft
Broken from 11 o'clock to 1 o'clock, length: 10inch, intruding:
4inch / COLLAPSING

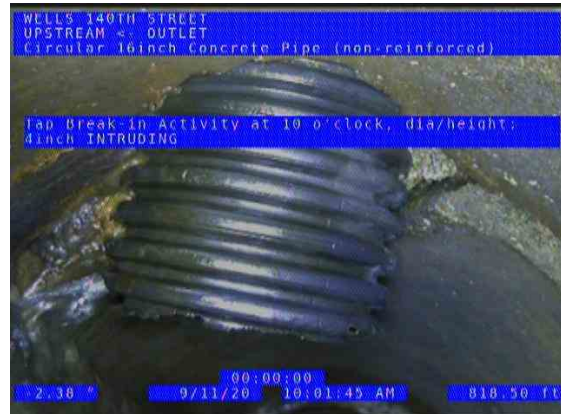
HUEPER BRANCH OUTLET (US)
UPSTREAM_493fb134-c9a4-4a87-8907-f65ebaed01c7_2020
0911_102212_412.jpg, 00:29:02, 818.50ft
Tap Break-in Activity at 10 o'clock, dia/height: 4inch /
INTRUDING, COLLAPSING IN THE PRIVATE TILE

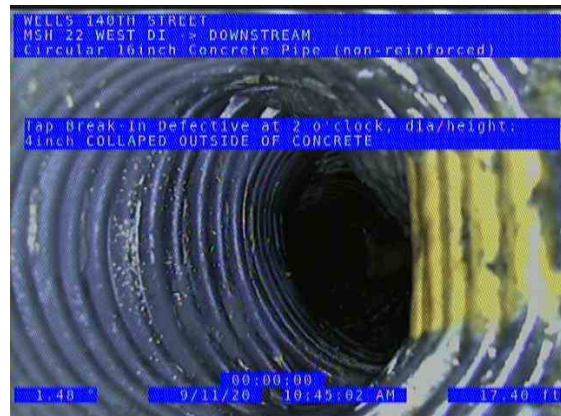
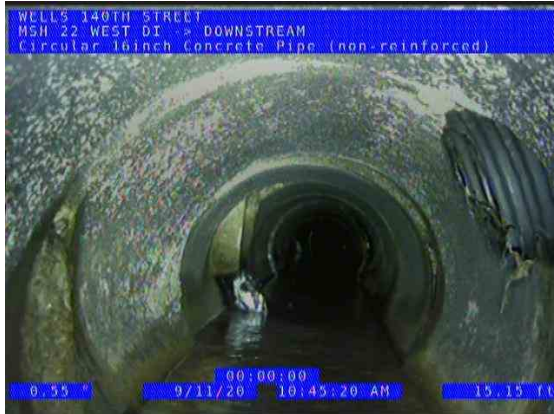
MSH 22 WEST DI (DS)
DOWNSTREAM_e12a6a6b-80d2-4101-aaf7-940b6f3b7361_2
0200911_110529_961.jpg, 00:01:08, 17.52ft
Tap Break-In Defective at 2 o'clock, dia/height:
4inch COLLAPED OUTSIDE OF CONCRETE

MSH 22 WEST DI (DS)
DOWNSTREAM_c175e4ec-5a87-44ca-aec0-985ab2599884_20200911_110546_714.jpg, 00:01:08, 17.52ft
Tap Break-In Defective at 2 o'clock, dia/height: 4inch / COLLAPSED OUTSIDE OF CONCRETE

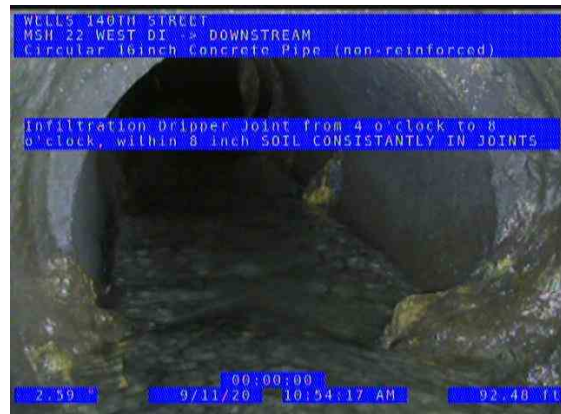
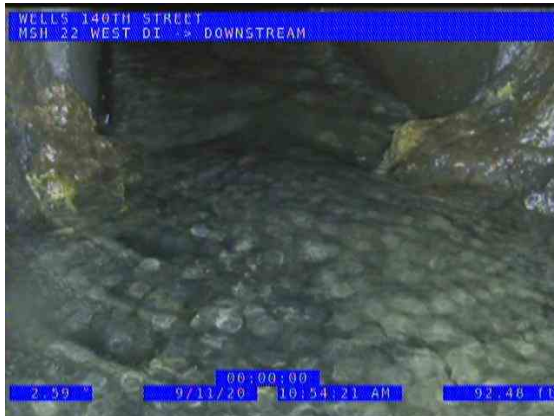
MSH 22 WEST DI (DS)
DOWNSTREAM_8b752099-743d-4bde-b97f-68672c156f28_2
0200911_111444_739.jpg, 00:07:57, 92.48ft
Infiltration Dripper Joint from 4 o'clock to 8
o'clock, within 8
inch / SOIL CONSISTANTLY IN JOINTS

MSH 22 WEST DI (DS)
DOWNSTREAM_f5824195-cfad-4458-b205-25eb10b966a4_2
0200911_111448_403.jpg, 00:07:57, 92.48ft
Infiltration Dripper Joint from 4 o'clock to 8 o'clock, within 8
inch / SOIL CONSISTANTLY IN JOINTS

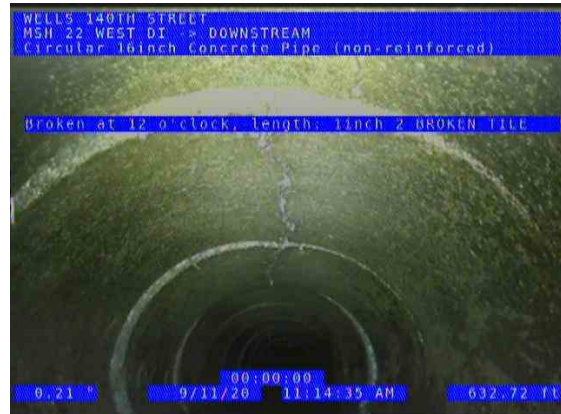
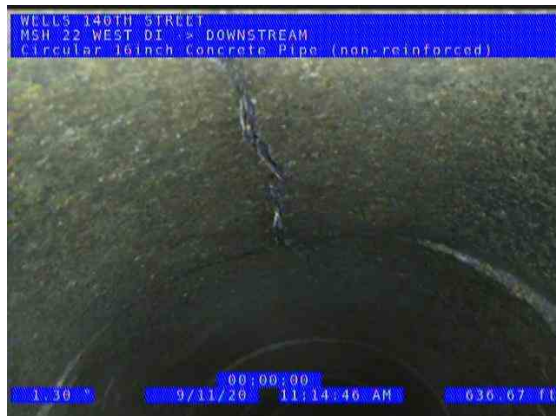
MSH 22 WEST DI (DS)
DOWNSTREAM_e18954db-a9d4-4ba0-b48b-64a52c9a7015_
20200911_113503_040.jpg, 00:21:20, 632.72ft
Broken at 12 o'clock, length: 1inch / 2 BROKEN TILE
LOCATER DEPTH 8' 2"

MSH 22 WEST DI (DS)
DOWNSTREAM_a5d005bb-fe03-467a-9310-f0a8782cfb82_2
0200911_113514_004.jpg, 00:21:20, 632.72ft
Broken at 12 o'clock, length: 1inch / 2 BROKEN TILE
LOCATER DEPTH 8' 2"

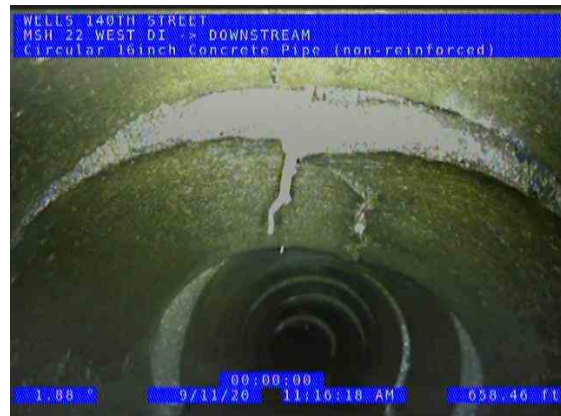
MSH 22 WEST DI (DS)
DOWNSTREAM_b0df0b05-c367-41bb-a07f-acacdd78ac5d_2
0200911_113645_469.jpg, 00:22:50, 662.22ft
Broken at 12 o'clock, length: 2inch / 1 TILE BROKEN
SEVERAL CRACKED

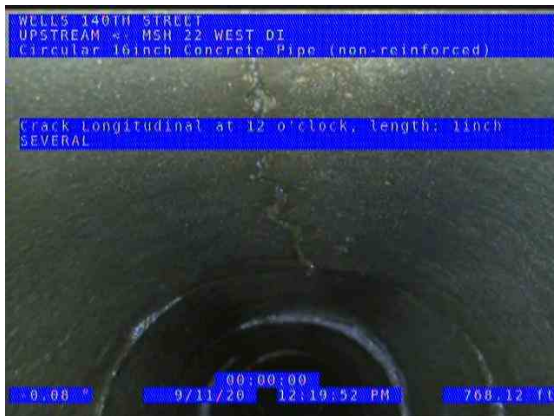
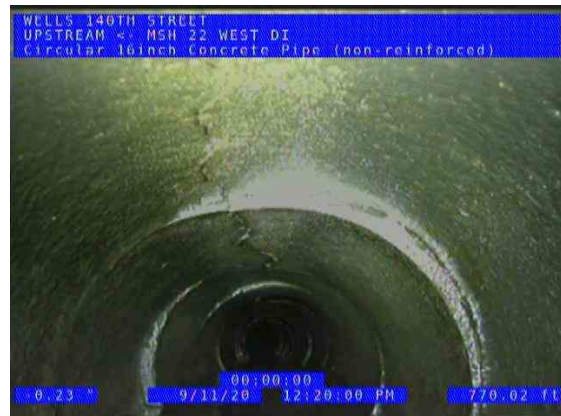
MSH 22 WEST (US)
UPSTREAM_d0f30d7a-154c-43ef-a84a-c36d32fad9c6_20200911_124019_140.jpg, 00:29:57, 768.12ft
Crack Longitudinal at 12 o'clock, length: 1inch / SEVERAL

MSH 22 WEST (US)
UPSTREAM_8042e241-301e-4f92-acb7-b39acf8c1d2f_20200911_124026_797.jpg, 00:29:57, 770.02ft
Crack Longitudinal at 12 o'clock, length: 1inch / SEVERAL

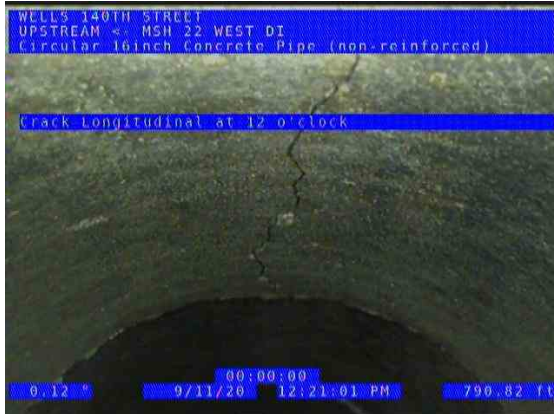
MSH 22 WEST (US)
UPSTREAM_b4fc8e30-b879-4f3c-8cbe-e9c28bfa50c6_20200911_124128_599.jpg, 00:29:57, 790.82ft
Crack Longitudinal at 12 o'clock

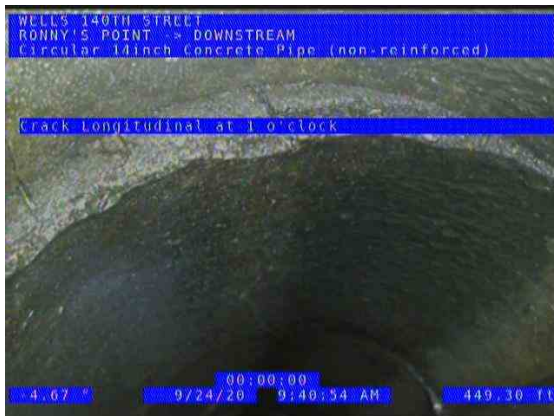
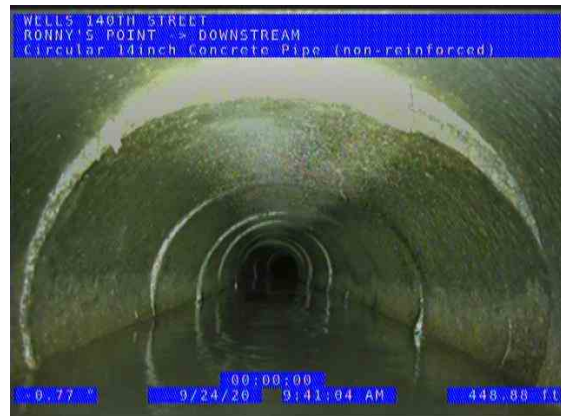
RONNY'S POINT (DS)
DOWNSTREAM_43655d47-7dbe-4540-85a6-a4e5d6c65c2d_20200924_100313_088.jpg, 00:09:33, 449.30ft
Crack Longitudinal at 1 o'clock

RONNY'S POINT (DS)
DOWNSTREAM_7c744c2b-6155-446f-9fbd-11bfa932c5ba_20200924_100322_263.jpg, 00:09:33, 449.30ft
Crack Longitudinal at 1 o'clock

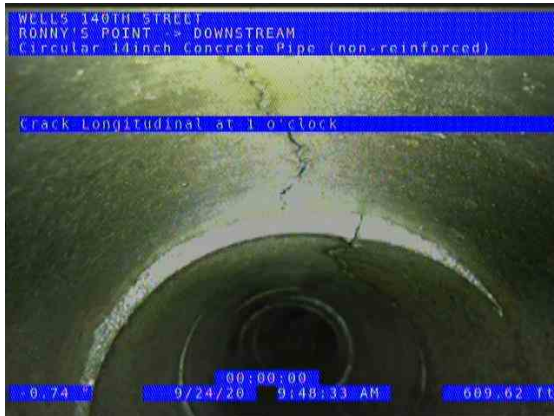
RONNY'S POINT (DS)
DOWNSTREAM_6de5e123-def9-4616-82cc-5593a249632b_2
0200924_101051_613.jpg, 00:14:02, 609.62ft
Crack Longitudinal at 1 o'clock

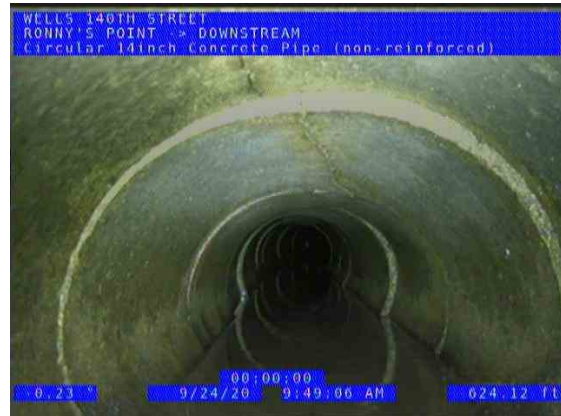
RONNY'S POINT (DS)
DOWNSTREAM_ee76ac7b-b14f-43b8-98d4-fd27049e56e5_2
0200924_101124_515.jpg, 00:14:31, 624.12ft
Crack Longitudinal at 1 o'clock

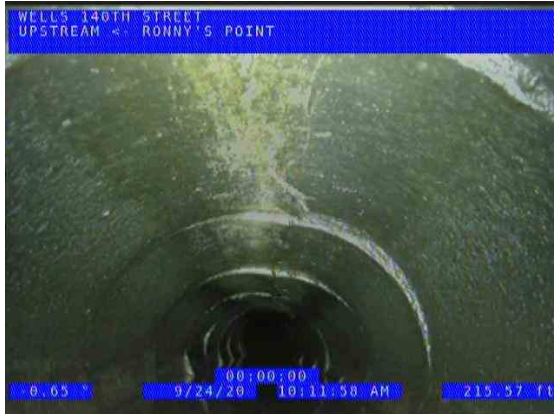
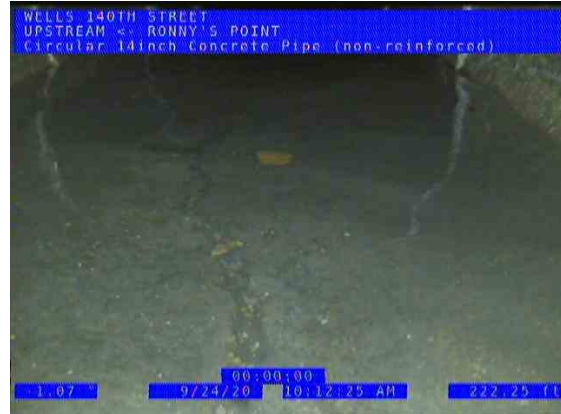
RONNY'S POINT (US)
UPSTREAM_ed7e8834-2e4d-4ab5-af6f-208567e58228_2020
0924_103416_527.jpg, 00:07:24, 215.57ft
Crack Longitudinal at 12 o'clock / STARTS

RONNY'S POINT (US)
UPSTREAM_a178090c-a63a-4ab7-af60-a3e73fa6efc3_2020
0924_103443_442.jpg, 00:07:24, 215.57ft
Crack Longitudinal at 12 o'clock / STARTS

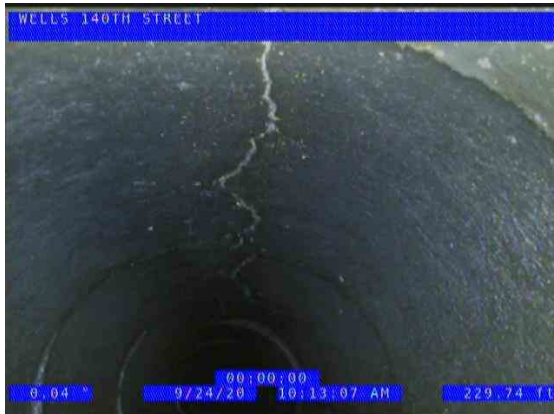
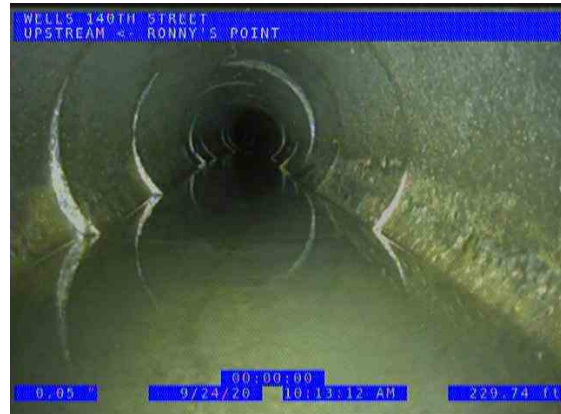
RONNY'S POINT (US)
UPSTREAM_0e1bc8c6-9bd7-473f-af5c-a9a4c50491df_2020
0924_103525_526.jpg, 00:08:16, 229.74ft
Crack Longitudinal at 12 o'clock / END OF A FEW BAD TILE

RONNY'S POINT (US)
UPSTREAM_39553e5a-45b3-48ca-9860-18def4ea2392_2020
0924_103530_053.jpg, 00:08:16, 229.74ft
Crack Longitudinal at 12 o'clock / END OF A FEW BAD TILE

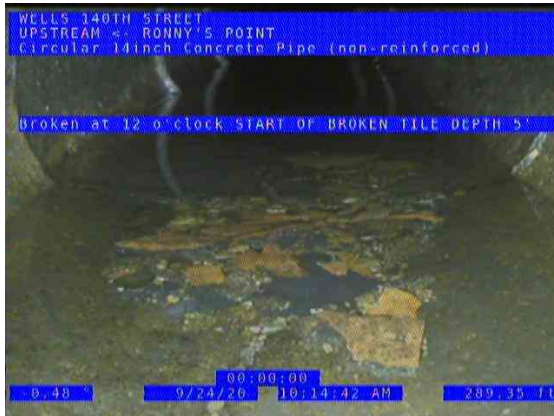
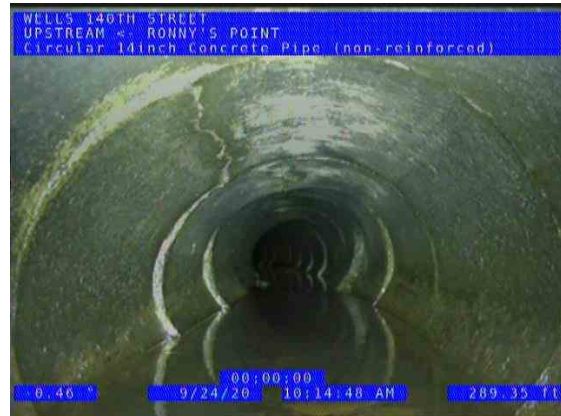
RONNY'S POINT (US)
UPSTREAM_39a809de-0ae9-4101-a0b9-3fa7217bcde0_2020
0924_103700_818.jpg, 00:09:24, 289.35ft
Broken at 12 o'clock / START OF BROKEN TILE DEPTH 5' 9"

RONNY'S POINT (US)
UPSTREAM_6053434c-195f-49ed-bbda-1295638bfaa5_2020
0924_103705_803.jpg, 00:09:24, 289.35ft
Broken at 12 o'clock / START OF BROKEN TILE DEPTH 5' 9"

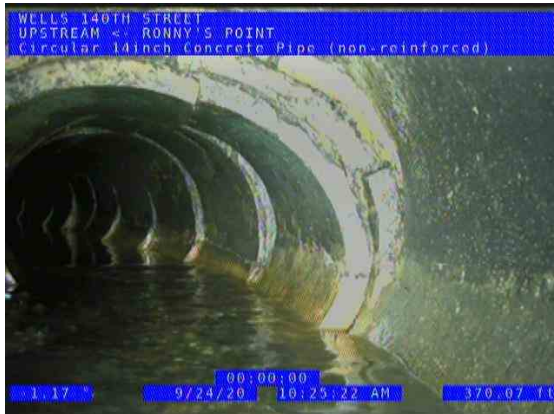
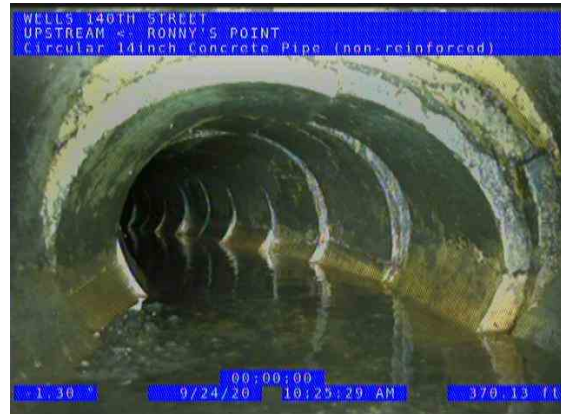
RONNY'S POINT (US)
UPSTREAM_604ccbf6-a7a6-4249-9718-82773e2145ec_2020
0924_104740_987.jpg, 00:15:27, 370.14ft
Miscellaneous Shape or Size Change, dia/height: 12inch /
FAILING

RONNY'S POINT (US)
UPSTREAM_57e8f55f-f40e-4120-8ab8-2ff05dc94e57_202009
24_104747_018.jpg, 00:15:27, 370.14ft
Miscellaneous Shape or Size Change, dia/height: 12inch /
FAILING

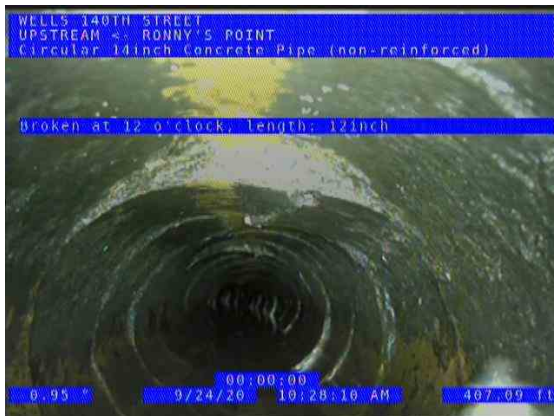
RONNY'S POINT (US)
UPSTREAM_e79b1519-cffb-4246-8141-0b242127b4df_20200
924_105028_736.jpg, 00:17:17, 407.09ft
Broken at 12 o'clock, length: 12inch

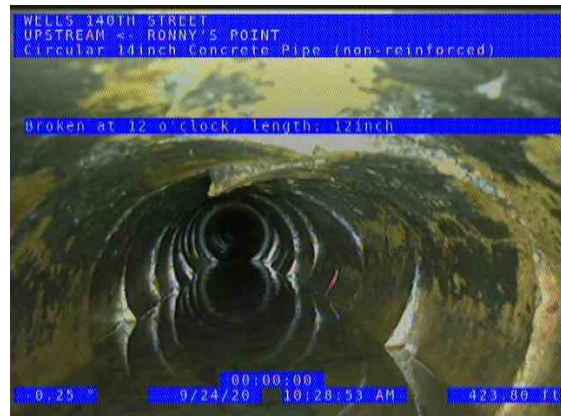
RONNY'S POINT (US)
UPSTREAM_e629e8a9-806d-4c8b-93fc-dec3dc06f704_20200
924_105111_457.jpg, 00:17:52, 423.80ft
Broken at 12 o'clock, length: 12inch

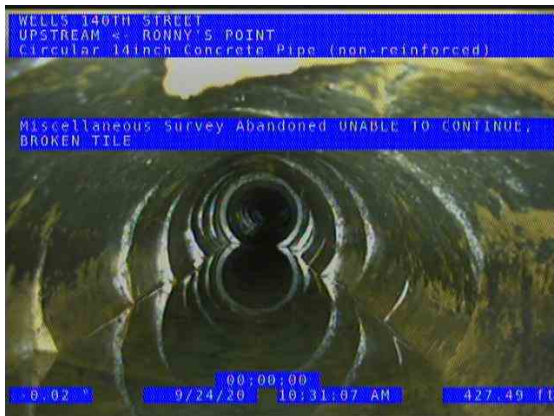
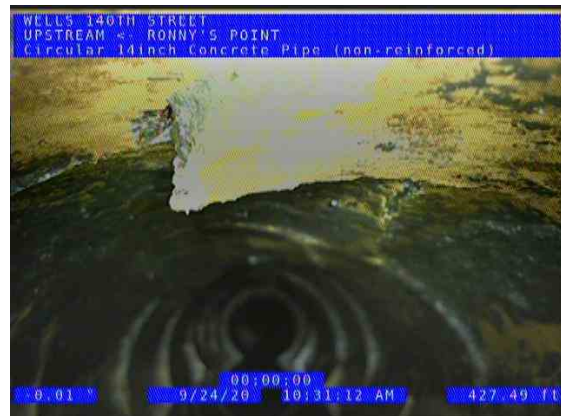
RONNY'S POINT (US)
UPSTREAM_ec9d819f-136e-448f-b255-9ef79eb24f75_20200924_105325_883.jpg, 00:19:08, 427.49ft
Miscellaneous Survey Abandoned / UNABLE TO CONTINUE, BROKEN TILE

RONNY'S POINT (US)
UPSTREAM_89be9b19-dbf9-4655-96fd-f51179d77125_20200924_105330_344.jpg, 00:19:08, 427.49ft
Miscellaneous Survey Abandoned / UNABLE TO CONTINUE, BROKEN TILE

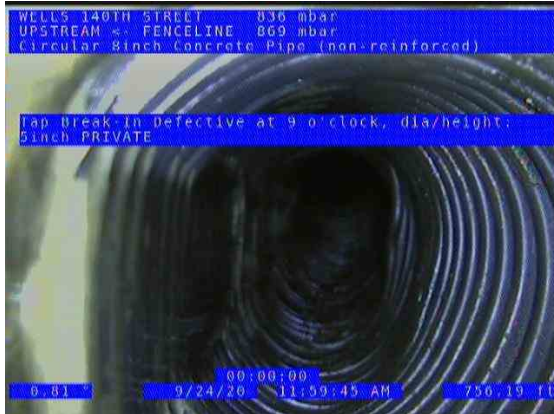
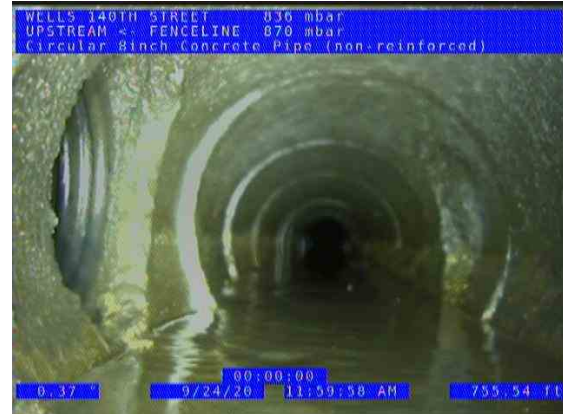
FENCELINE POINT (US)
UPSTREAM_06da4976-ea3c-4f97-a795-b85963c21597_2020
0924_122204_841.jpg, 00:26:06, 756.19ft
Tap Break-In Defective at 9 o'clock, dia/height: 5inch /
PRIVATE

FENCELINE POINT (US)
UPSTREAM_680b6eb1-c1be-4a4b-b9ce-f67bf88ebe9d_2020
0924_122218_272.jpg, 00:26:06, 756.19ft
Tap Break-In Defective at 9 o'clock, dia/height: 5inch /
PRIVATE

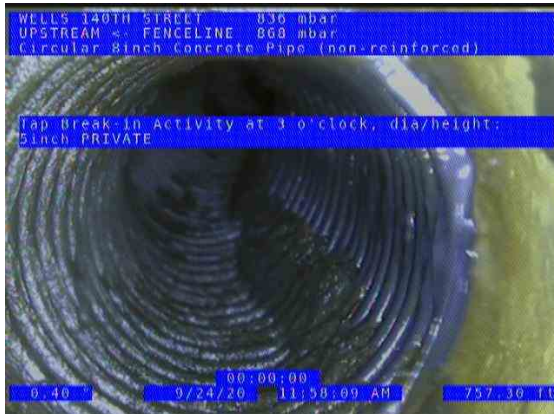
FENCELINE POINT (US)
UPSTREAM_0d8b17d8-129b-4b6f-a301-59098cd11c0c_2020
0924_122028_542.jpg, 00:26:06, 757.30ft
Tap Break-in Activity at 3 o'clock, dia/height: 5inch / PRIVATE
