Faribault County, Minnesota

Judicial Ditch #19F

Staff Repair Report

October 2022

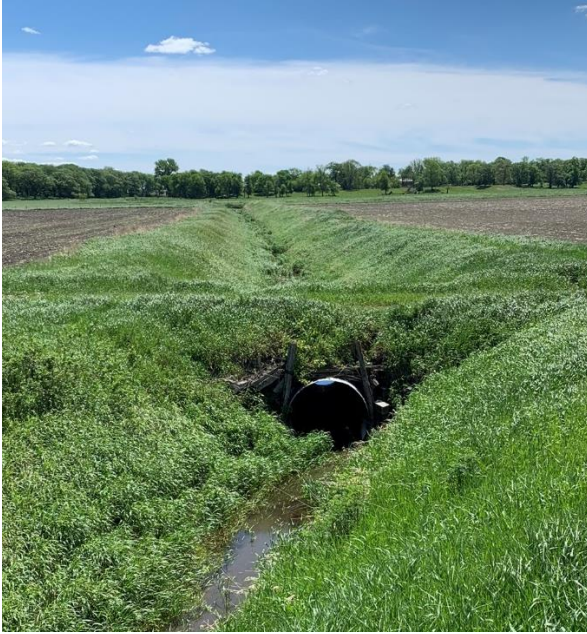
Field Crossing at Station 11+15

Many changes to field and road crossings have been made in the past 70 years. The farthest downstream field crossing (station 11+15) is a 72" corrugated metal pipe (CMP) in good condition. This pipe was newly installed in 1954 as a 60" CMP, thus sometime after 1954 it was replaced with the current pipe. The next crossing (station 69+00) is a 72" CMP in poor condition. This is likely the same pipe that was ordered for the 1963 repair and has met its effective life.

Figure 1. Photos of the four open ditch crossings. The only crossing that appears to be in fair condition is the field crossing near the outlet at Station 11+15. The field crossing at Station 69+00 is very narrow, in poor condition, and not in regular use. The 335th Ave Township Road crossing is so impacted by sediment that its condition is not able to be assessed. The 330th Ave Township Road crossing is above legal grade and pulling apart on the upstream side.

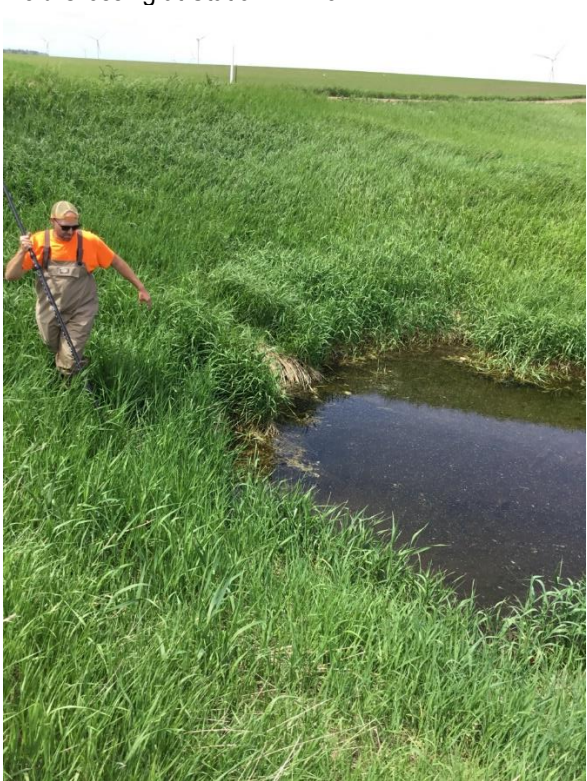
335th Ave Township Road Crossing.

The last two crossings are for Jo Daviess township roads. The existing culvert for 335th Ave. (station 84+70) is likely the one ordered for the 1963 repair. Staff are unable to determine the condition of this pipe due to sediment accumulation (Figure 1). Judging by the condition of the field crossing at station 69+00, this culvert is likely to be in poor condition, having serviced the ditch for nearly 60 years. The 330th Ave. (station 128+10) crossing has likely been replaced since the 1963 repair. The 1963 repair report identified the 330th Ave crossing as a concrete box culvert that was above the legal grade of the ditch. Instead of replacing the box culvert, the engineer called for a 30" CMP baseflow culvert be installed at the legal grade adjacent to the existing box culvert. Sometime after 1963 this box culvert and base flow culvert was replaced with a 66" CMP, currently in poor condition. The repair profile also suggests that this culvert was installed above legal grade.

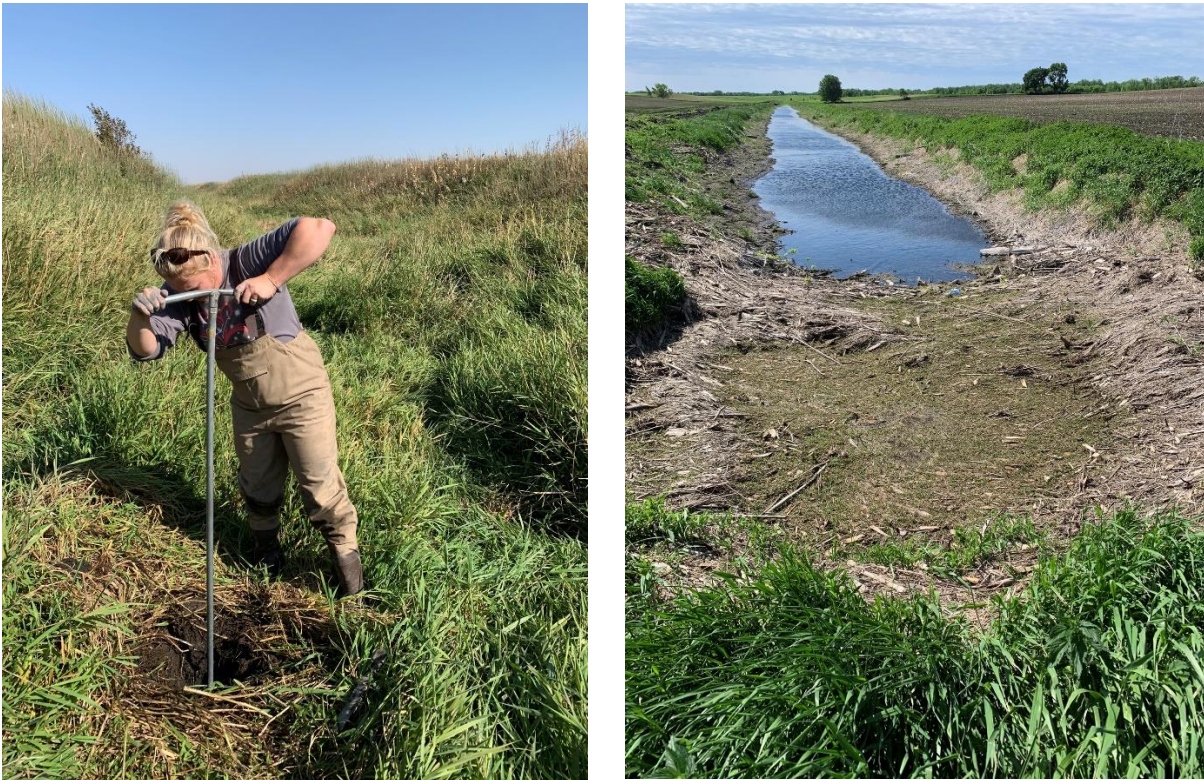
It is clear from the survey, soil, borings, and profile of the open ditch that large amounts of sediment have accumulated in the JD19F open ditch. The legal grade from the 1958 repair report provides a more accurate fit for the profile when considering soil borings and existing culvert flowline elevations. The profile from the 1963 repair report would result in multiple crossings above grade and an additional 1.5' of sediment needing to be removed from the open ditch. Even with the higher proposed repair grade, there are still locations where as much as 3 to 3.5' of sediment has accumulated in the channel.

Figure 2. Left: Staff using a soil auger to locate the legal bottom of the open ditch. Right: Sediment accumulation in the open ditch.
