Technical Memorandum

Subject: Judicial Ditch 2F Repair Project

Date: February 27, 2020

Project: 6255-0014

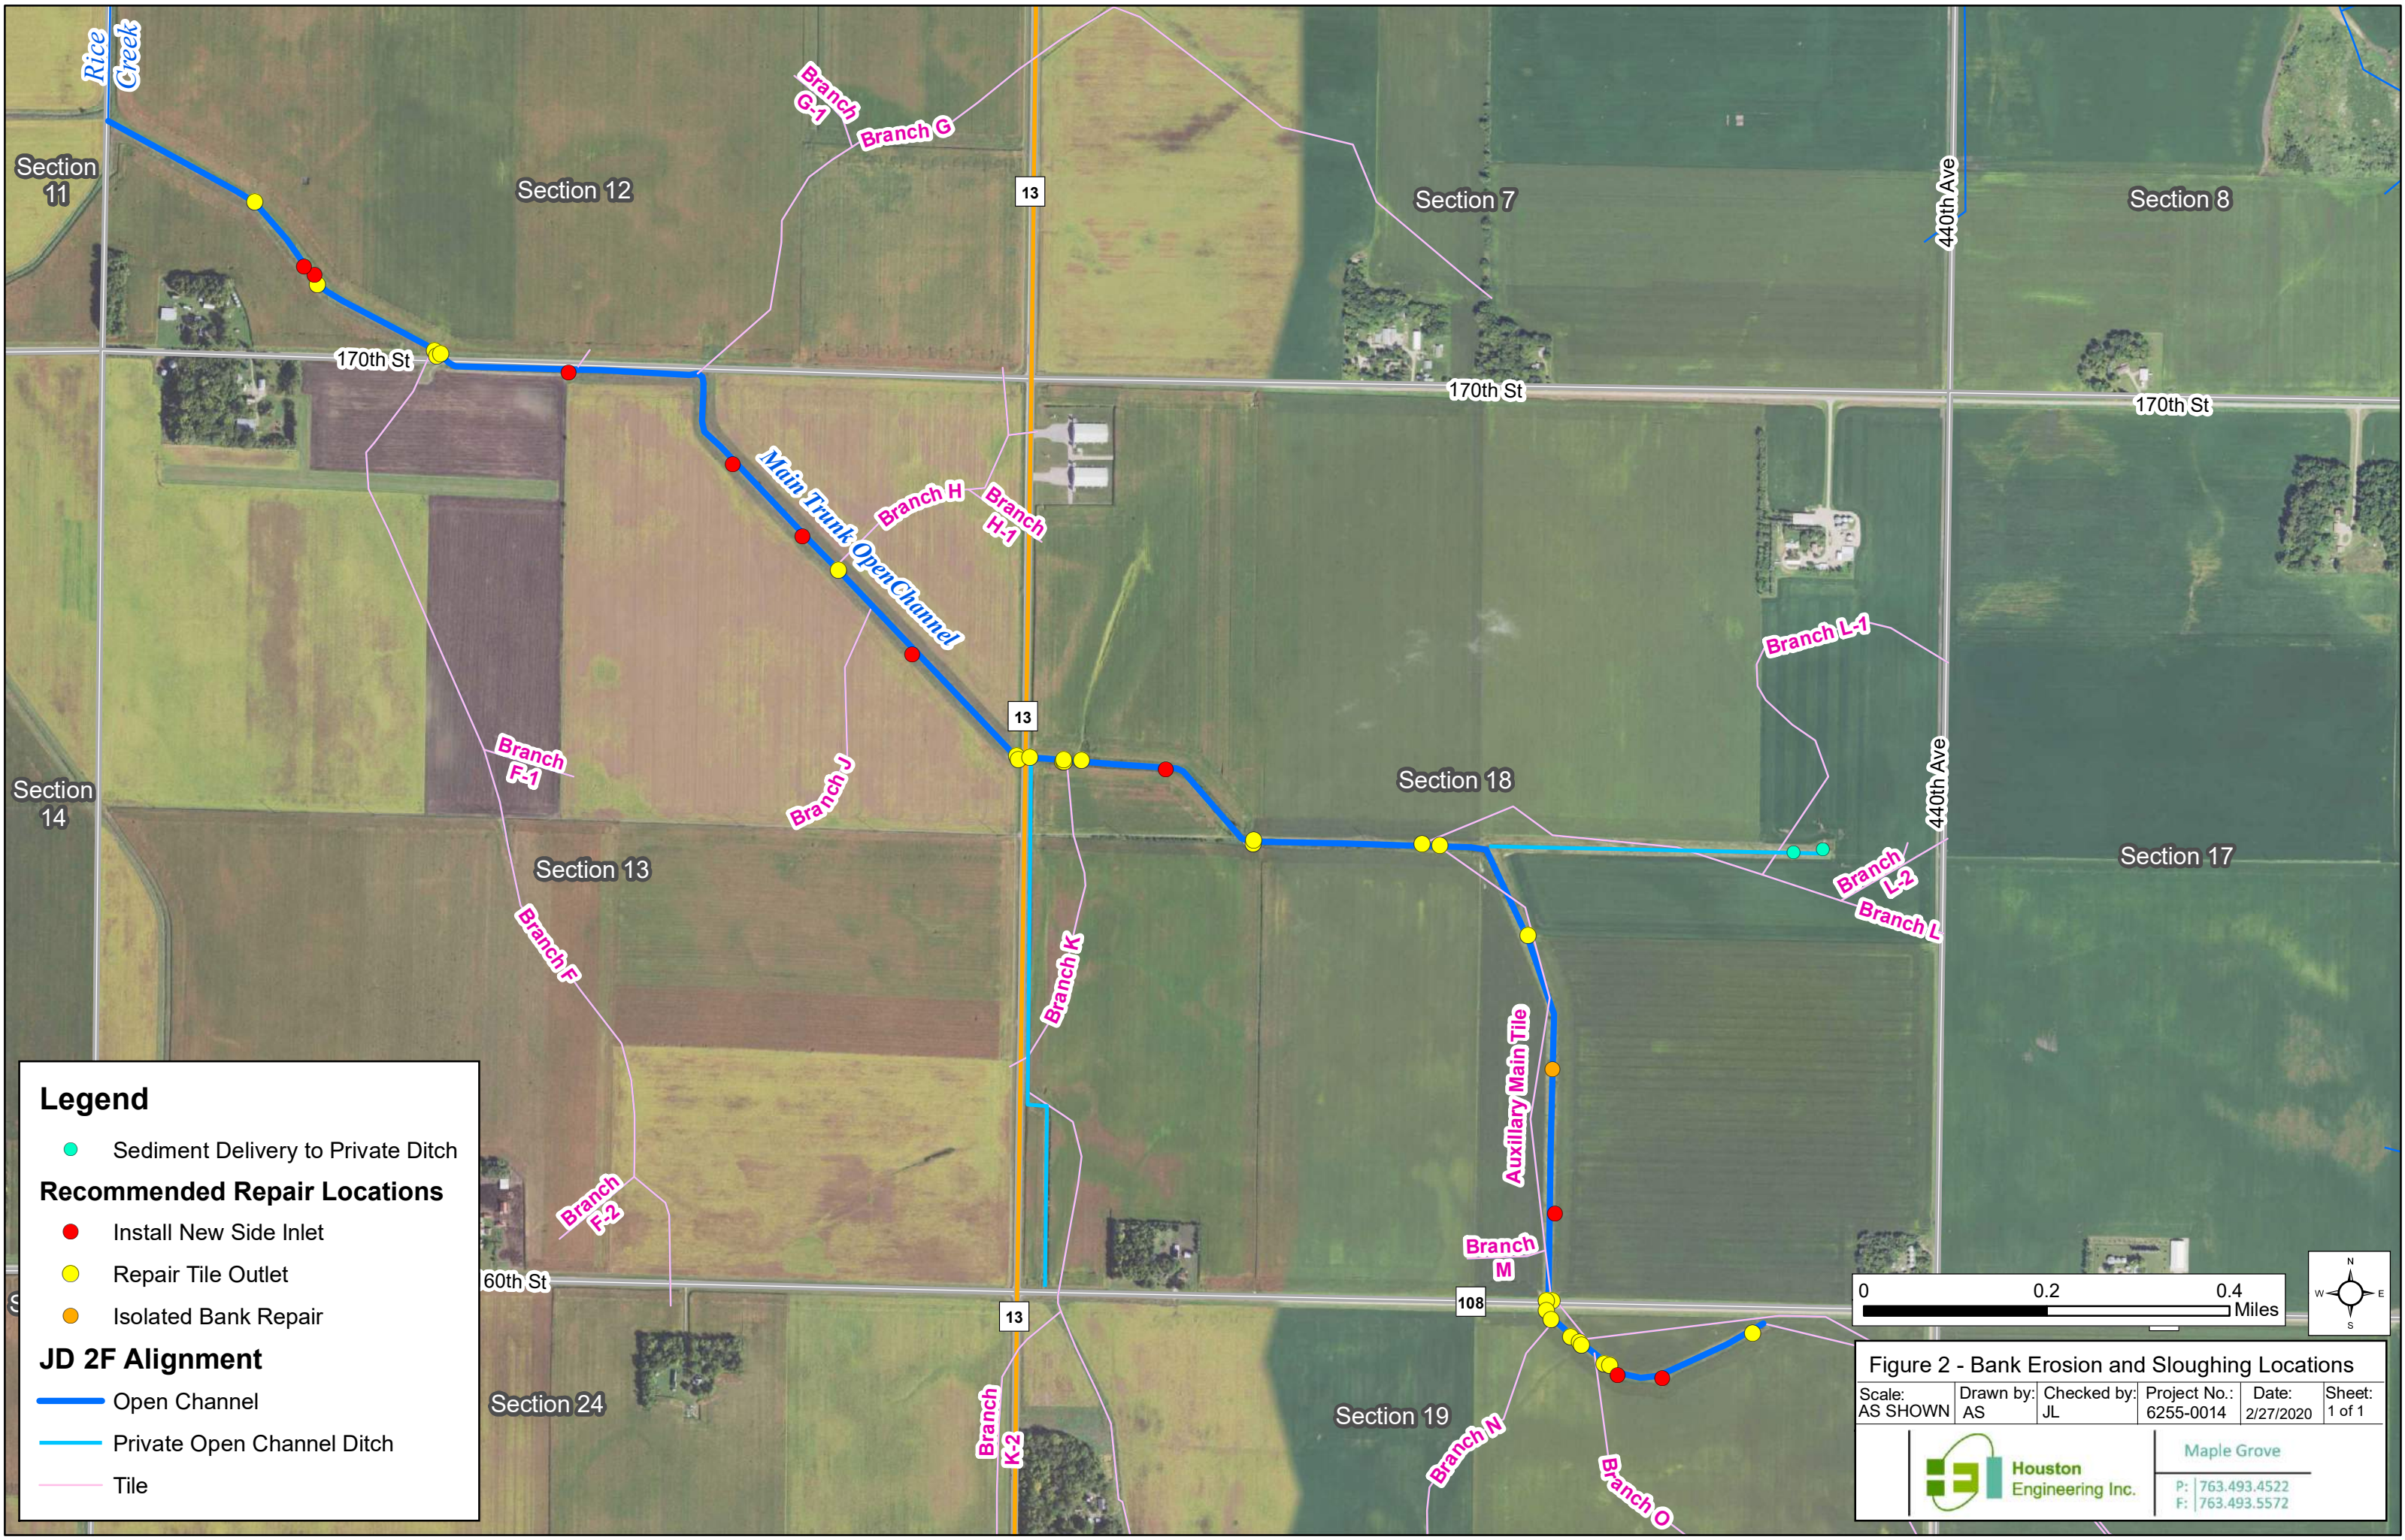
Figure 2 - Bank Erosion and Sloughing Locations

Additionally, there is bank sloughing along a few isolated portions of the open channel. Bank sloughing leads to a widening of the channel and deposition of sediment in the channel over time

impacting the function of the drainage system and contributes to the degradation of water quality downstream. The locations of bank sloughing are shown on **Figure 2**.

There are multiple locations where existing tile outlets or side inlets are in disrepair which create bank erosion issues and allow sediment to enter the open channel. These locations include both outlets for tile branches on the public drainage system and private tile outlets. **Figure 2** shows a map of the locations.

There are also multiple locations where bank erosion is occurring due to concentrated surface flow entering the open channel from adjacent fields. These locations are adding sediment to the ditch which is reducing the functionality of the ditch and reducing downstream water quality. **Figure 2** shows a map of the locations. Installation of side inlets will limit bank erosion and decrease sediment from entering the channel, thereby reducing the frequency of future maintenance.

Bank erosion occurring from tile outlets, side inlets and surface flow also need to be addressed. Specifically, rip rap is recommended to be installed at the outlets to prevent further erosion. Furthermore, where the tile pipe has deteriorated to a condition where it may fail in the near future, it is recommended that the last 20-feet of pipe be replaced with Corrugated Plastic Pipe (CPP) of equivalent size. This will extend the life of the tile and decrease the likelihood that a failed outlet will impact upstream drainage. Furthermore, we recommend that a drop side inlet be installed at locations where erosion is being caused by surface flow into the channel from adjacent fields.

Forthcoming repairs should include work to address the sloughing banks to ensure long-term and reliable drainage function. Given the isolated nature and mild severity of bank instability issues observed during field survey, the side slopes should be reconstructed with minor resloping to a 2:1 side slope during the repair, and vegetation should be rapidly reestablished by seeding and installing erosion control blanket or hydromulch. An additional option with this approach is to install riprap to protect the toe and thereby prevent bank sloughing further up the bank slope.

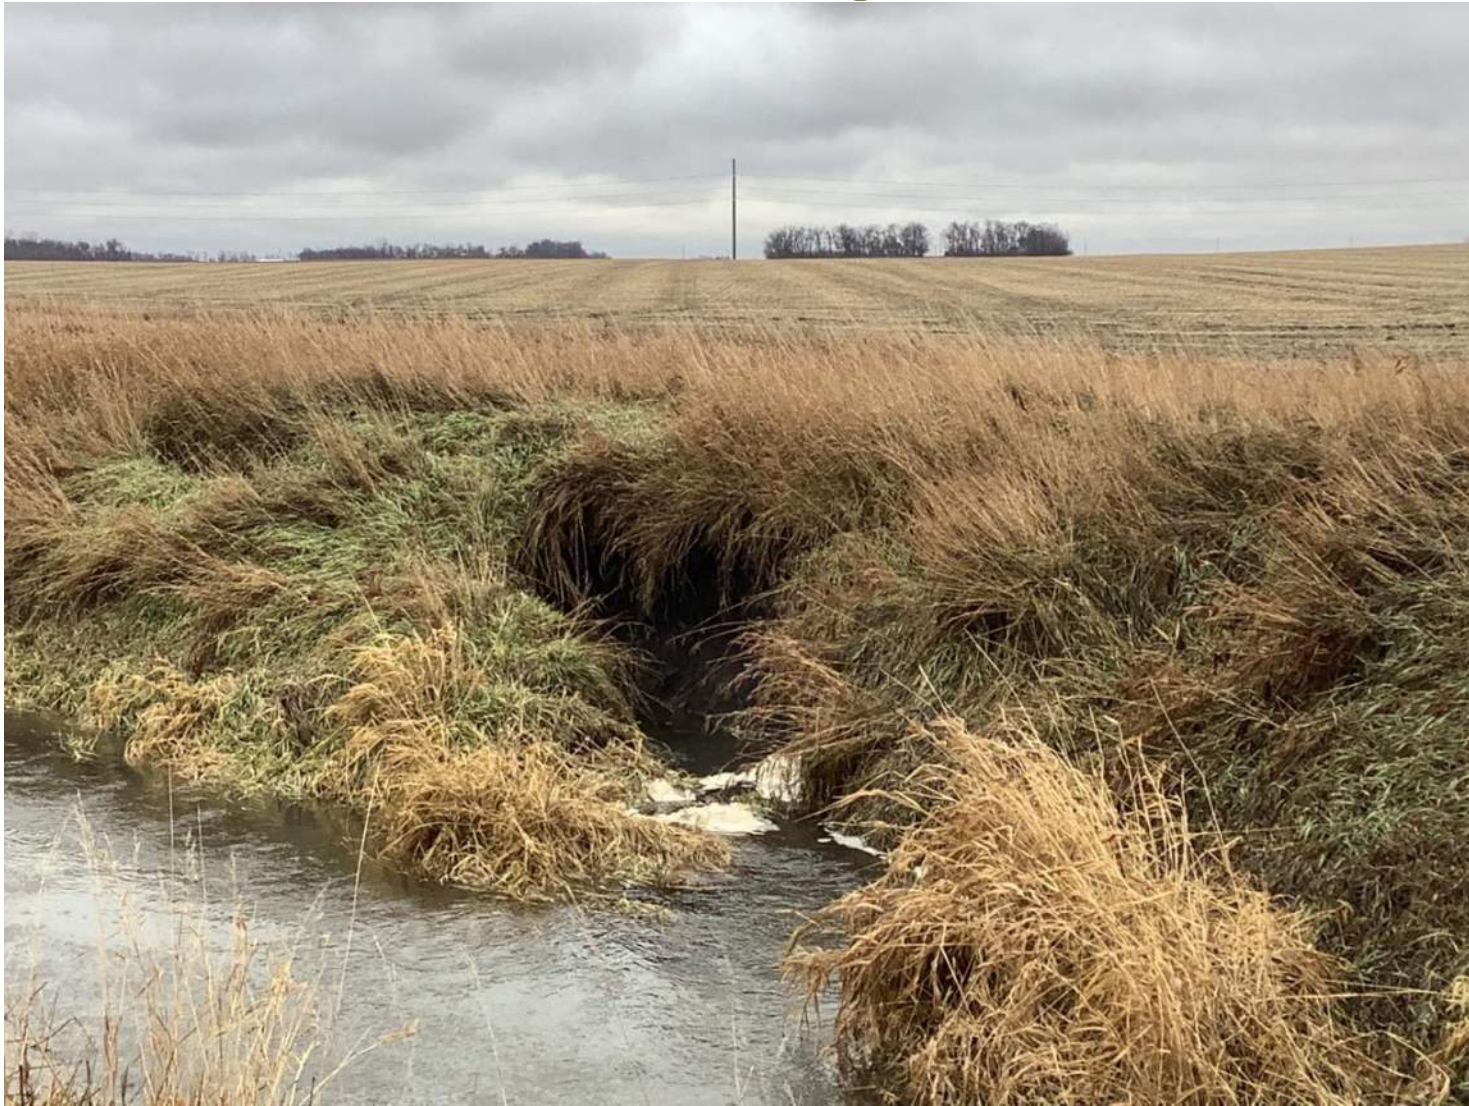
Field Survey Photograph 1: Eroded Bank at Station 45+50

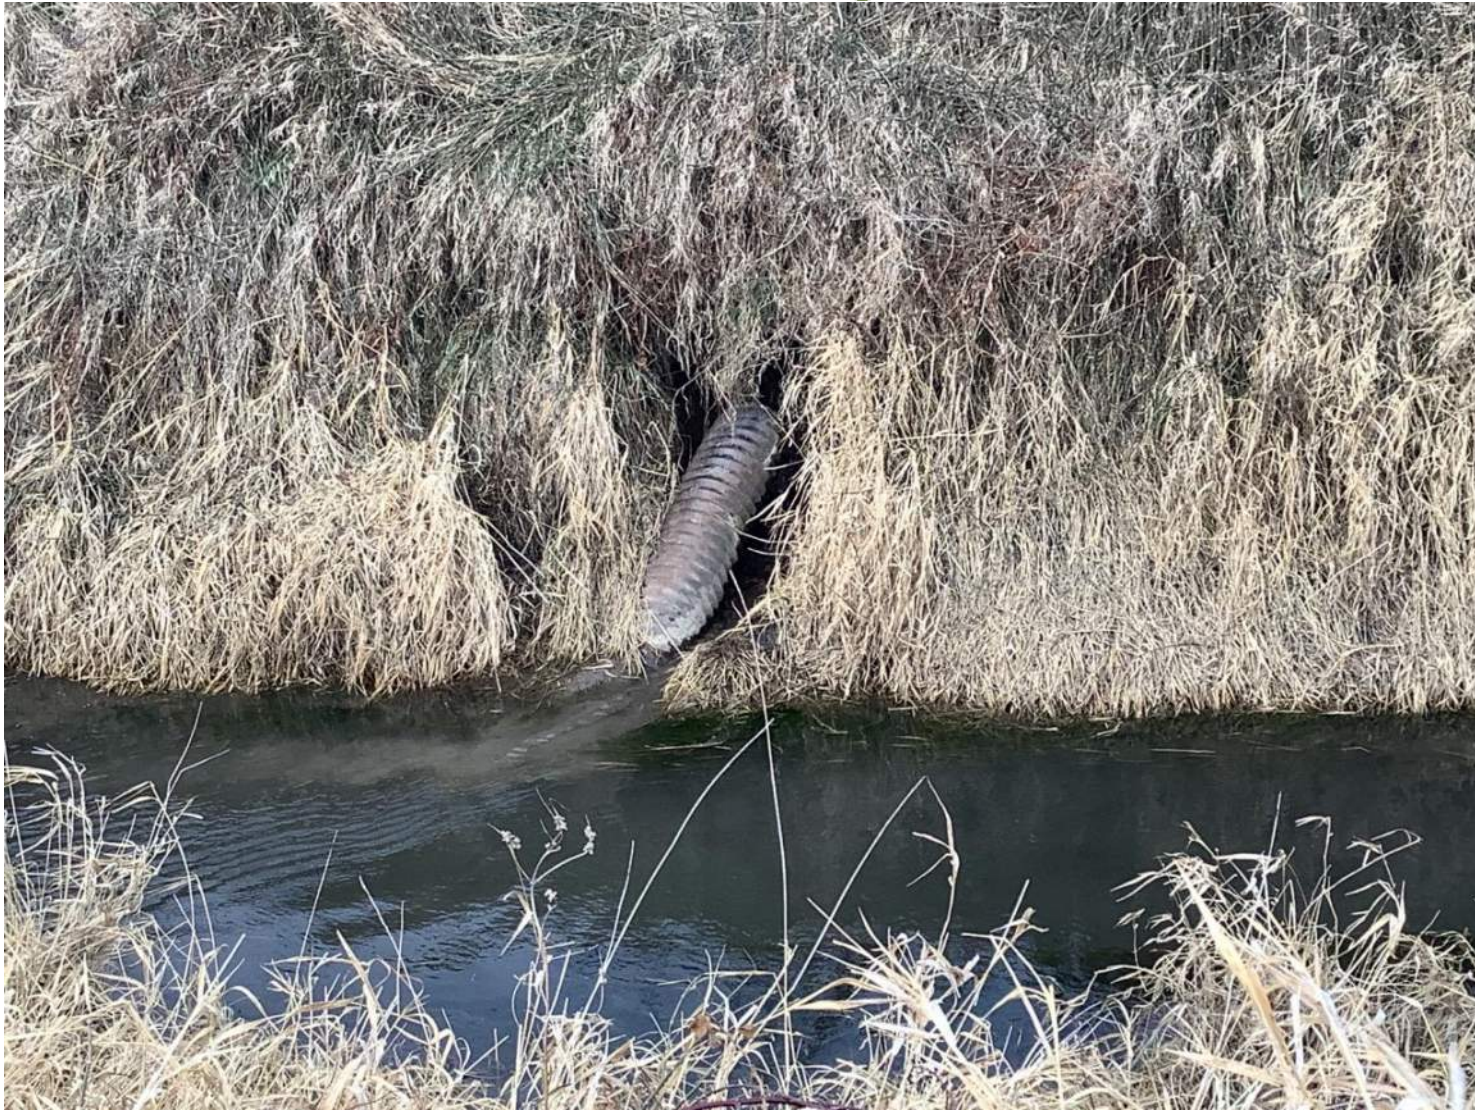
Field Survey Photograph 2: Broken 12" CMP at Station 95+69

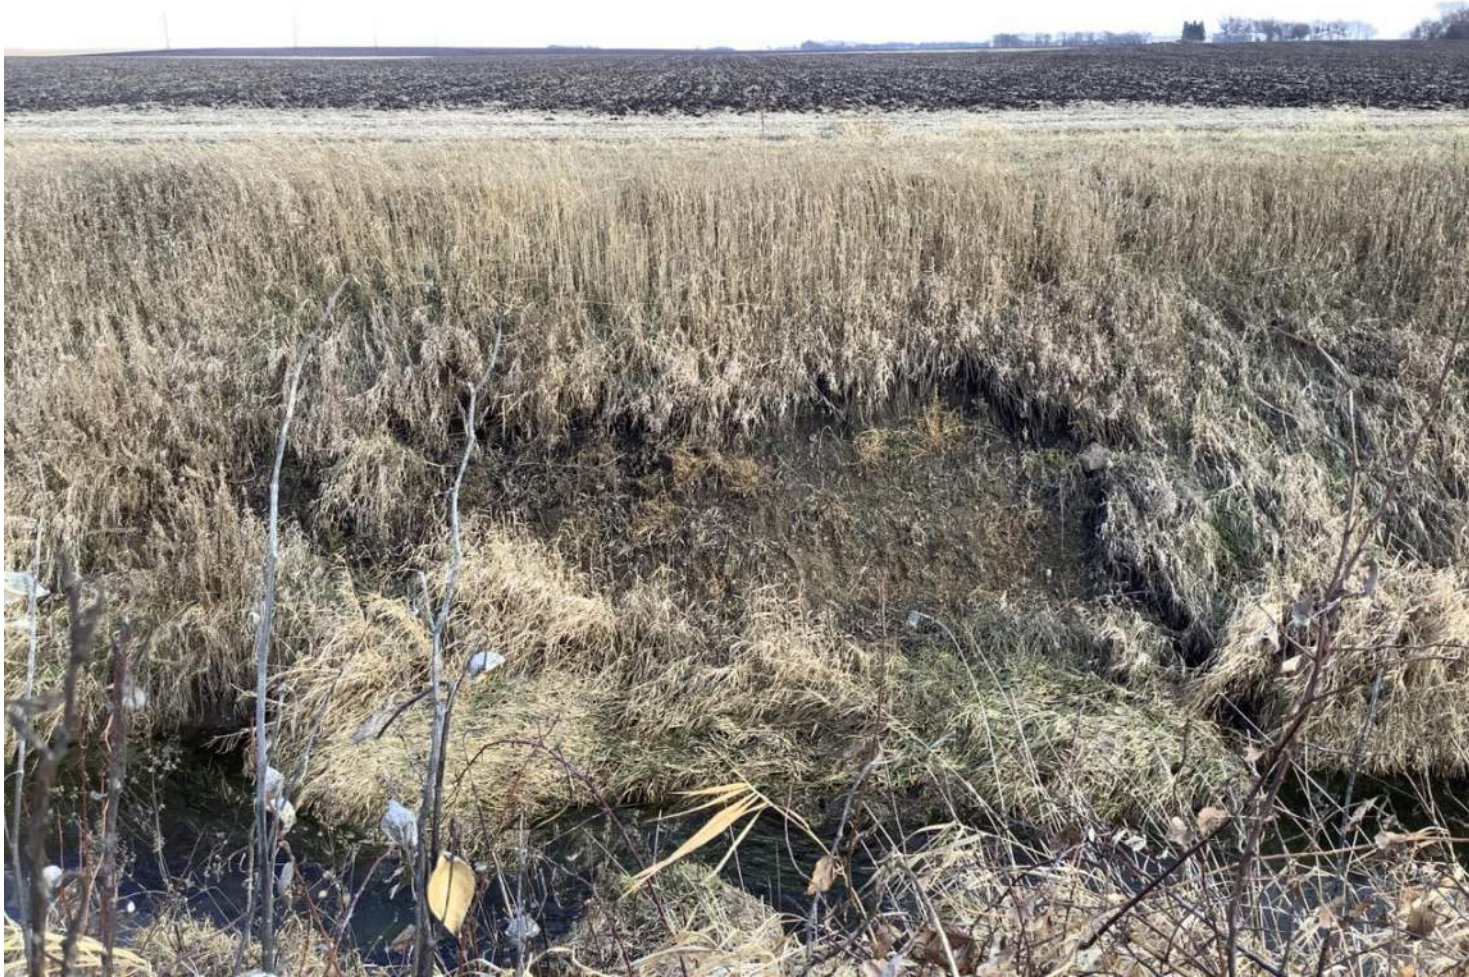
Field Survey Photograph 3: Bank Sloughing at Station 112+00

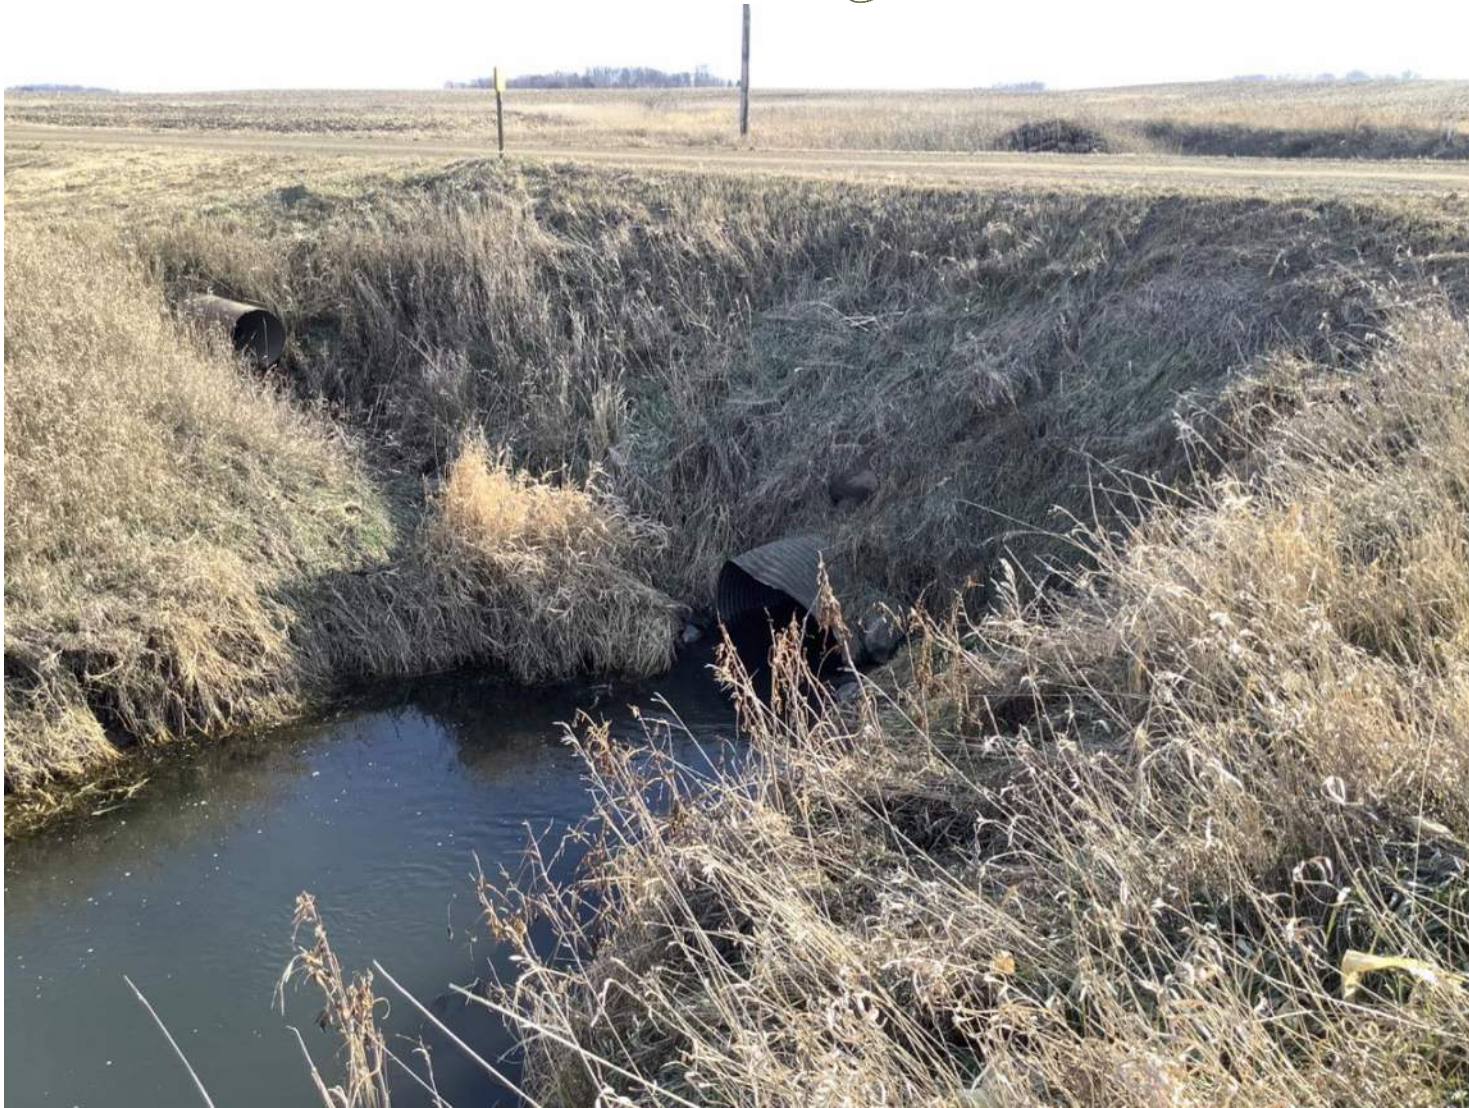
Field Survey Photograph 4: Bent 48" CMP Culvert at Station 125+18

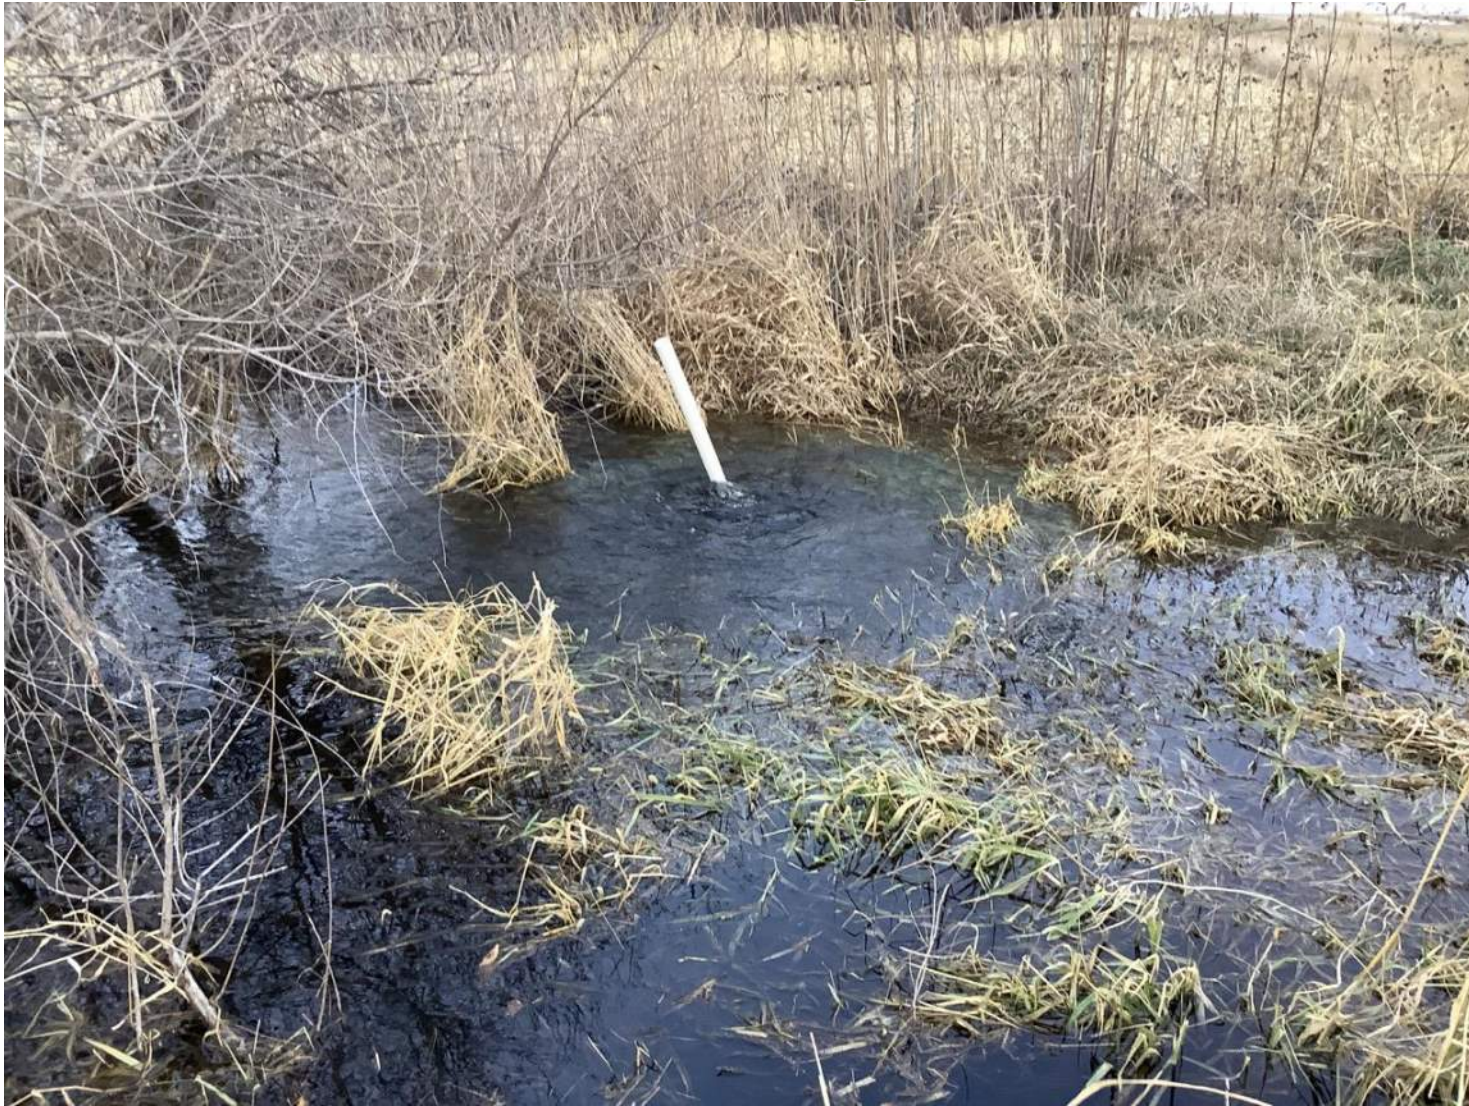
Field Survey Photograph 5: Flow Coming Straight Up from Tile in Private Ditch alongside Branch K

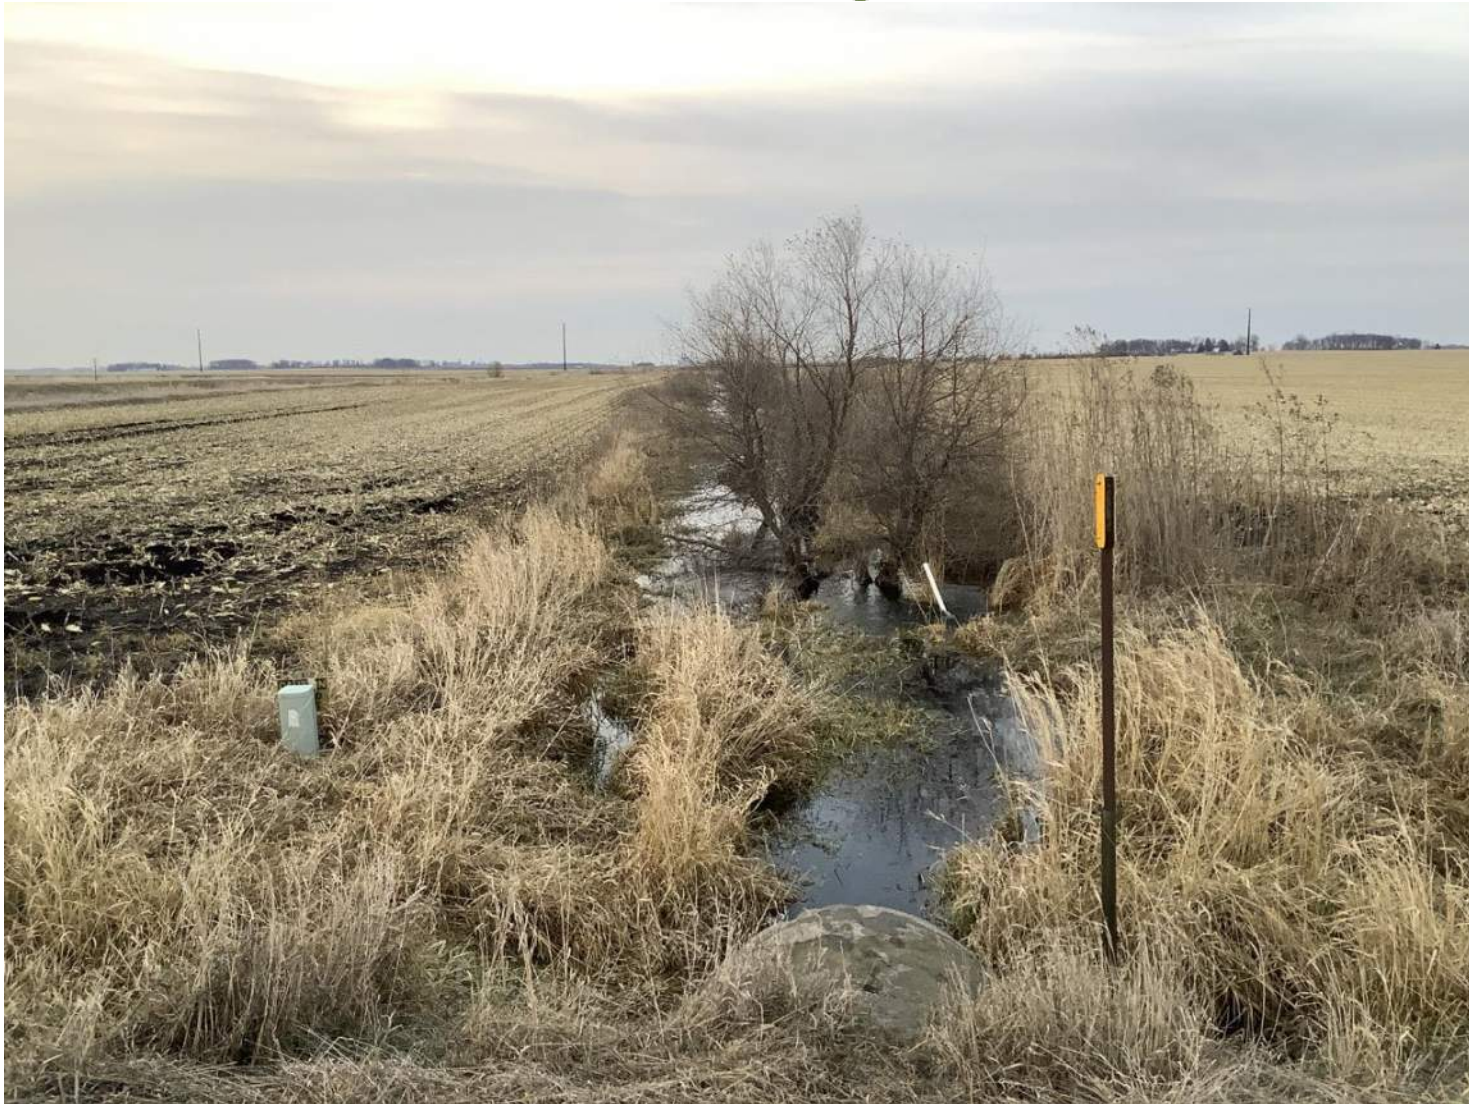
Field Survey Photograph 6: Tree and Other Obstructions in Center of Private Ditch alongside Branch K

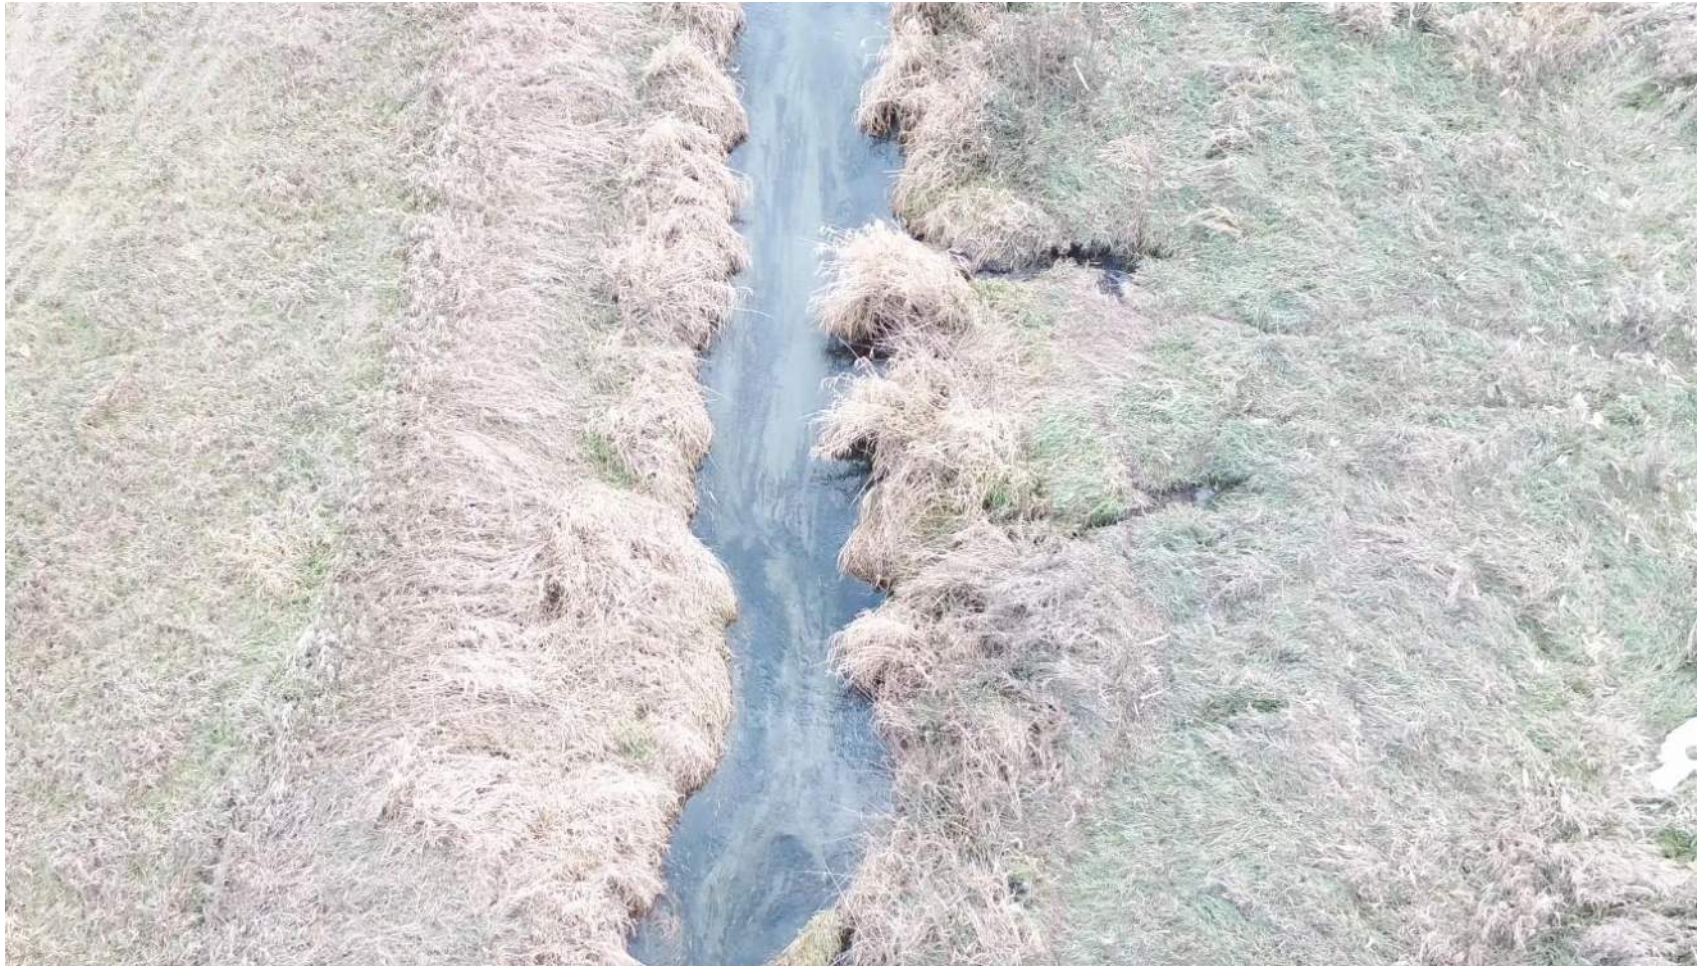
Drone Survey Photograph 1: Bank Erosion at Station 15+00

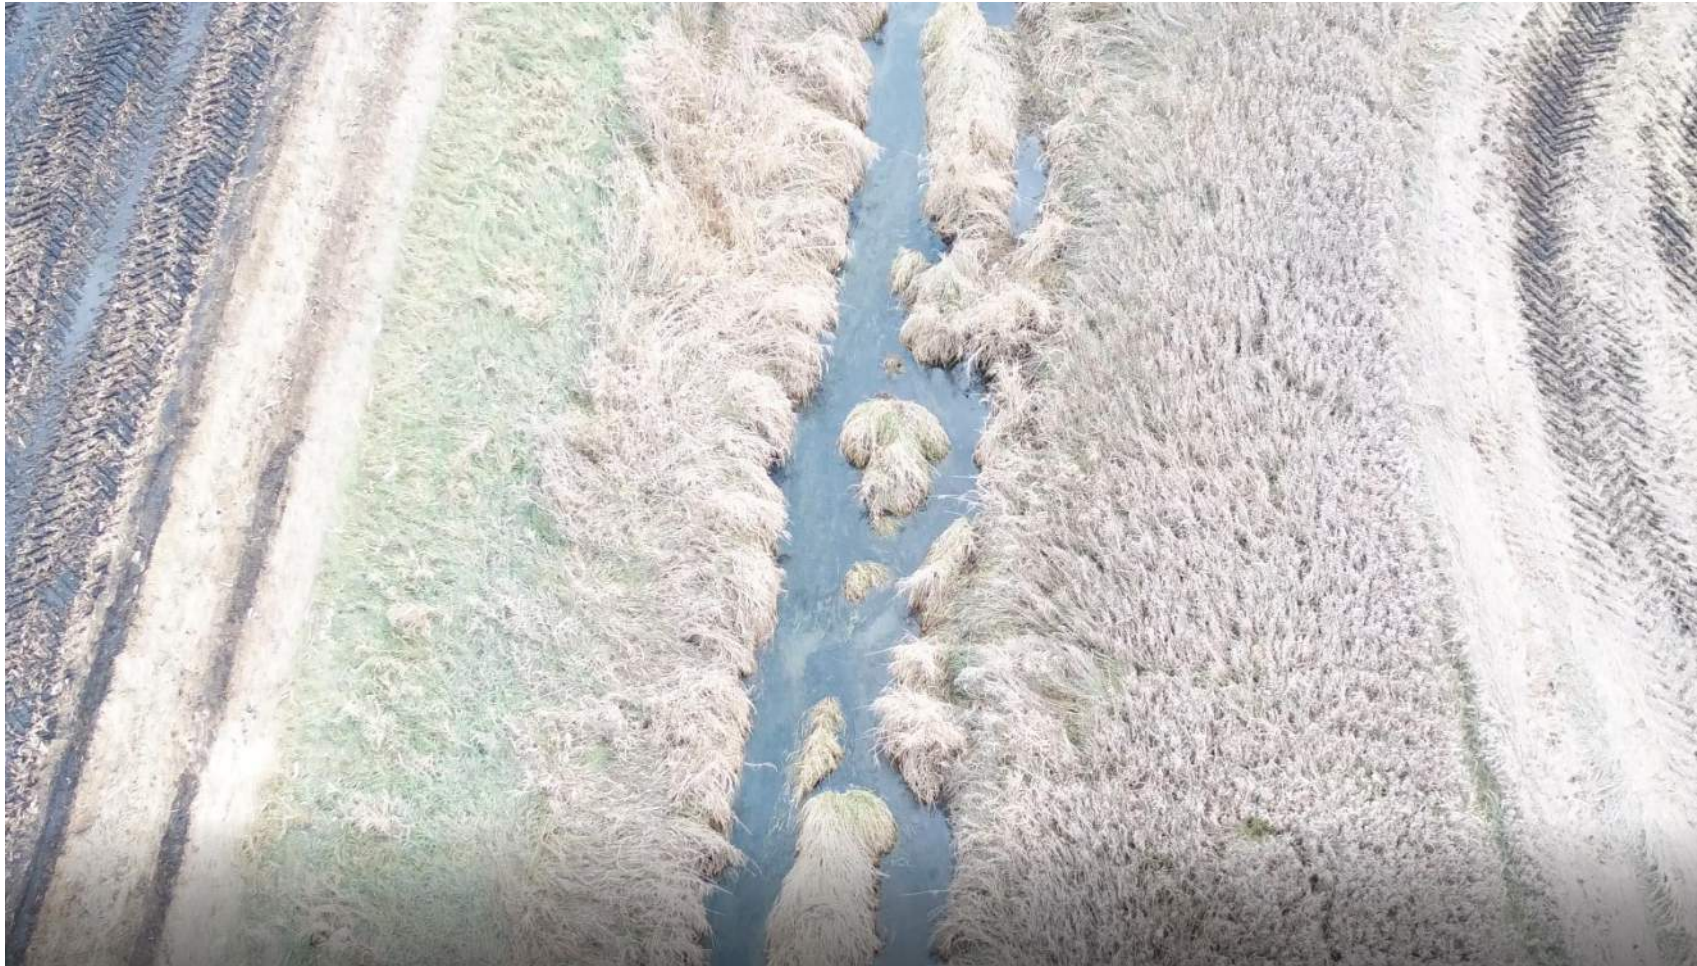
Additionally, there are many locations where the channel bottom has been partially blocked by sediment accumulation (mid-channel sediment deposition), but the channel invert is only slightly above the ACSIC. See photo 2 in **Attachment B** for an example. The reduction in flow area across the channel section reduces capacity leading to elevated water levels in the channel.

Drone Survey Photograph 2: Major Sediment Build-Up in Channel at Station 23+00

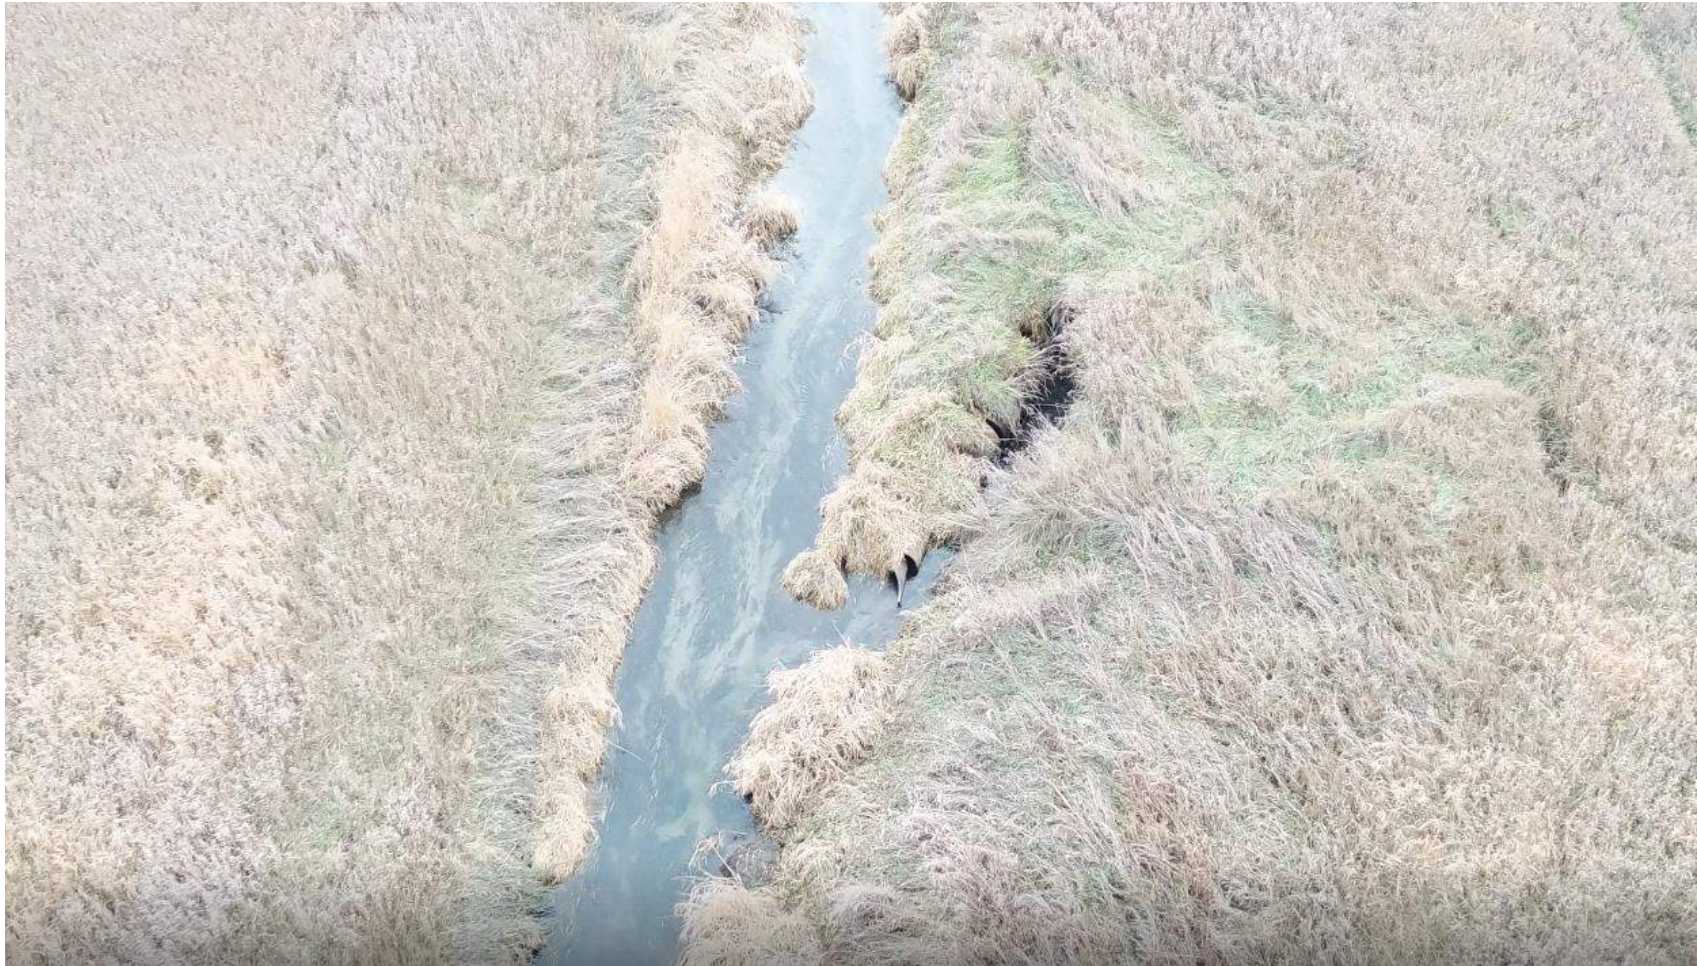
Drone Survey Photograph 3: Collapsed Tile and Erosion at Station 45+50

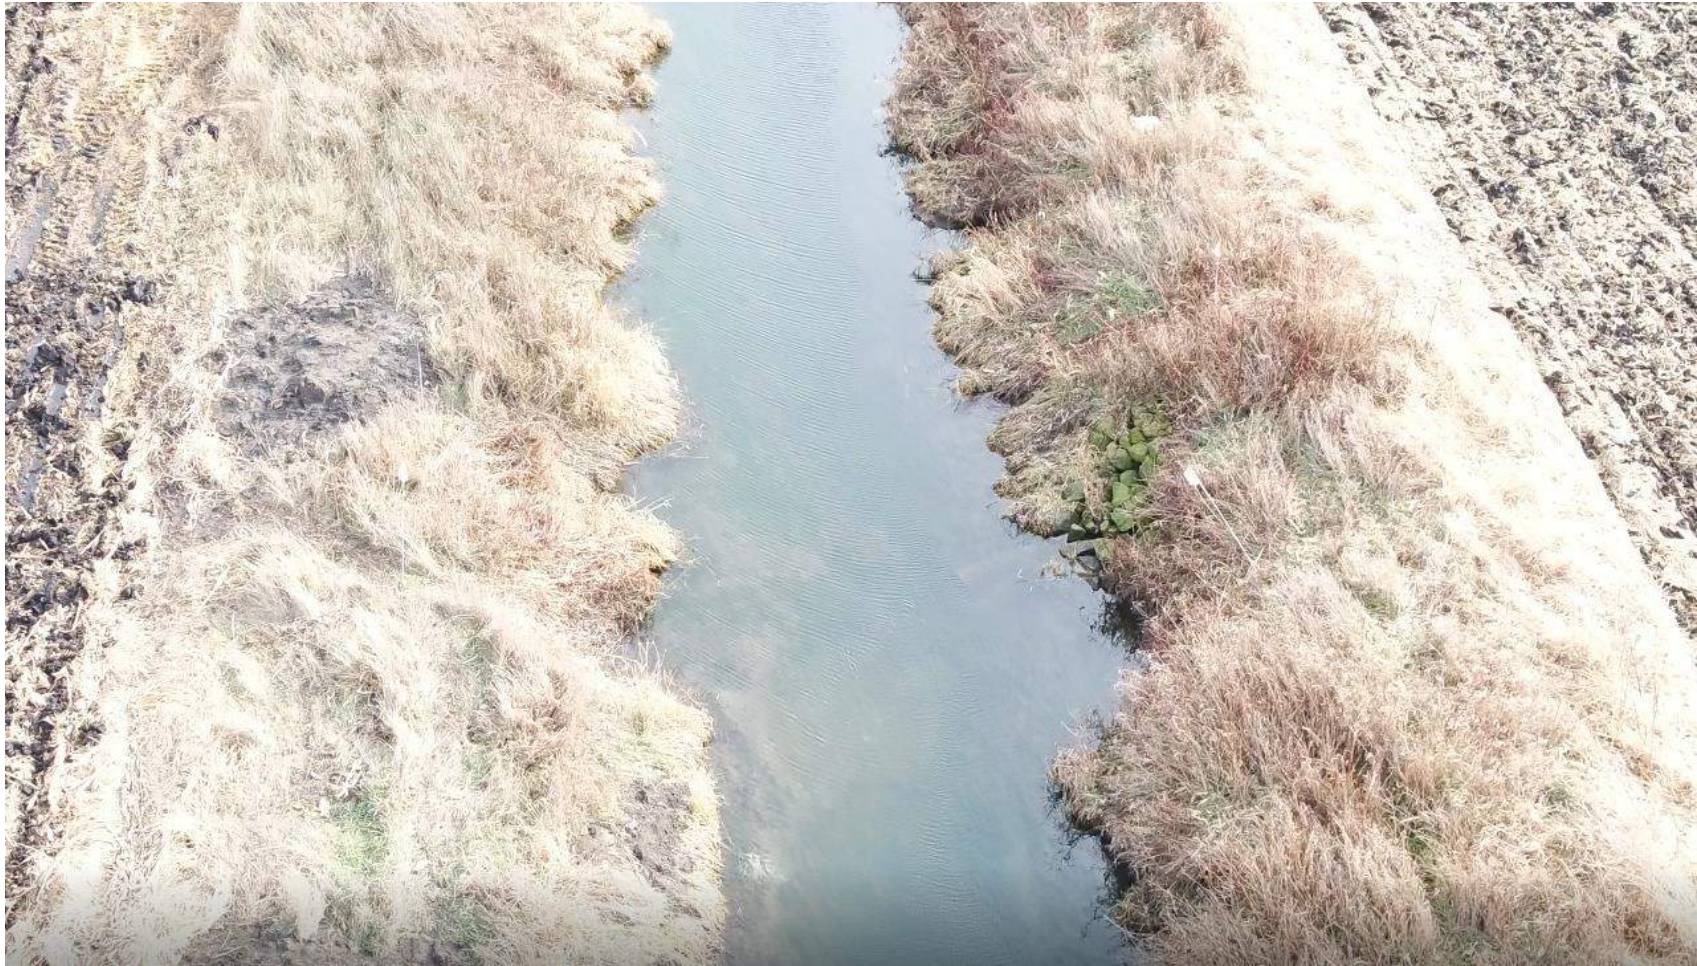
The drainage area of Branch K is approximately 1,765 acres which is nearly 40% of the drainage area of JD 2F at its CR 13 / 430th Avenue crossing. The 1950 improvement plans show Branch K tile is 18-inches in diameter at its outlet. The design slope was not available in the historic documents but is estimated to have a slope of 0.25%. Based on the pipe dimensions and upstream area, Branch K capacity is calculated to have a 0.1-inch drainage coefficient. Branch K, like many systems designed and constructed a long time ago, has a smaller drainage coefficient compared to drainage systems designed and installed today. This is consistent with the findings of the 1969 Bolton and Menk report on the most upstream section of Branch K. The ACSIC of Branch K is below current design standards (typically 0.5-inch drainage coefficient) and incapable of containing drainage flow during even moderate rainfalls. In addition to the limited capacity of the Branch K tile, the tile outlet was submerged during field survey which would further reduce drainage performance. See Photo 4 in **Attachment B**.

Drone Survey Photograph 4: Submerged Tile Outlet from Branch K at Station 72+00

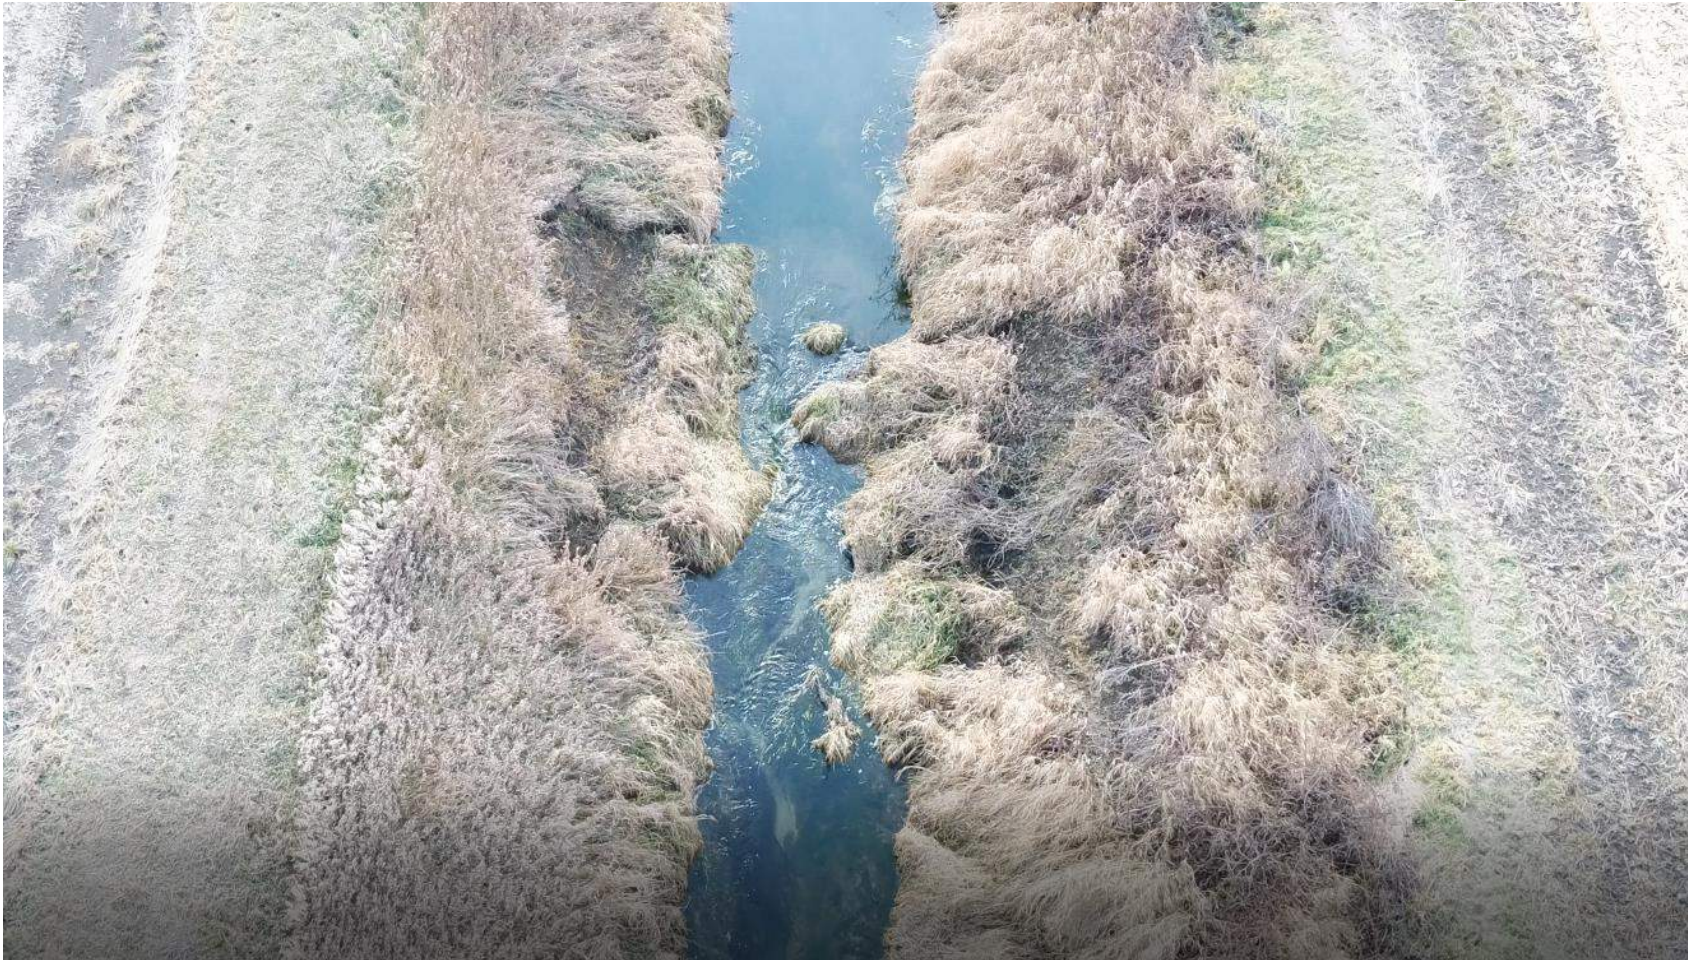
Drone Survey Photograph 5: Sediment in Channel due to Bank Sloughing at Station 113+00
