Technical Memorandum

Subject: Judicial Ditch 2F Repair Project

Date: February 27, 2020

Project: 6255-0014

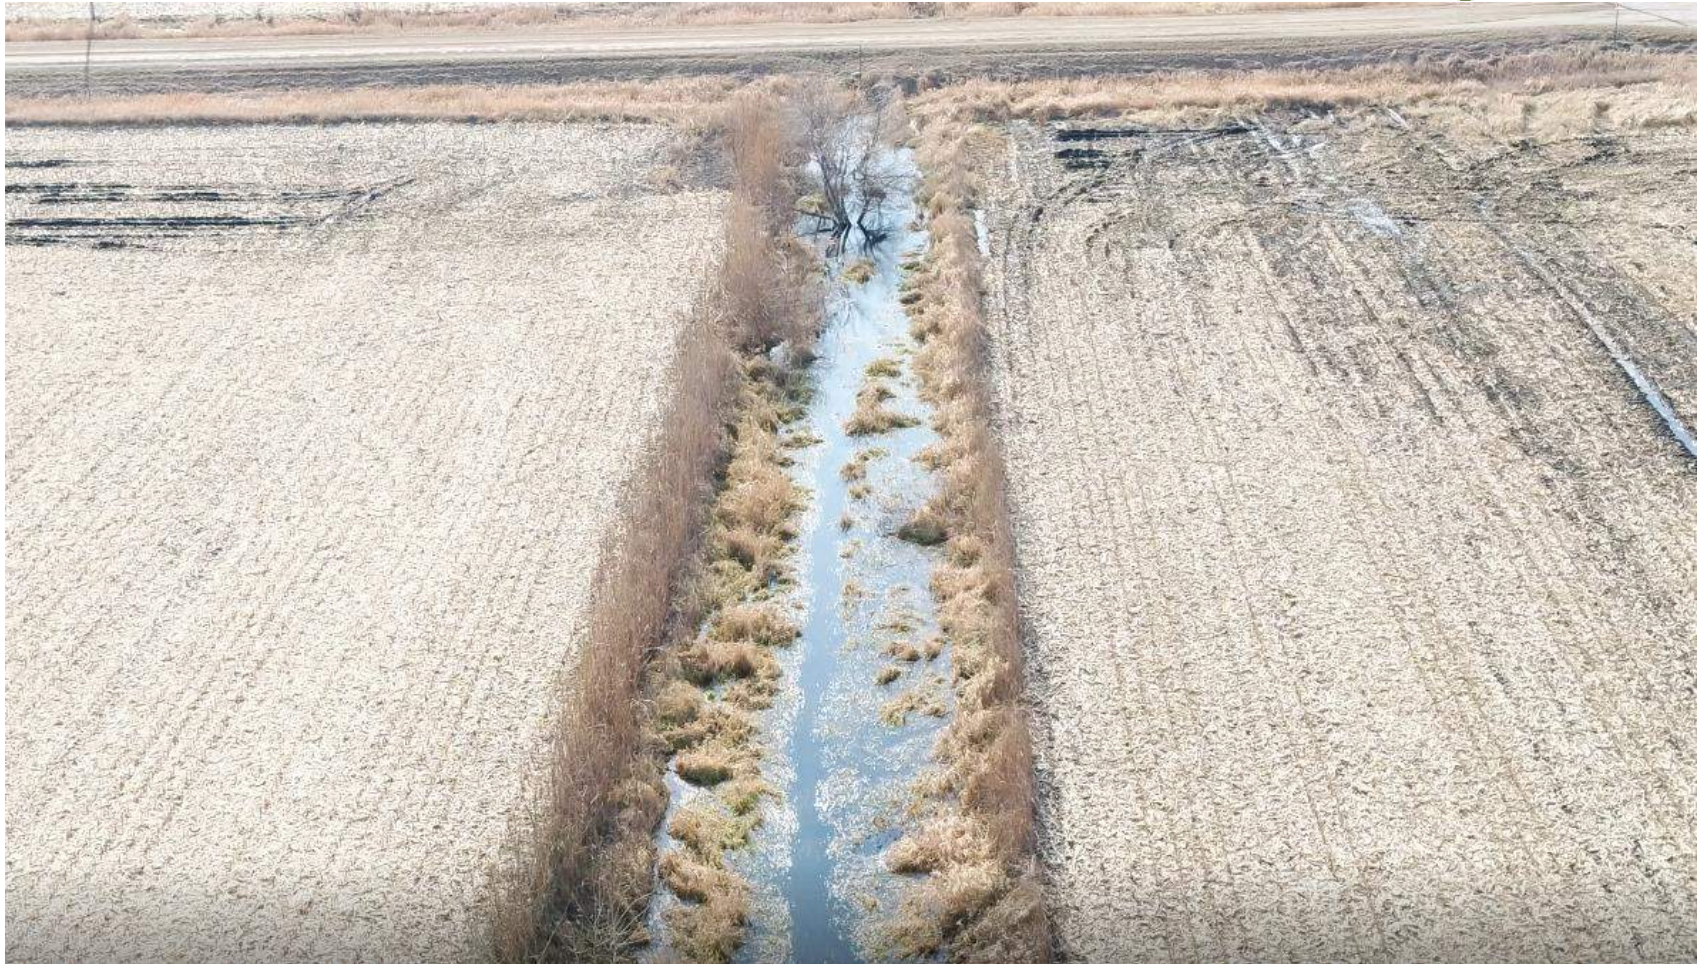
Drone Survey Photograph 6: Private Ditch alongside Branch K

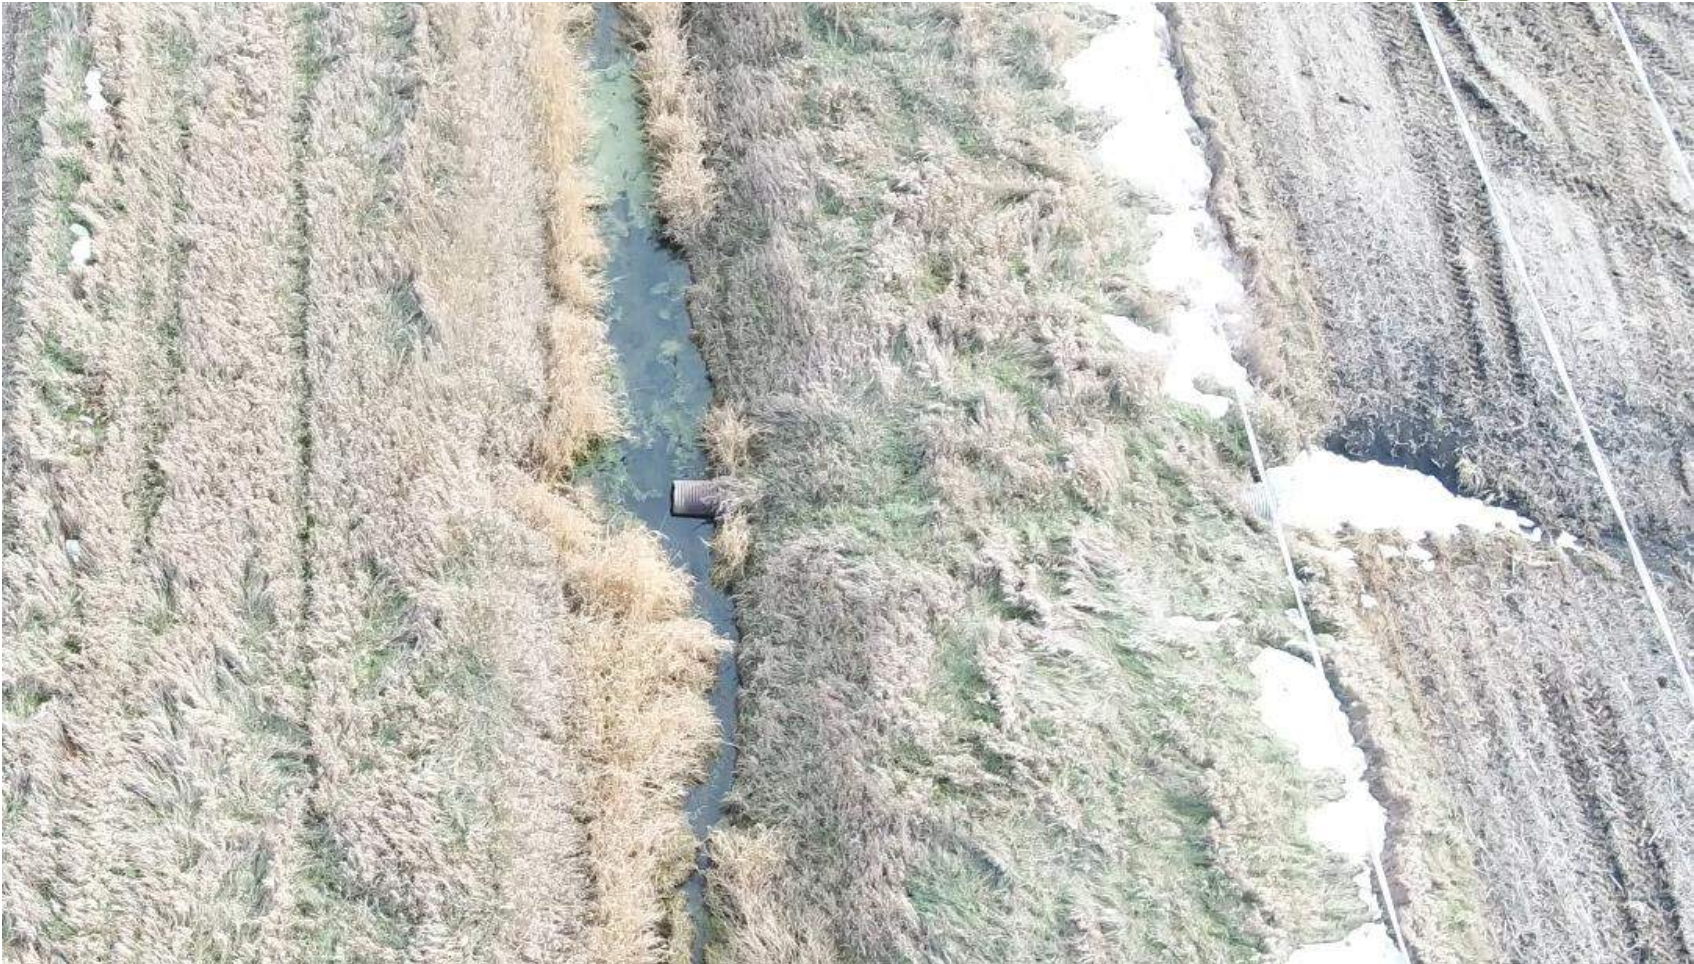
Drone video was collected over the channel to visually identify any evidence that excessive amounts of sediment is entering the private channel and ultimately JD 2F. Several side inlets are visible and appear to sediment sources into the private channel. At the very upstream (east) end of the channel, there are two shallow surface drains that enter the channel via side inlets. Below each side inlet, the channel has noticeably denser vegetation and less water, and upstream of each side inlet there was noticeably deeper water depths in the channel. See Photos 7 and 8 in **Attachment B**. This indicates that sediment has accumulated in the private open channel. However, field survey and drone imagery does not indicate sediment is entering the JD 2F channel from the private open channel at greater levels than the overall length of the JD 2F channel. It is still recommended that the implementation of measures to reduce sediment loading from the private channel be investigated further. A critical component to implementation of such measures is the willingness of landowners to collaborate with the Drainage Authority.

Drone Survey Photograph 7: Sediment Entering Private East-West Ditch in Section 18 of Barber Township via Side Inlet Pipe

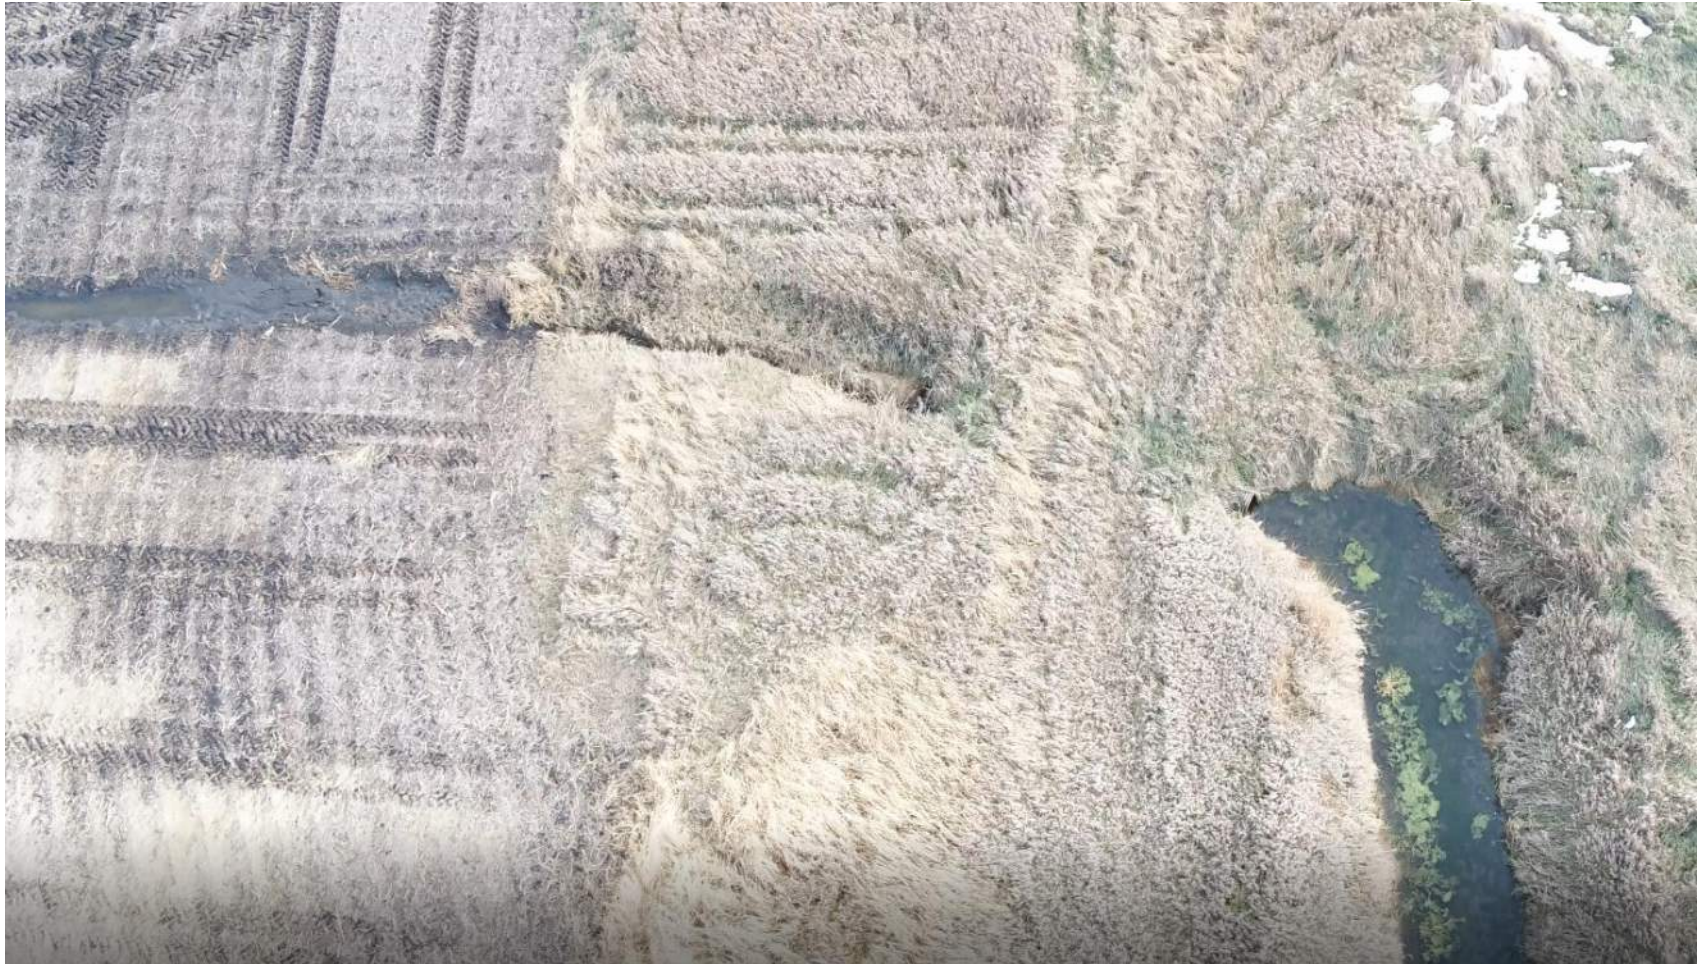
Drone Survey Photograph 8: Sediment Entering Upstream End of Private East-West Ditch in Section 18 Barber Township
