Repair of Judicial Ditch #2

PUBLIC HEARING NOTICE

JD2MF Repair Scope

Faribault County Drainage Department
 JD2MF Repair
 March 5, 2020

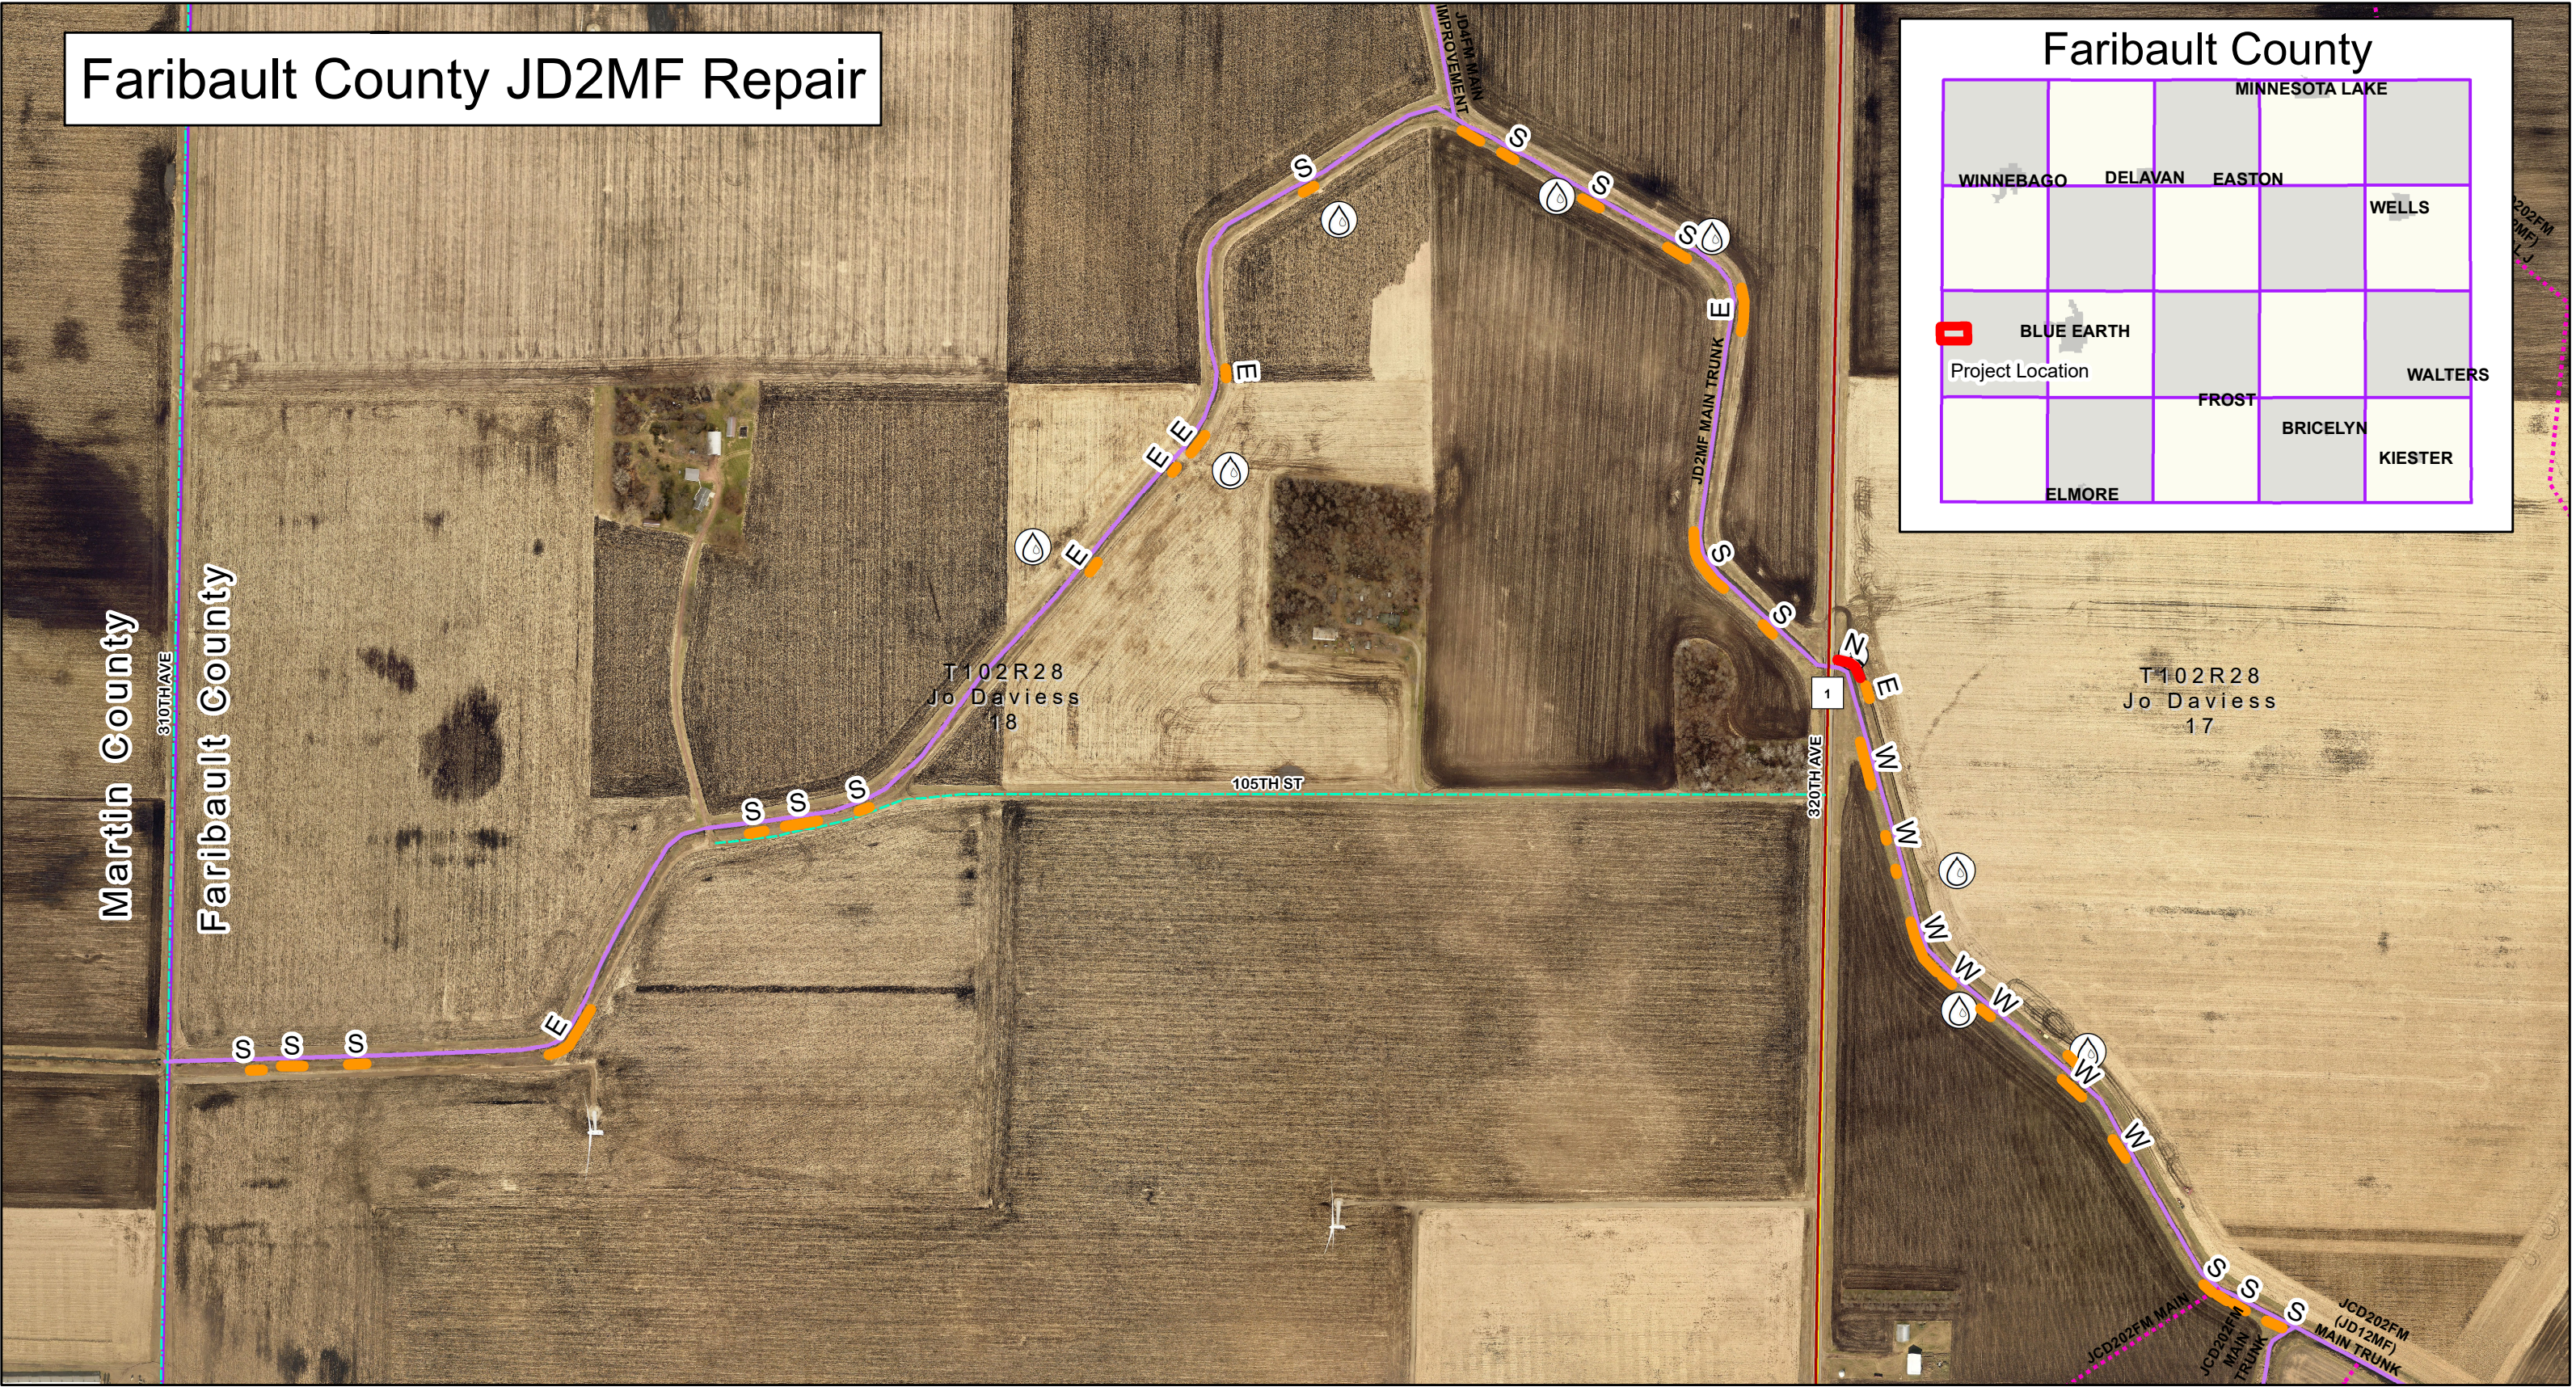
Faribault County JD2MF Repair

The JD2MF open ditch underwent an extensive repair project that was completed in early 2014. The project consisted of a clean out of nearly the entire open ditch, the repair of all tile outlets to the open ditch, and multiple areas of slough repair. The JD2MF channel was inspected in the fall of 2019. Many areas of the open ditch had extensive sloughing, more concentrated to the outlet of the JD2MF ditch.

Slough Repair: Multiple sloughs have been identified that need repair. Approximately 2,395 linear feet of ditch requires slough repair where riprap is placed at the toe for stabilization. Ditch bank side-slope seeding will need to be done where vegetation is disturbed from slough repair.

Ditch Bank Re-Slope: Approximately 101 linear feet of ditch bank needs to be reshaped to the original 1.5:1 slope. This area is located just downstream of the CR1 bridge crossing in Jo Daviess Township Section 17 SWNW.

Tile Outlet Repair: Most of the tile outlets are in good condition, having been replaced and armored during the 2014 repair. One outlet where the ditch bank needs to be reshaped needs to be repaired in Jo Daviess Township Section 17 SWNW.

Alternative Side Inlets: Eight locations where gully erosion and/or traditional side inlets exist will be replaced with an alternative design. See ASI schedule for sizing information. Funding could be available to offset some of the cost of the installation and material costs.
