Faribault County, Minnesota

County Ditch #73

Staff Repair Report

March 2023

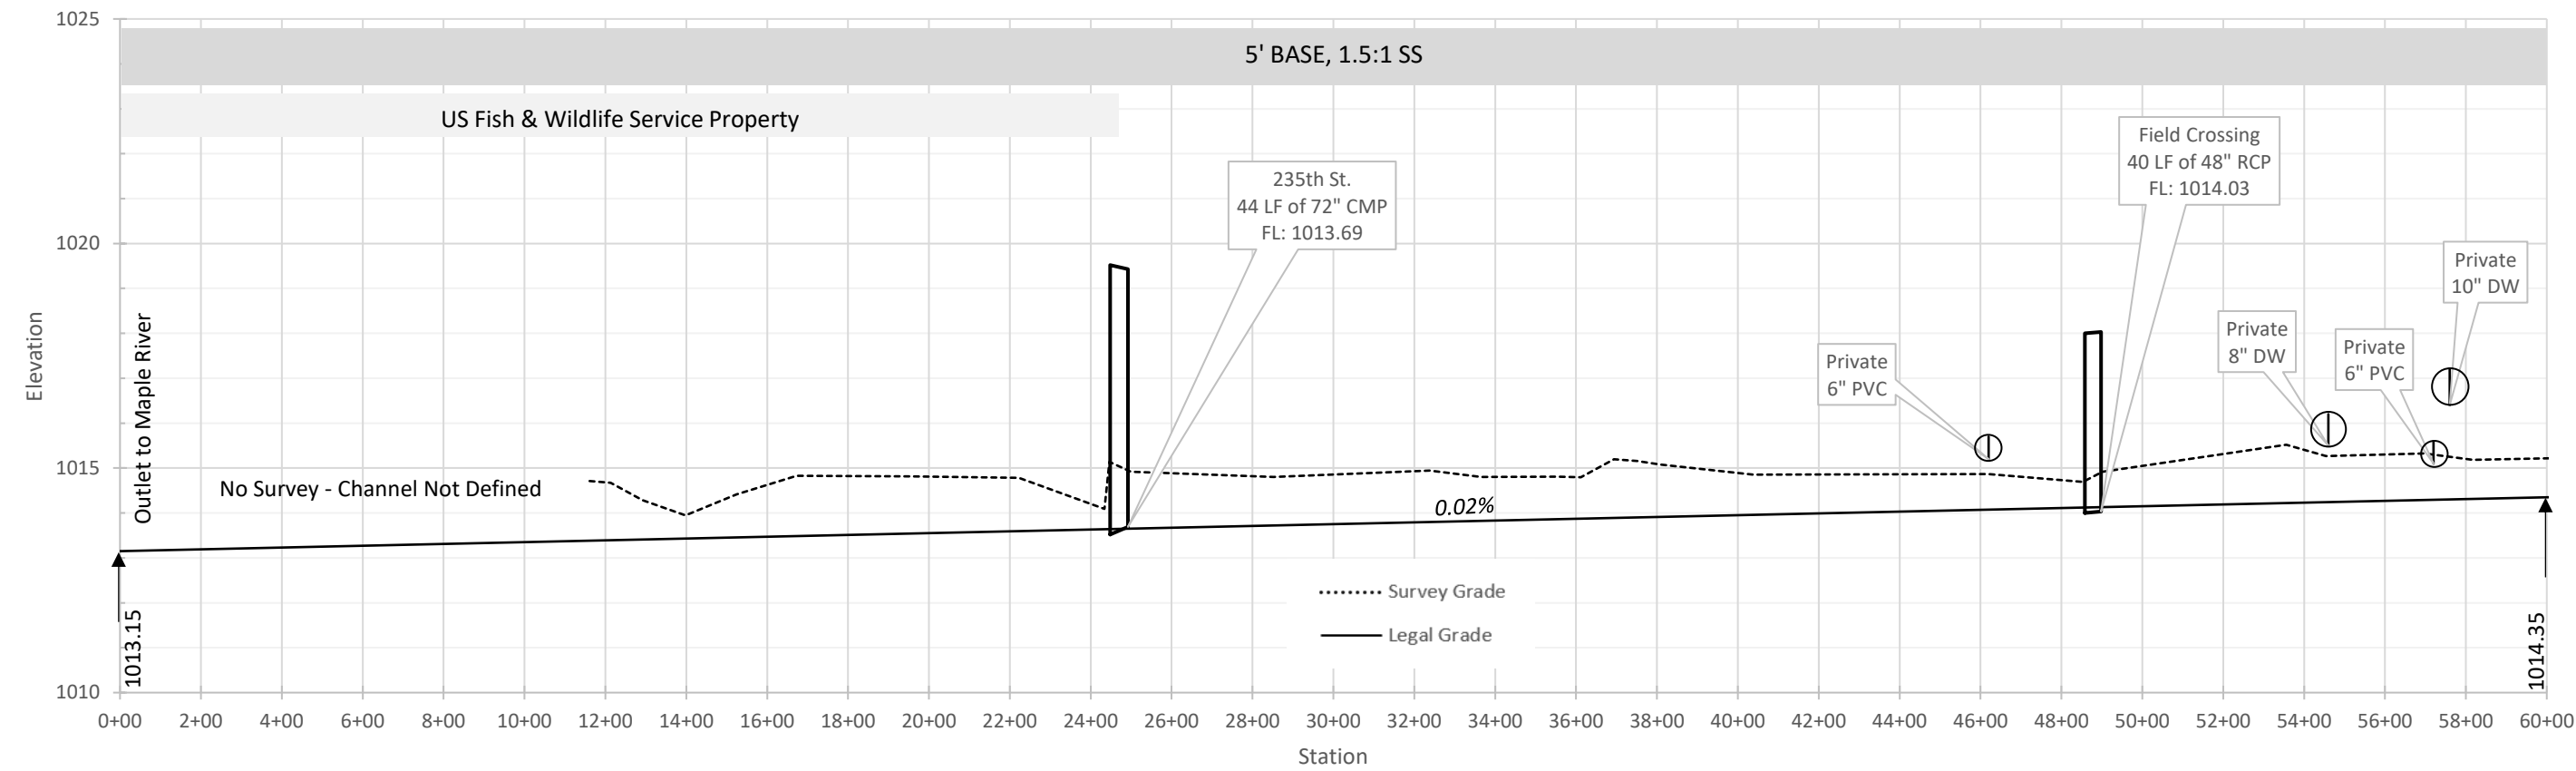
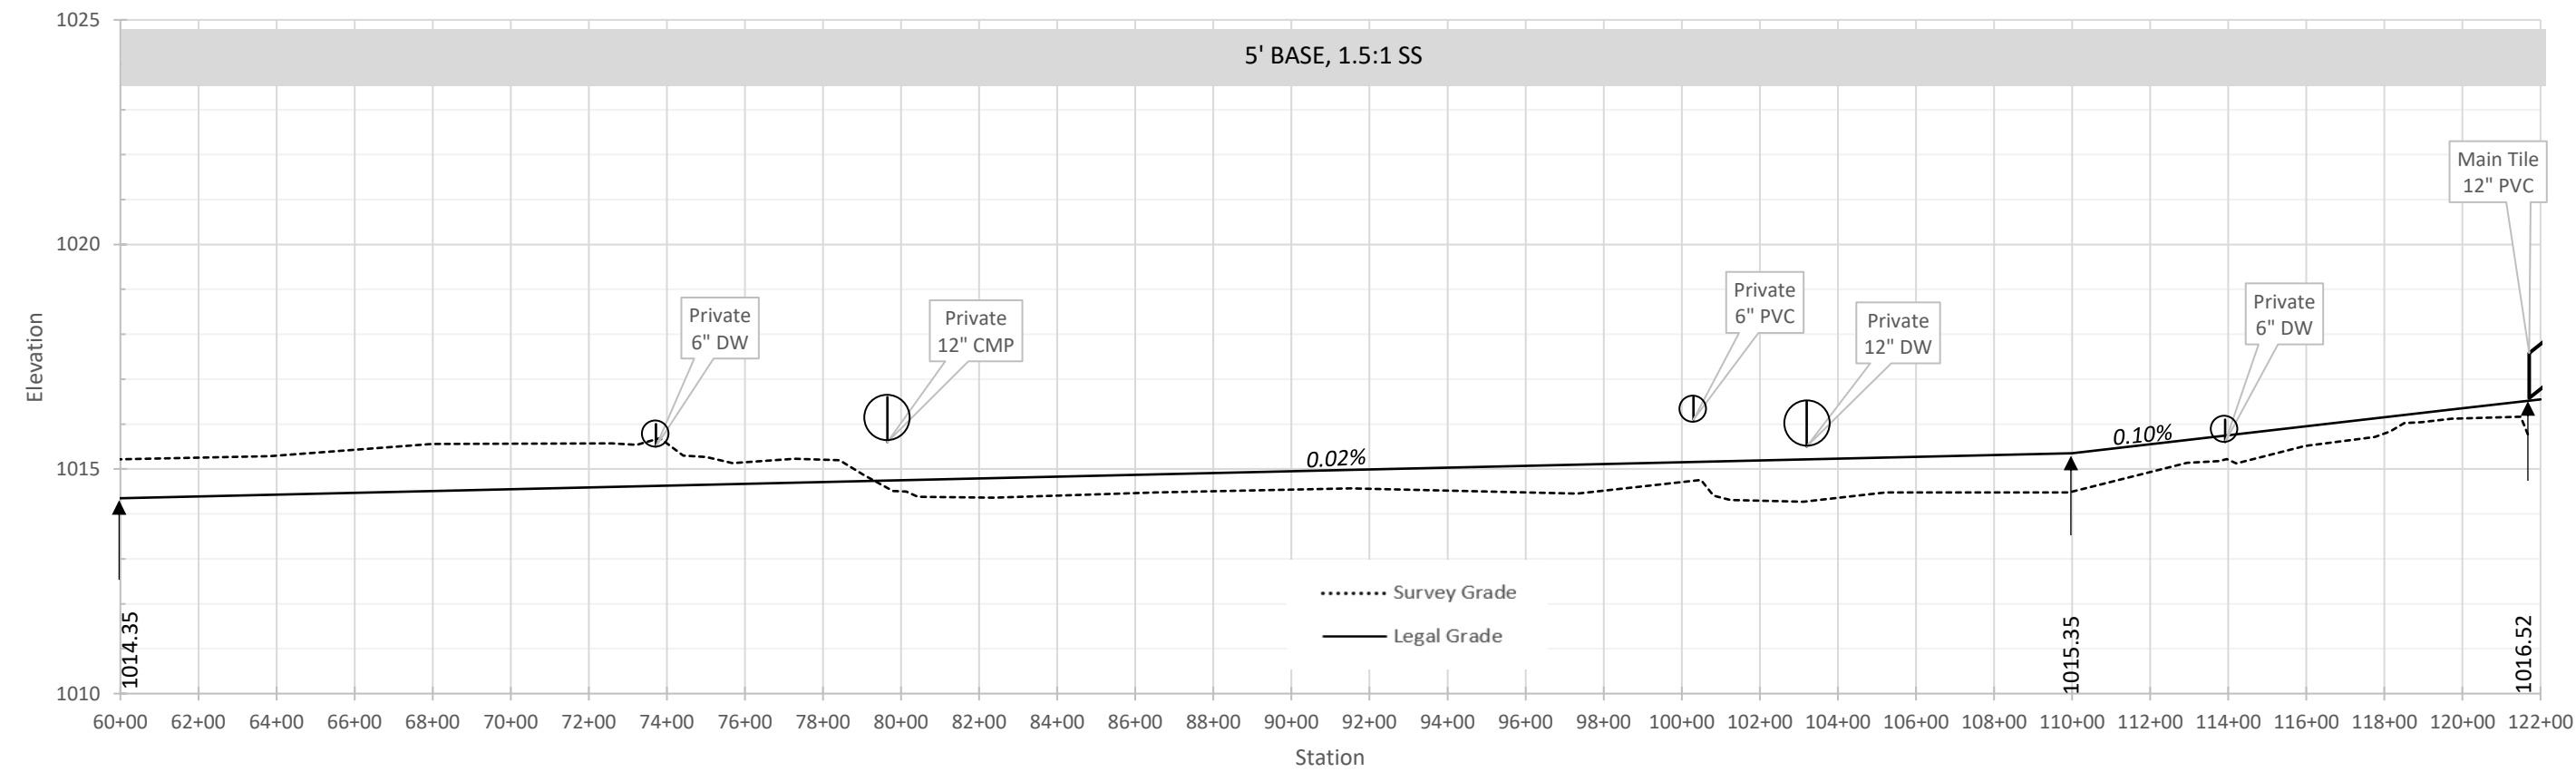
CD73 Open Ditch

Drainage Department staff completed a survey of the open ditch in 2022. The location of tile outlets and side inlets as well as the invert elevations of the two ditch crossings were recorded. Legal grade was determined by fitting the grade line to the invert elevations of the two crossings.

From the open ditch profile, sediment has accumulated in the open ditch. To restore the open ditch to its original grade or make any measurable positive effect on drainage, cleaning would need to begin at the outlet to the Maple River. This poses numerous challenges due to the marshy, wet conditions of the open ditch through the USFWS property. Additional tree removal would also need to be undertaken to access the open ditch channel.
