# Faribault County, Minnesota County Ditch #8/42 Staff Repair Report

January 2023

## CD8/CD42 Open Ditch Repair

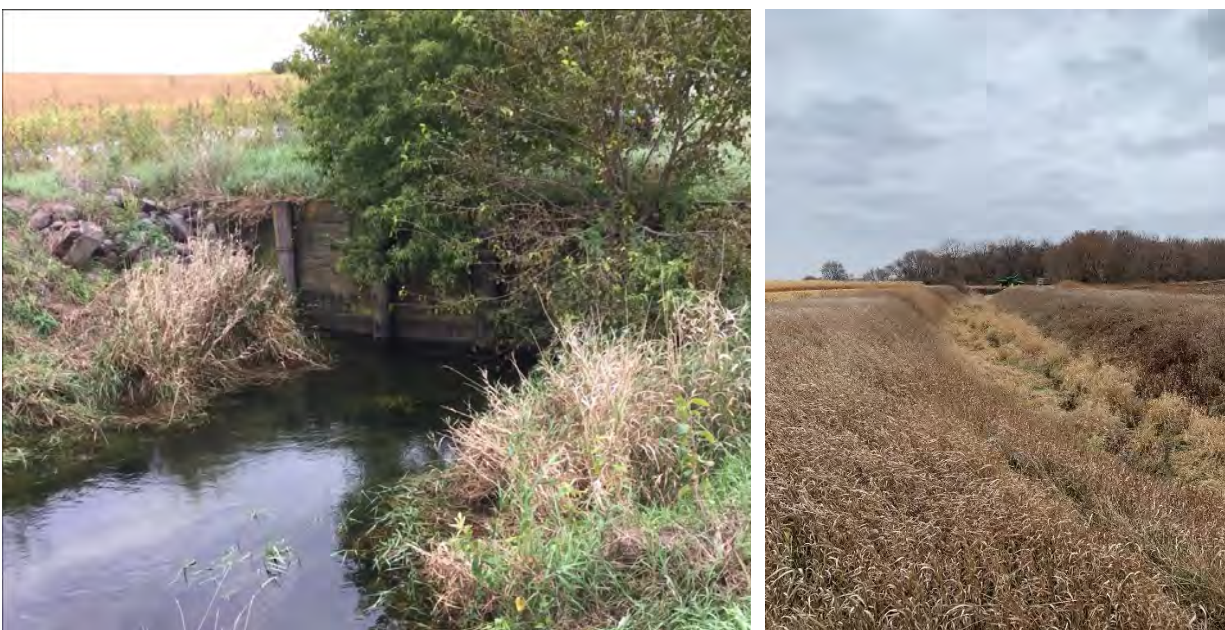
The CD8/42 open ditch system was inspected in 2019. The open ditch appeared to have accumulated sediment in the upper reach as evidenced by the submerged outlet of the CD42 Main Tile Outlet and intense vegetation growth in the ditch bottom (Figure 1). Also revealed during the scheduled inspection was tree and brush growth ranging from small and sporadic to mature and dense. Tree removal began in early 2021 and early 2022 in preparation for a potential ditch cleanout.

**Figure 1.** The wooden headwall at the beginning of the CD42 open ditch (left) serves as the outlet for the CD42 Main Tile. The 2019 inspection revealed that the Main Tile did not have an unimpeded outlet. Vegetation growth and the lack of a definable channel downstream from the headwall (right) indicate that sediment has accumulated in the open ditch.

Open Ditch Cleaning: Remove sediment from the channel to the original grade of the open ditch. Level spoils.

1. CD42 Station 0+00 to -91+00.
2. CD8 Station 0+00 to 57+00.

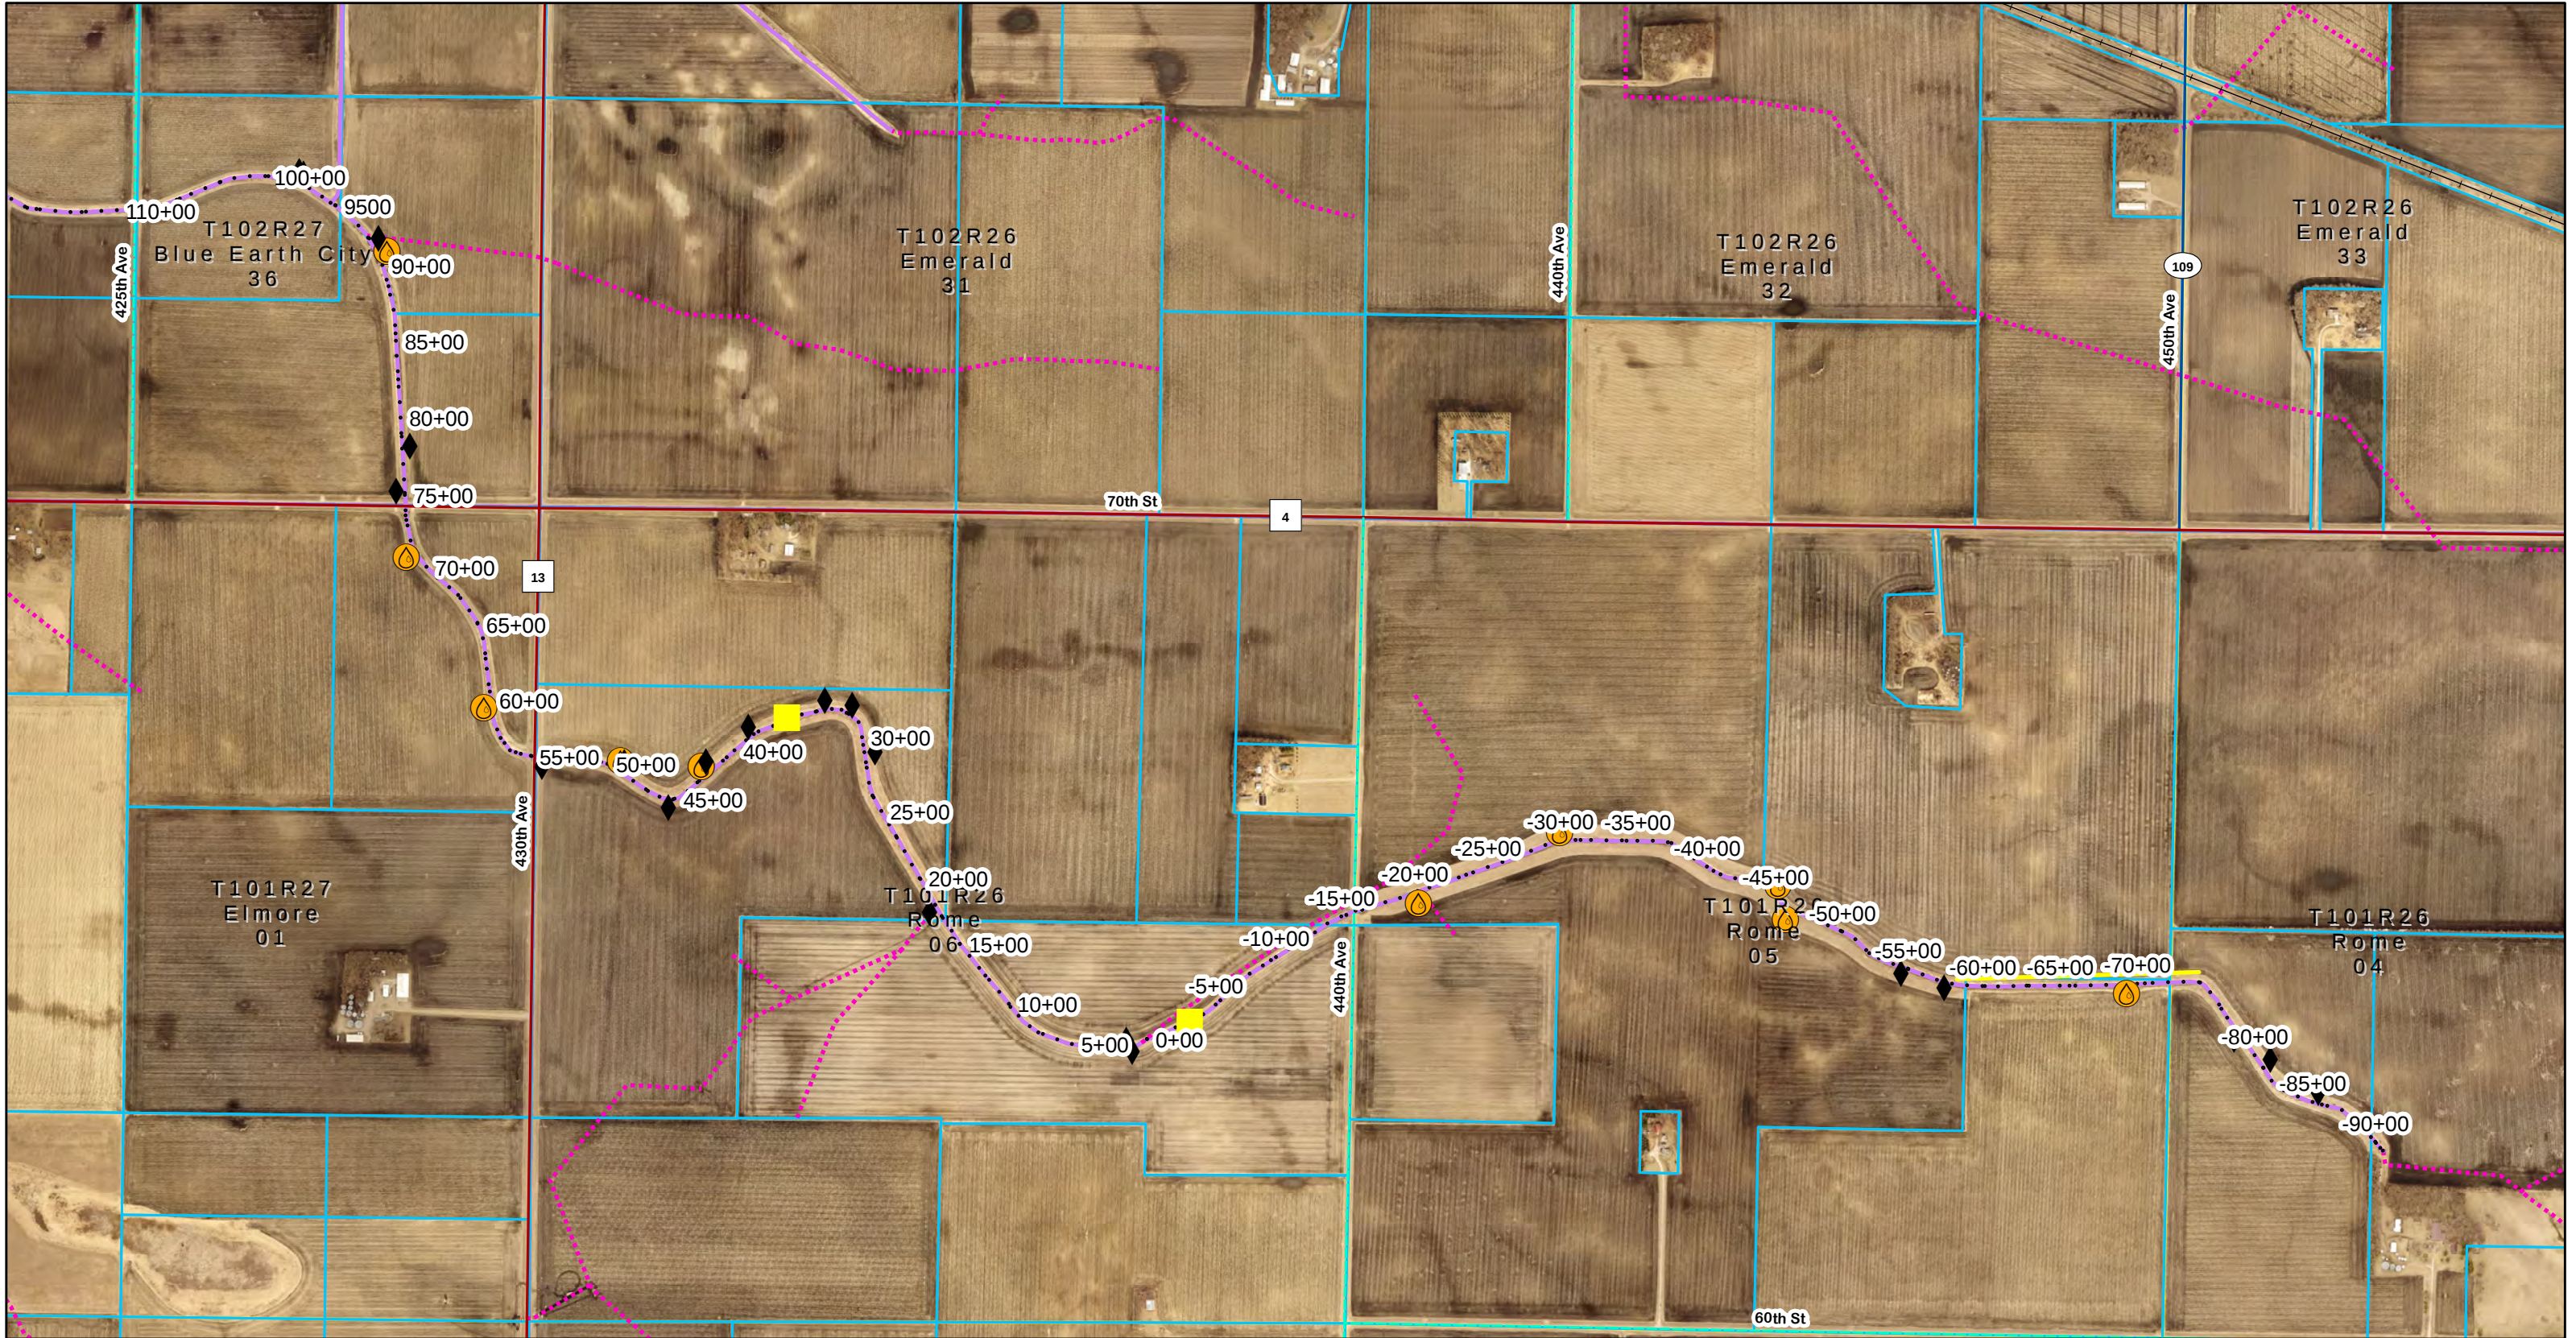
## CD8/42 Overview Map

Stationing Note: Station 0+00 marks the end of CD42 and the beginning of CD8. CD42 stationing is negative

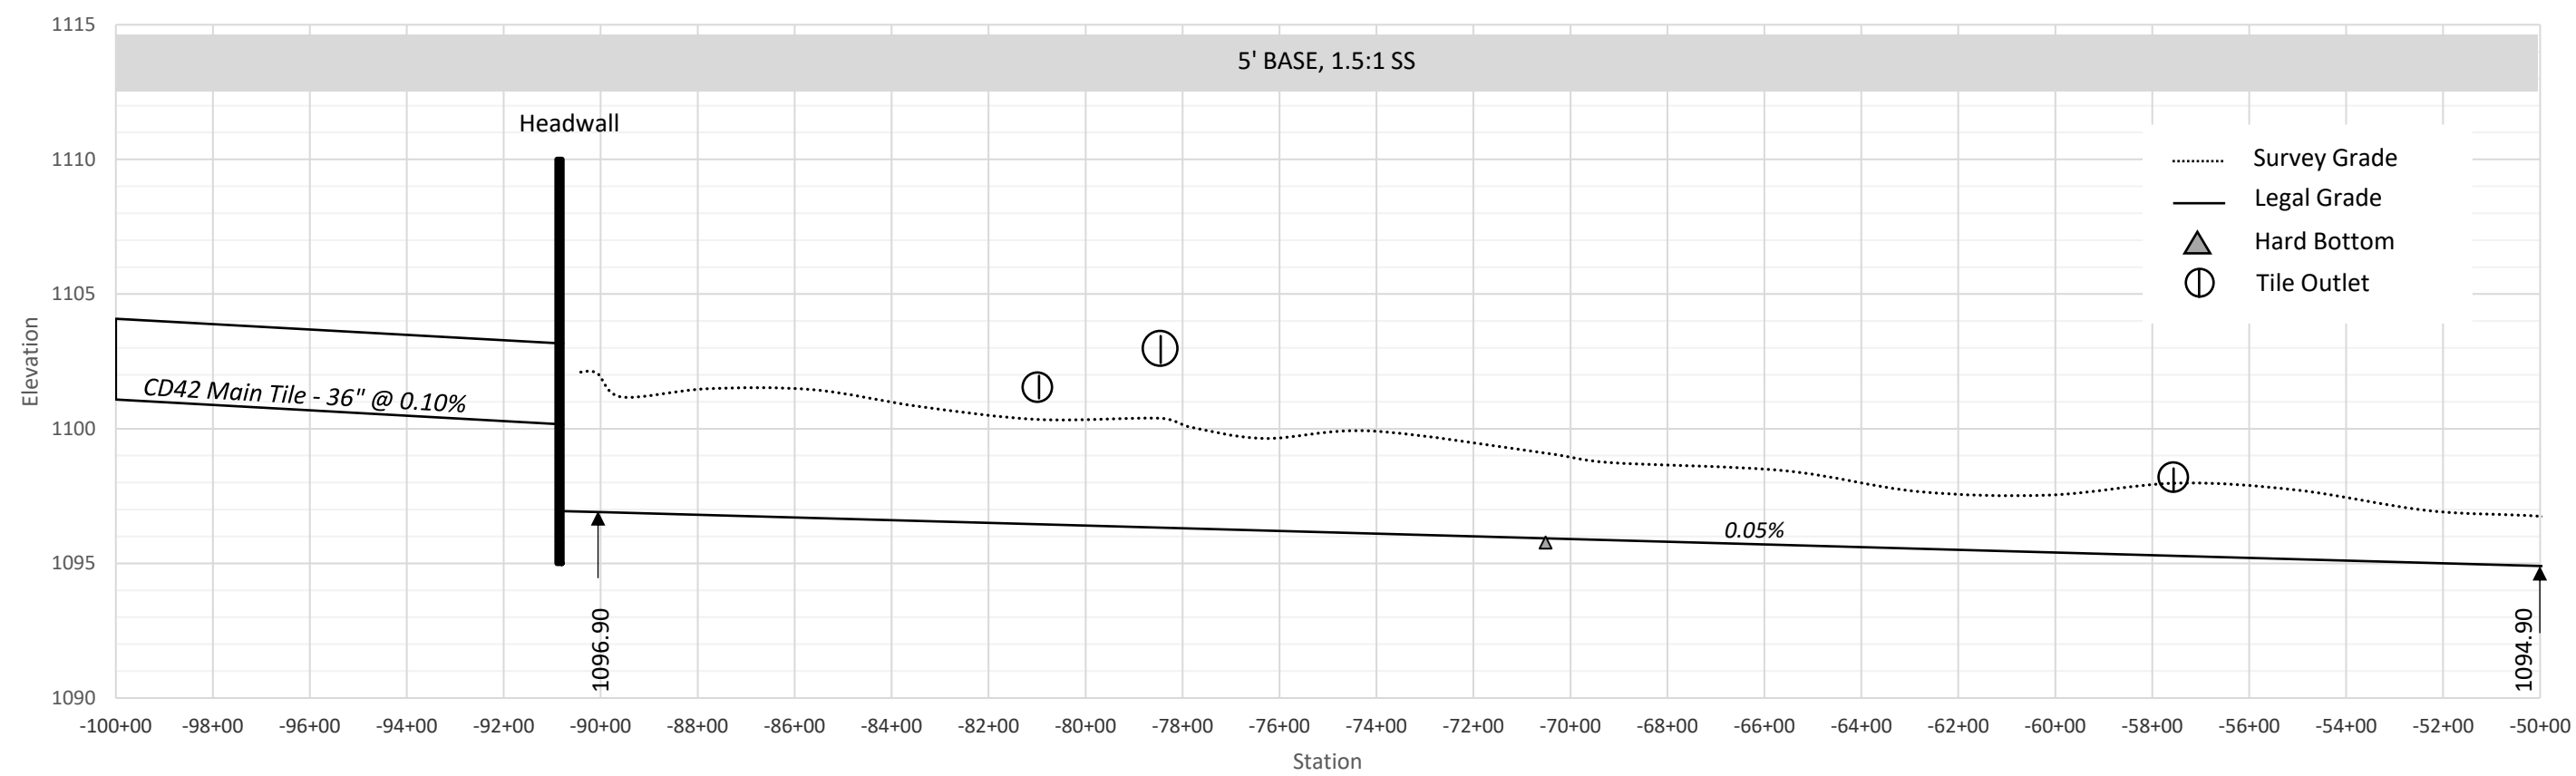
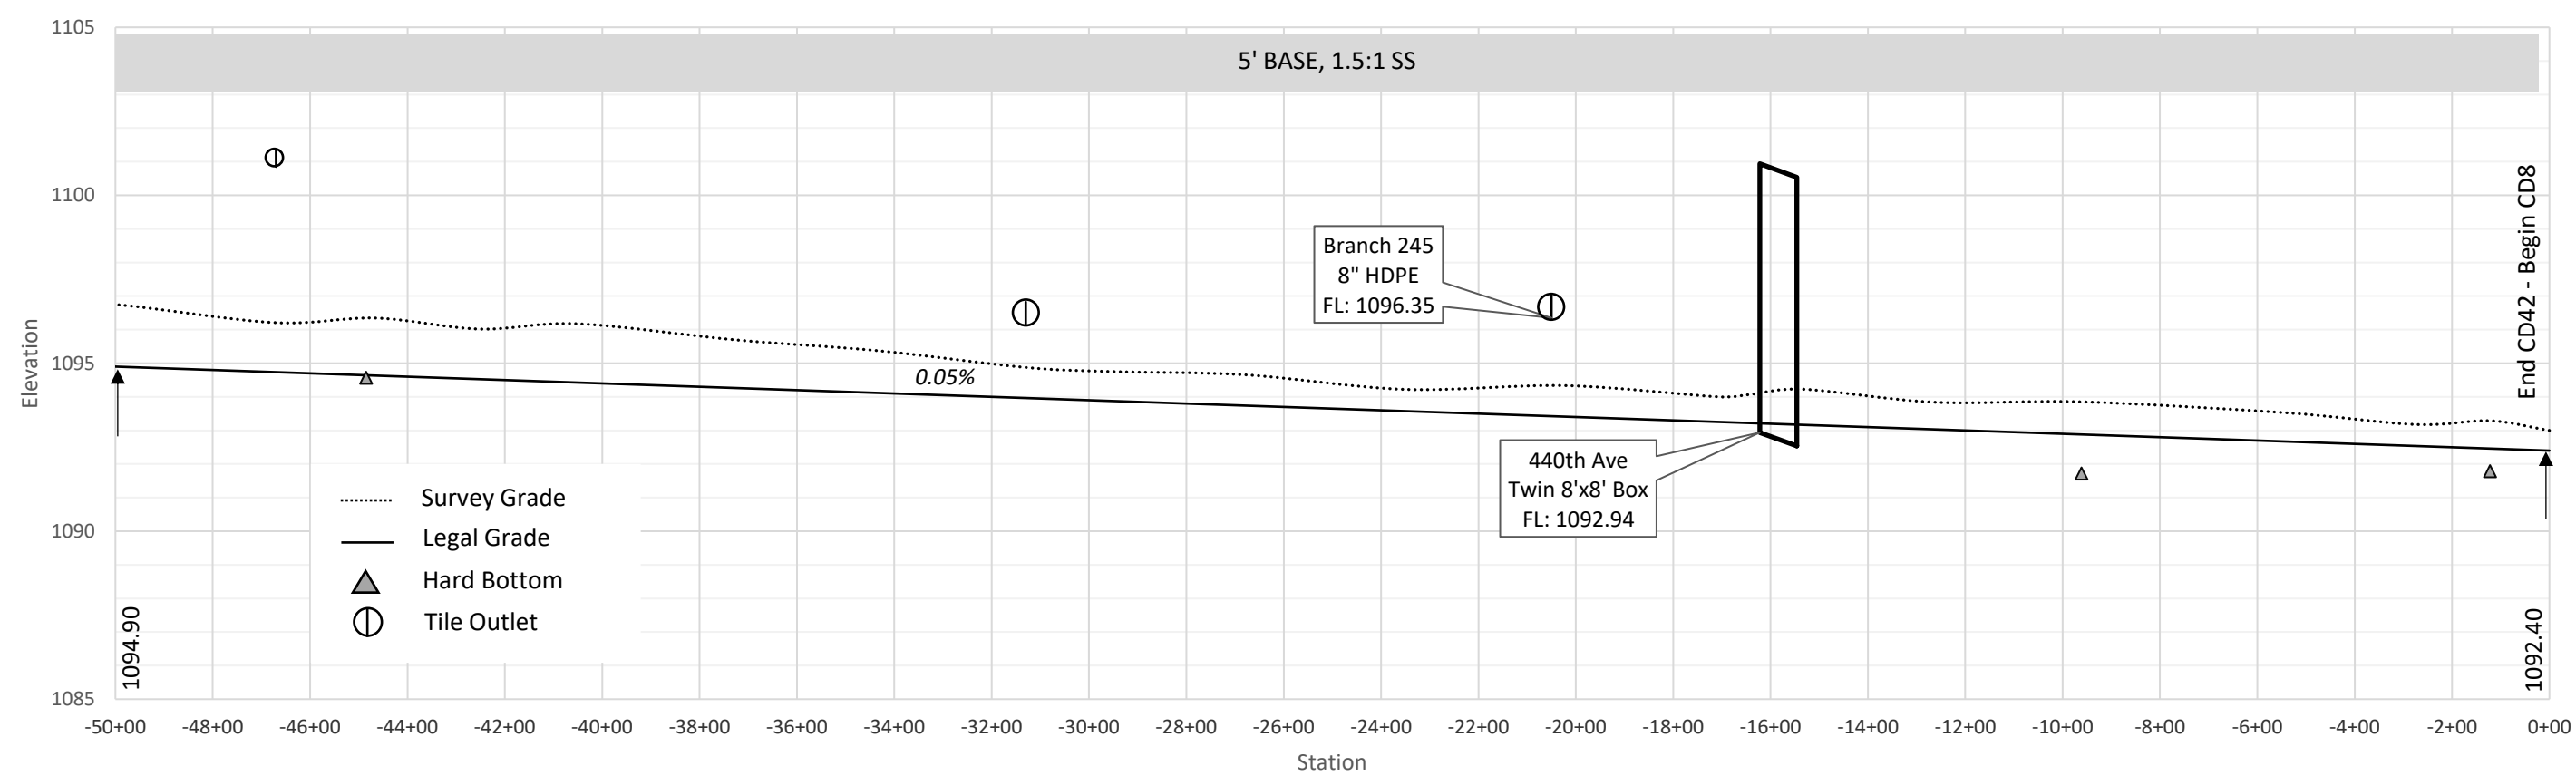
CD42 Main Open Ditch Profile

Record of the most recent ditch cleaning project on the CD8/42 Main Open Ditch is from 1952. The repair profile showed more than 4 feet of sediment accumulating in the top end of the CD42 open ditch. The repair report called for removing sediment from the entire 9,000-foot stretch of CD42 plus the first 1,000 feet of CD8. The CD8 open ditch was surveyed in 1942 and came to the same conclusion as the 1952 repair report, but it's unclear if any work was completed at that time.
