Technical Memorandum

Subject: County Ditch 60 Repair Project

Date: July 12, 2019

Project: 6255-0011

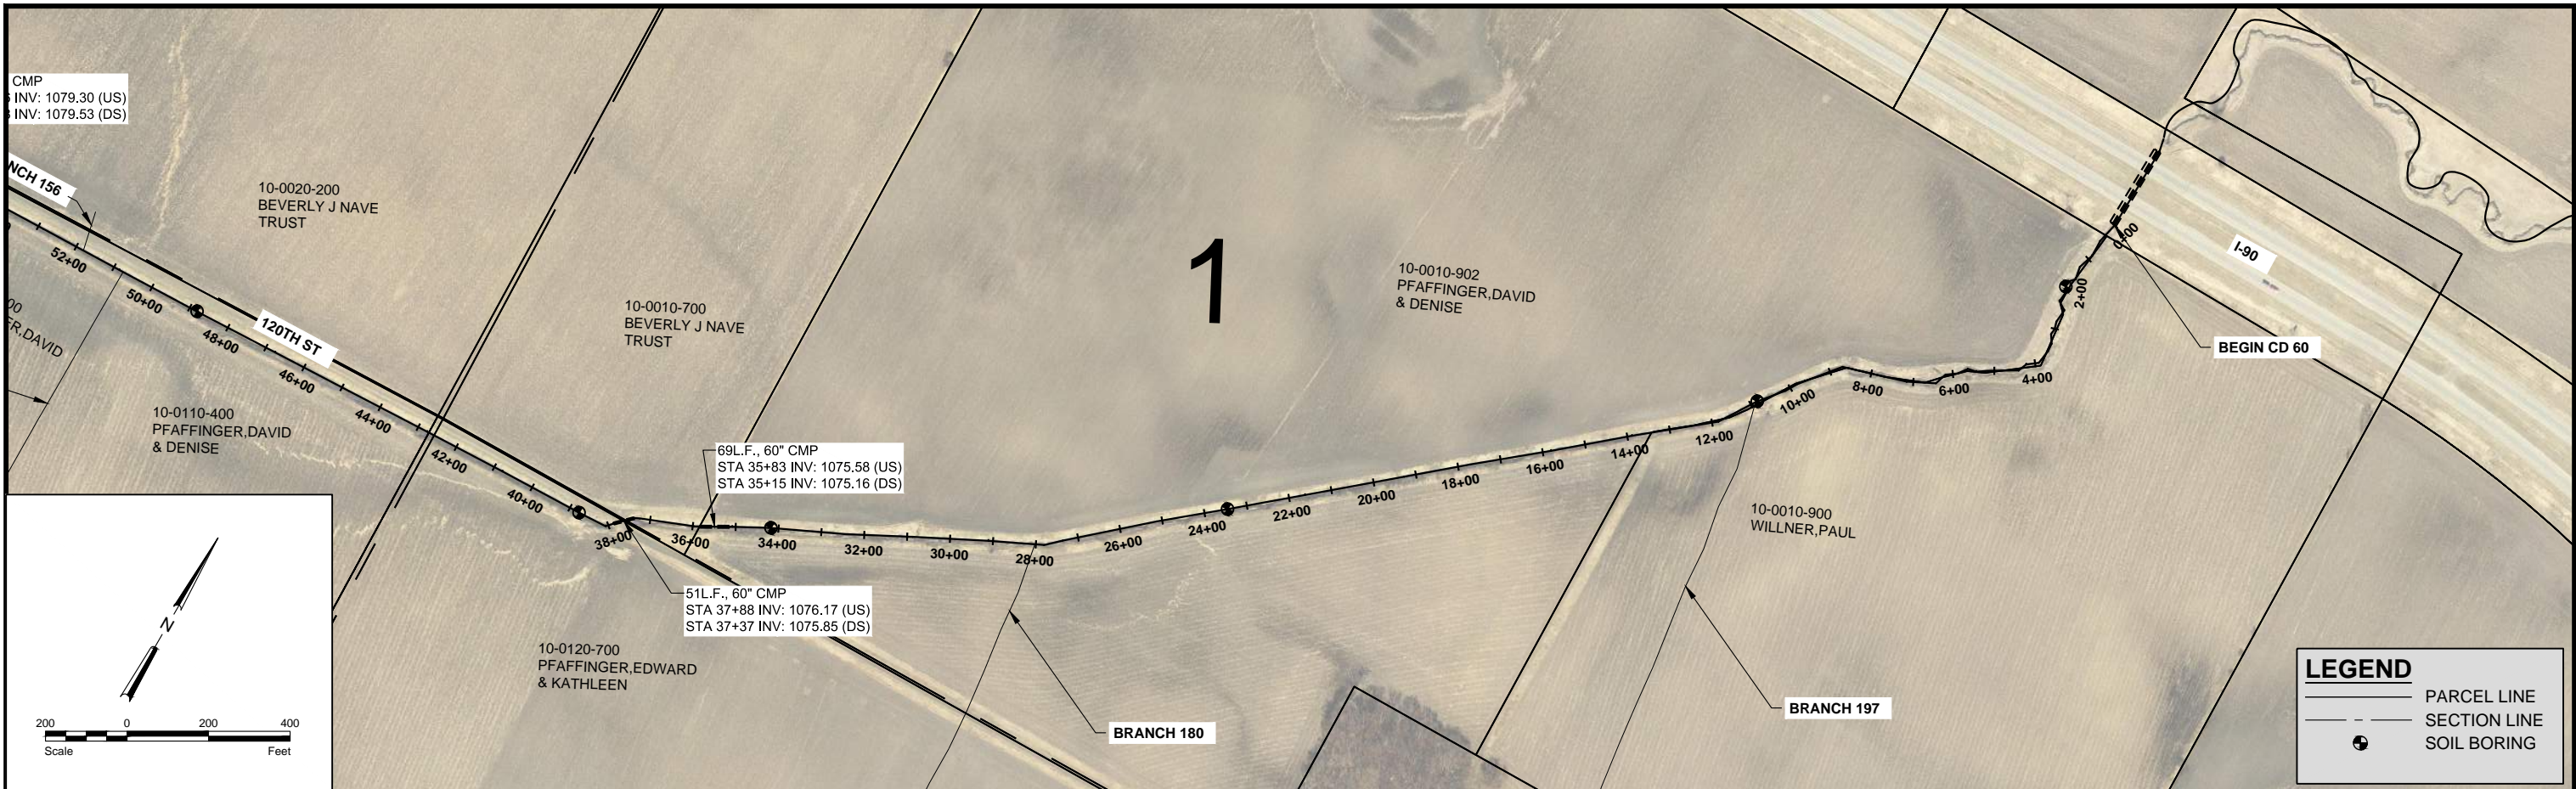
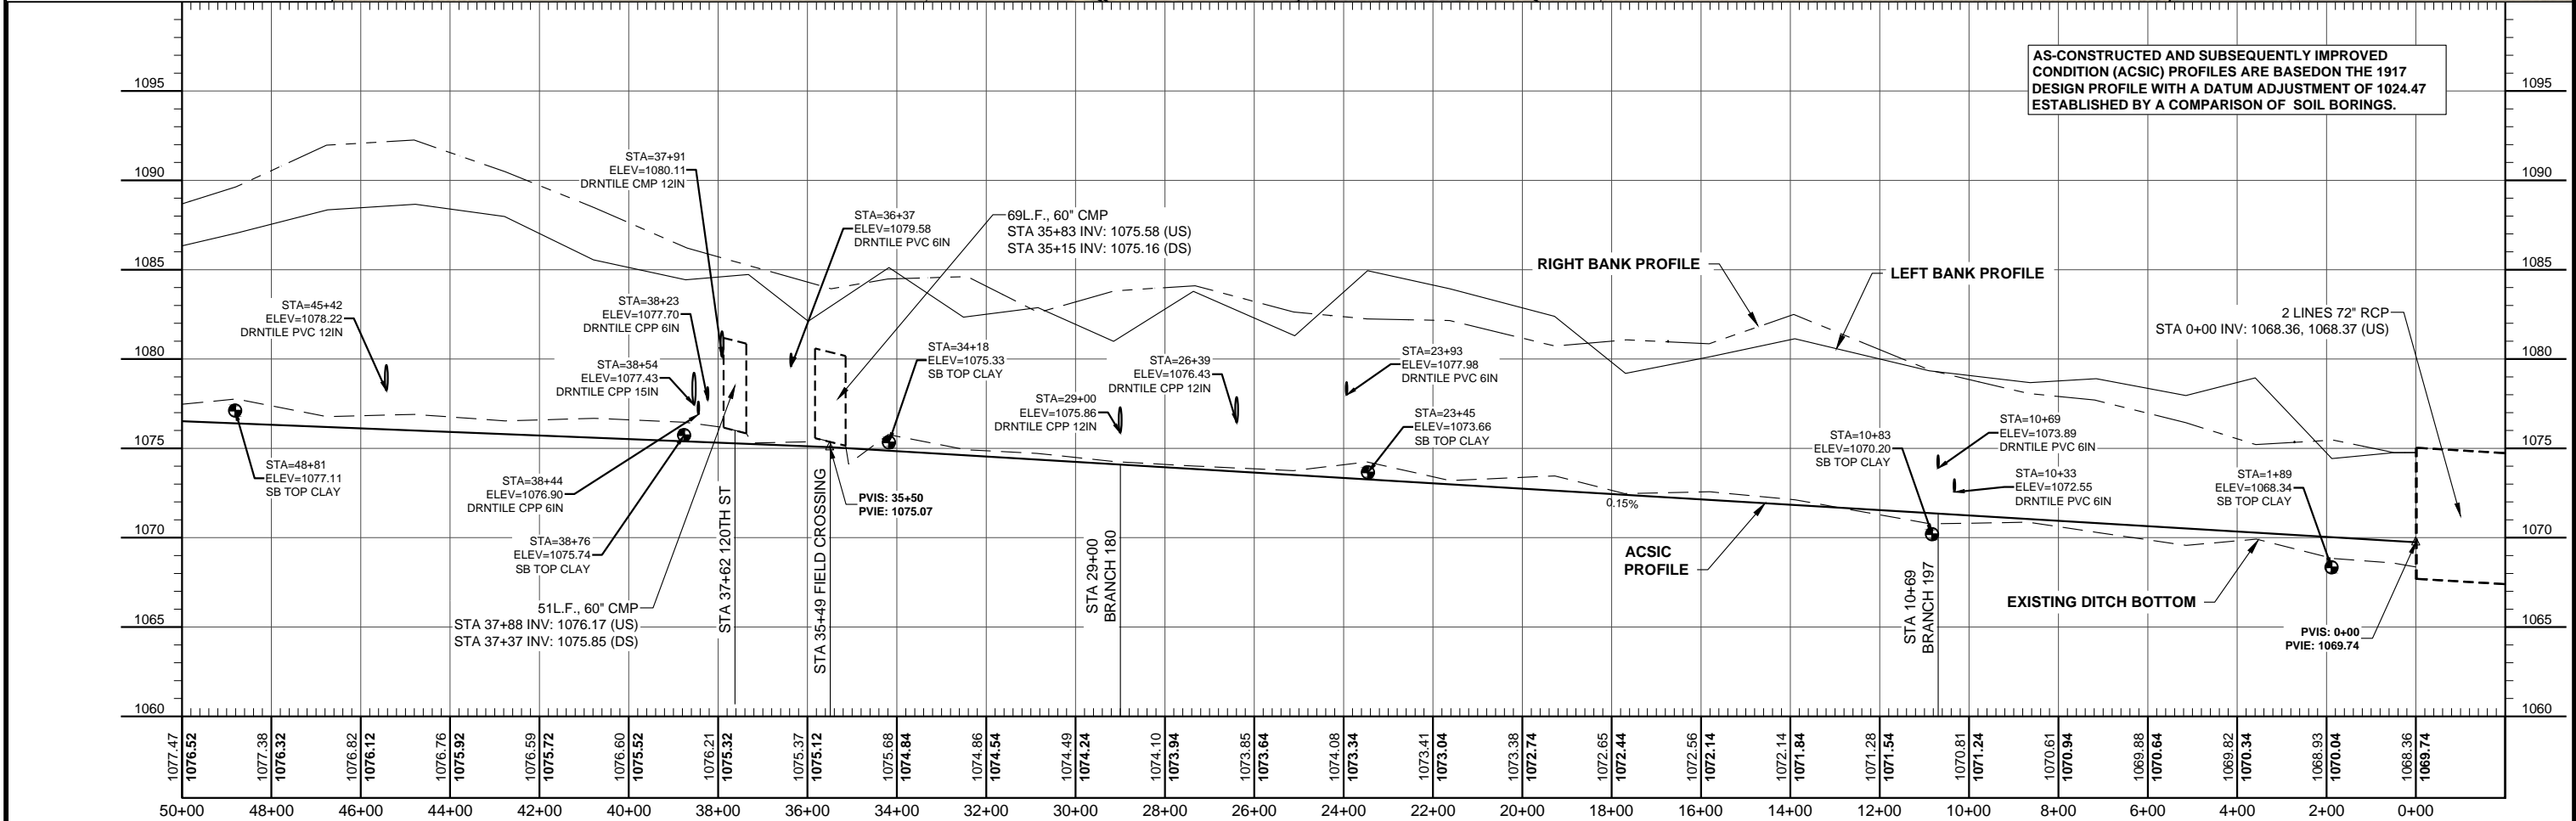
The proposed repair profiles are indicated as the ACSIC profile shown in **Attachment C**. The current channel bottom of the ditch is higher than the ACSIC profile due to sediment accumulation in the channel along most of its length. Accumulated sediment in the channel bottom should be excavated, placed at the top of the ditch bank, and leveled. A 1953 repair profile drawing includes a typical cross section with the dimensions of a 4-foot bottom width and 1.5:1 side slopes. To be consistent with the definition of "repair" under Minnesota Statute 103E, excavation of the channel bottom should not exceed a 4-foot width and should be consistent with the ACSIC grade identified in **Attachment C**.
