Faribault County, Minnesota

County Ditch #37

Staff Repair Report

CD 37 Open Ditch Repair

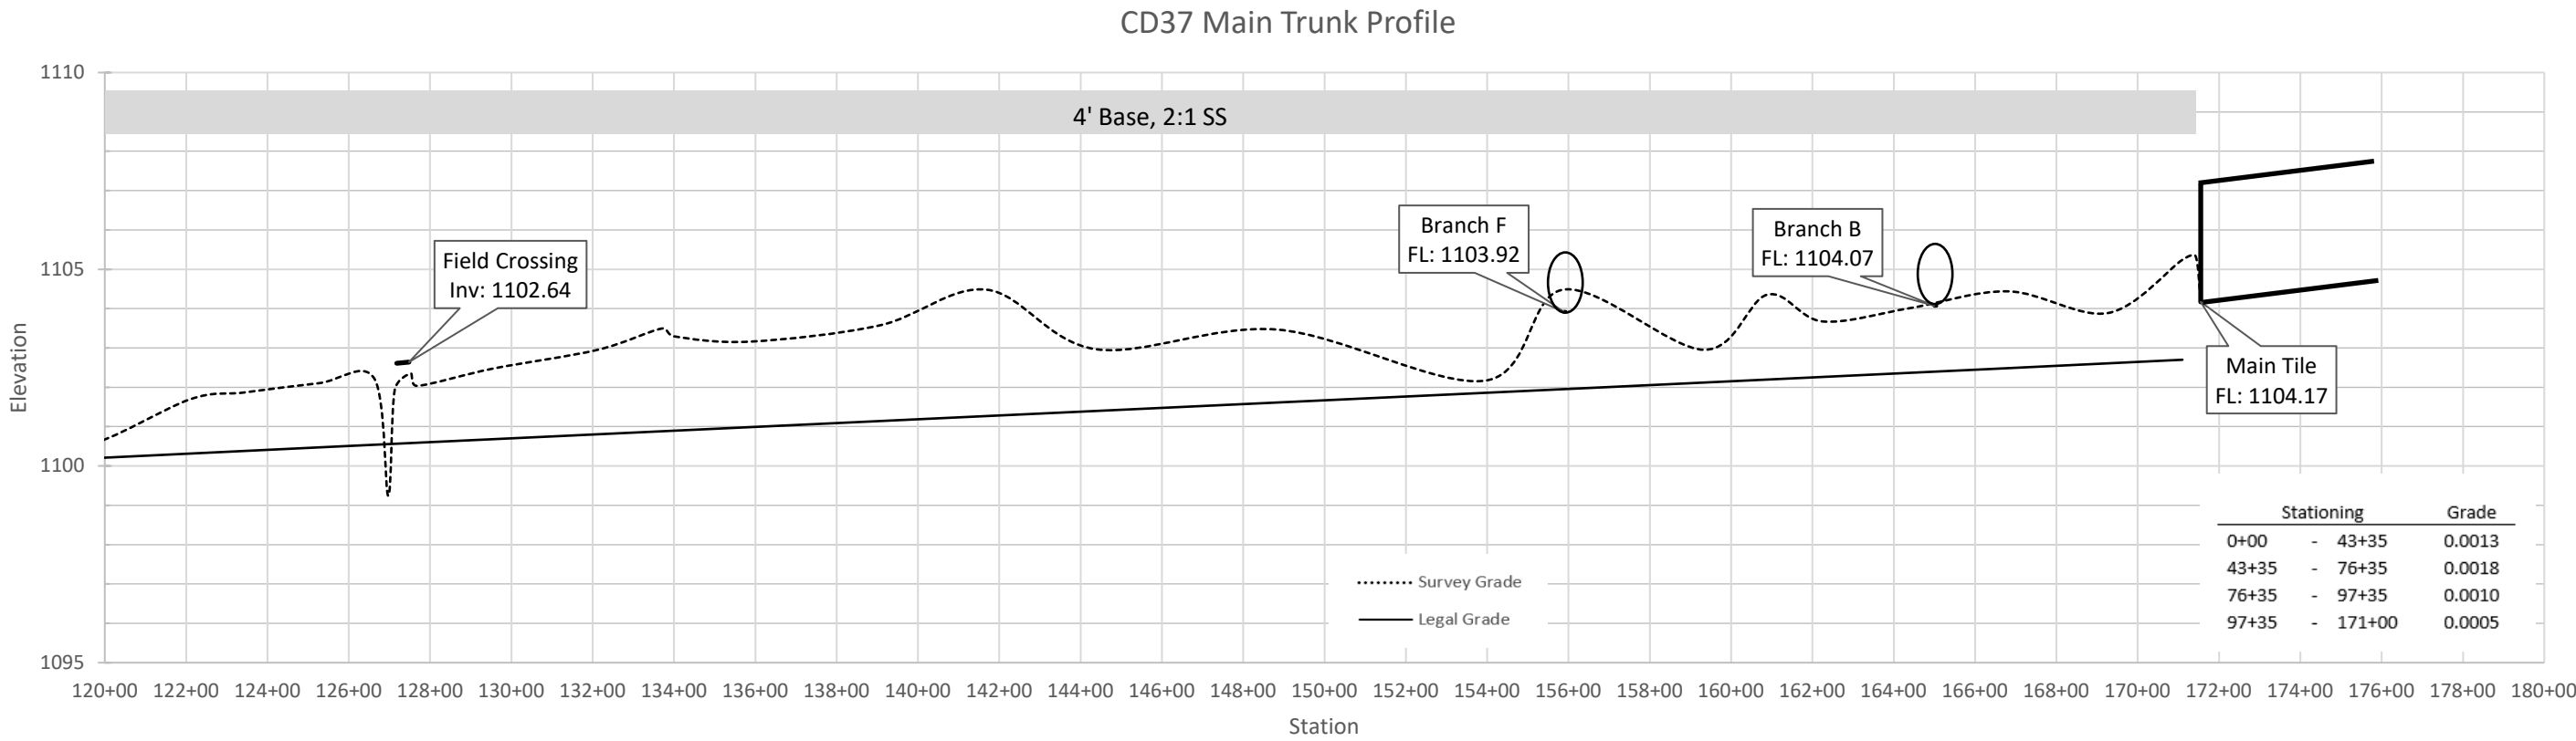
APPENDIX B: PLAN PROFILES

The high-water level in the open ditch has caused the Branch F tile to blowout in last 1,000 feet of the branch and has caused blowouts on the last 250' of the Main tile. Little cover over the Branch F tile was noted, with as little as 10" in some areas. This length of tile will need to be replaced. It is recommended that soil be placed over the new tile to a depth of no less than 24". It is suspected that the Main tile blowouts are caused by wide gaps in the tile, but the tile should be investigated to ensure its integrity. Wide gaps should receive fabric and bats where necessary.

Replace Branch F Tile: Replace the last 1,000 feet of the 24" Branch F tile with 24" dual-wall tile at .08% grade. Soil must be mounded over the tile to ensure at least 24" of cover on the tile. Mound shall not exceed 8H:1V slope to ensure farmability. Fill material will be obtained from on-site sources determined by Drainage Department Staff.

Investigate Main Trunk Tile: Excavate around the last 250 linear feet of the 36" Main Tile to evaluate repair needs. Suspect soil is sucking into the tile through wide gaps.
