# Repair Report

## County Ditch No. 64

Faribault County, Minnesota

ISG Project No.: 17-21098

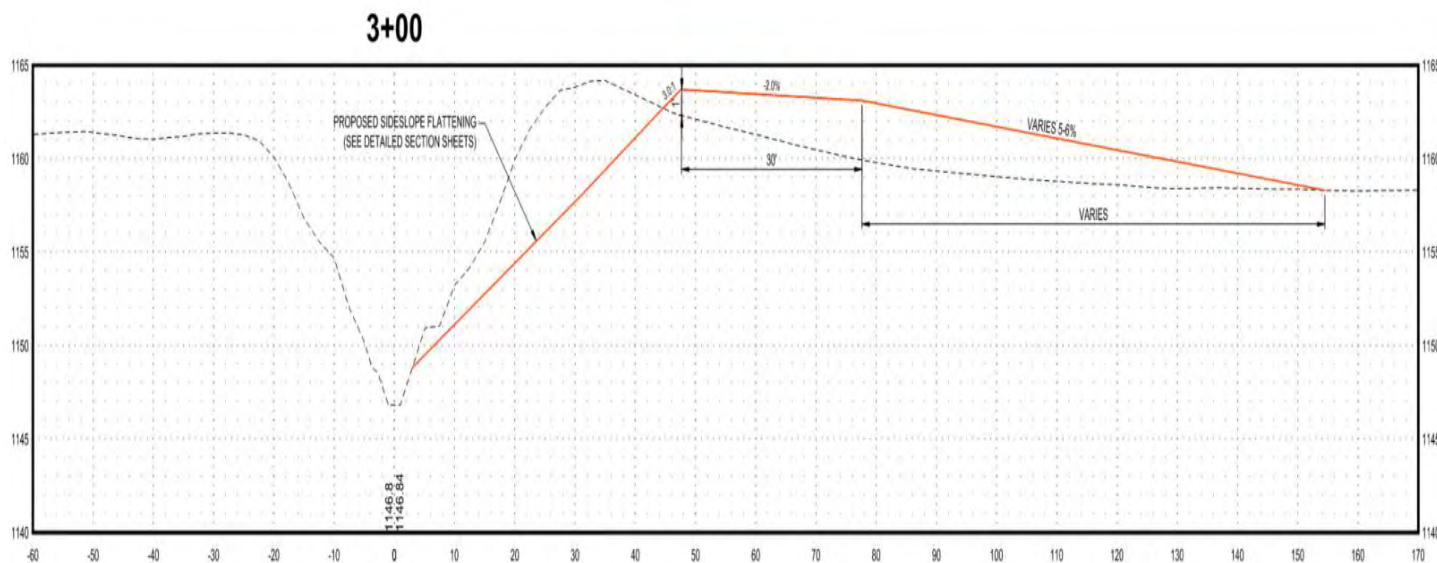
Figure 3: Sample Cross Section of Outlet Open Ditch

The outlet portion of the open ditch downstream of the private bridge crossing is experiencing significant bank sloughing that is causing erosion and downstream sedimentation. The existing bank slopes range between 1:1 and 1.5:1 which is very steep for open ditches. After reviewing the flow elevations and velocities with the permissible velocity method, the current channel geometry is at risk for further bank failures. In order to have a stable geometry in this stretch, the south bank side slope should have a minimum 3:1 backslope from Station 1+25 to 6+00 to achieve a 3.5 feet/second velocity. If the side slopes were flattened out to 4:1, the velocities of the channel would be 3.38 feet per second, slightly lower than a 3:1 side slope. Shown below shows a drone aerial of the outlet portion ditch while Figure 3 shows a cross section of this stretch.

This repair will include peeling back the existing sloughed material, flattening of the ditch bank, leveling of spoils adjacent to the ditch, and reseeding the bank and buffer area. Erosion control blanket is recommended for the seeding as it provides more stability for the flashy ditch system and also provides cover for the seed bed so the seeds stay in place. For this stretch, there are an estimated 0.4 acres of permanent damages for widening of the ditch easement and 1.5 acres of temporary damages for topsoil stripping and spoil placement. Since this repair area avoids the area next to the outlet and next to the bridge, the permanent easement is recommended to extend in a straight line across the entire stretch as this will make farming practices more practical.

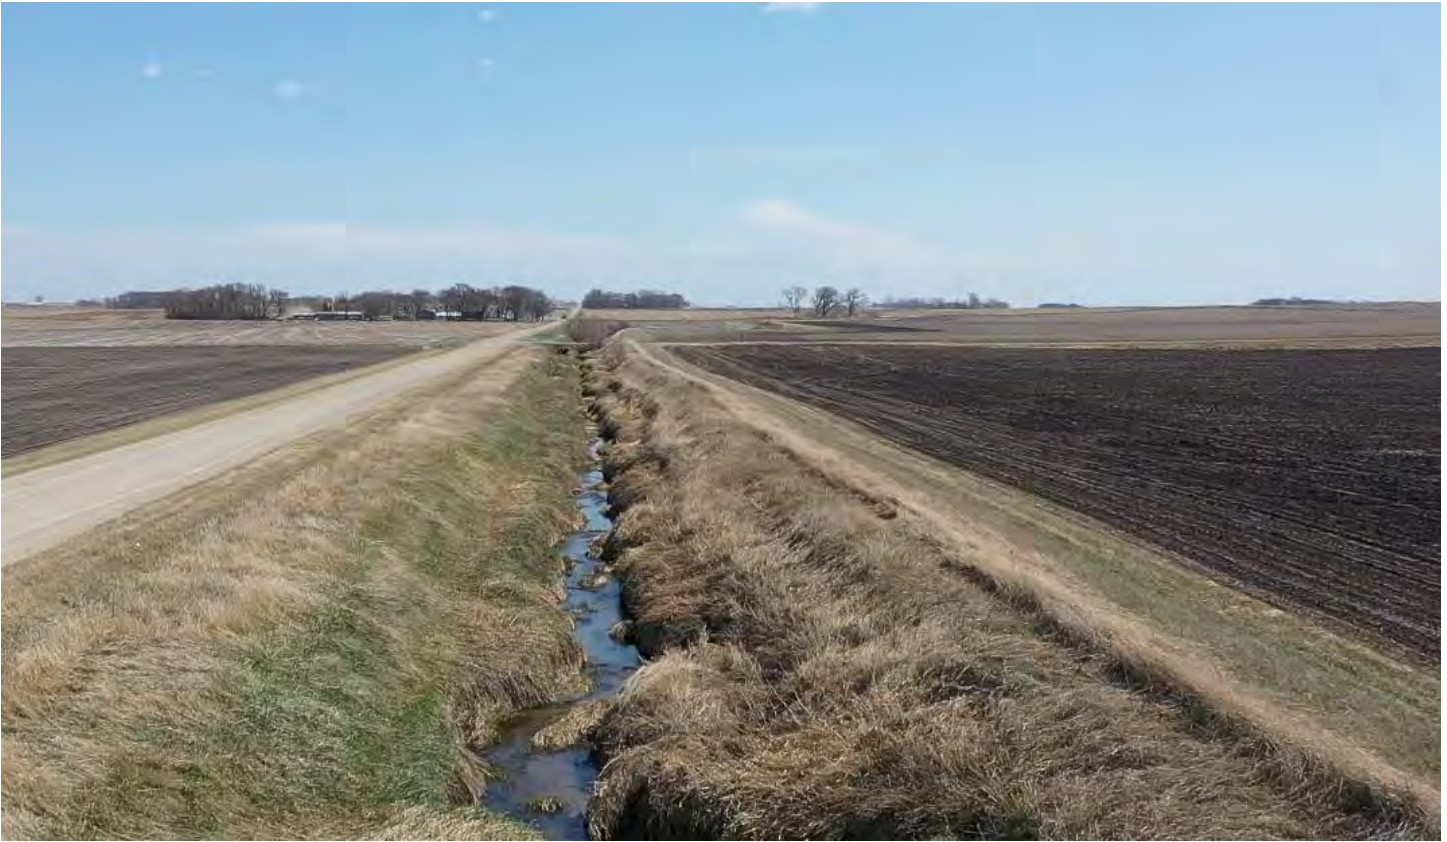
Figure 6: Drone Aerial of Two-Stage Ditch Area (Section 12, Seely Township)

A stretch of ditch spanning from 550<sup>th</sup> Avenue downstream for 2,100 feet (Station 13+40 to 34+40) currently is starting to form a small two-stage ditch geometry. In this geometry, there is a defined inner channel with small floodplain banks inside the overall open ditch. The overall channel depth is shallow ranging in depth from 6 to 10 feet and the inner channel itself is relatively stable. In order to amplify this geometry and provide more stability to the inner channel and outer ditch banks, a two-stage expanded channel is proposed.

In the CD 64 proposed two-stage ditch segment, only the south side is able to have an expanded bench as the north side would impede into 60<sup>th</sup> Street. This two-stage ditch will increase the width of the ditch by 30 feet for that length along the southern bank of the ditch. The implementation of the two-stage ditch will allow additional in-stream storage and velocity reduction in major storm and flooding events. Figure 6 shows a drone aerial of the existing 2,100-foot stretch of ditch while Figure 7 shows the proposed channel cross section. The two-stage ditch channel would require an additional 1.5 acres of permanent easement.

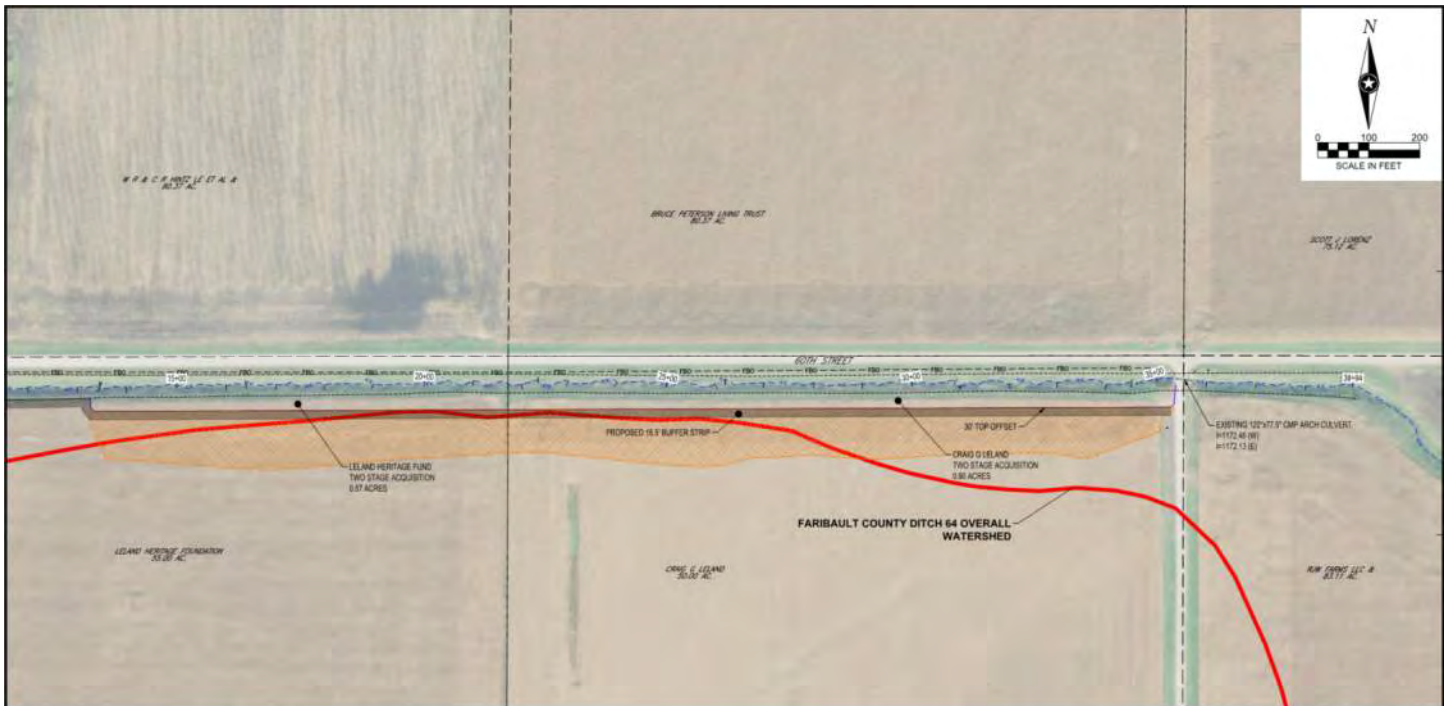
Figure 8: Overall Spoil Leveling Areas

Construction of the two-stage ditch will include stripping of topsoil areas adjacent to the open ditch, excavating the two-stage ditch bench, and placing the spoils in the stripped areas. After leveling, the topsoil will be reclaimed over the spoil areas for farming practices. The ditch banks and bench will be seeding with erosion control blanket for stability and seed bed protection. Some rip rap may be needed in areas where unstable soils may be present and also to protect tile outlets and side inlets. Overall, a total of 18,100 cubic yards (CY) of material will be excavated from the two-stage ditch bank and will require an estimated 4.6 acres in order to level. Some of the material is proposed to be utilized in other ditch repair areas, however conservatively these areas show what may be needed for overall spoil leveling as shown in Figure 8.

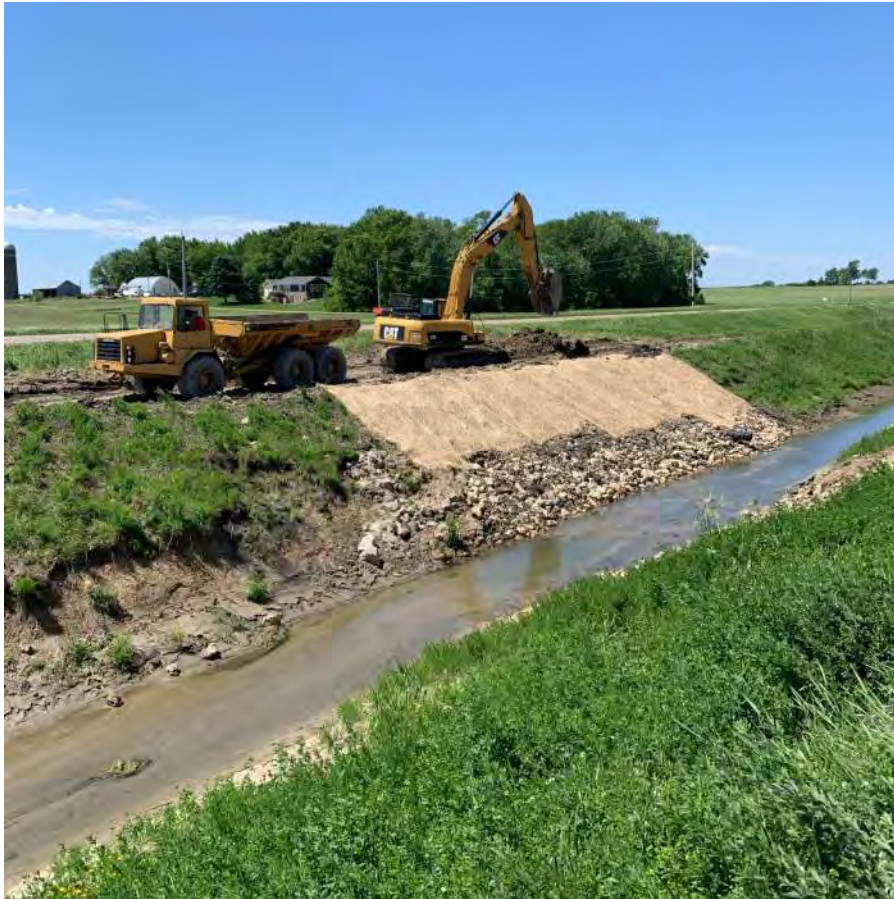
*Figure 12: Example Sideslope Repair*

Ditch bank repairs will include re-establishing a stable ditch bank where erosion or sloughing is occurring. This includes flattening the side slope to a stable grade in that area and leveling the ditch bank. It will also include seeding the repaired area. In some extreme cases, rip rap will be added at the toe of the ditch to better hold the bank from sloughing again. Additional ditch bank repairs may be necessary based on the condition of the banks where construction is occurring. Figure 12 shows an example of a bank side slope repair.

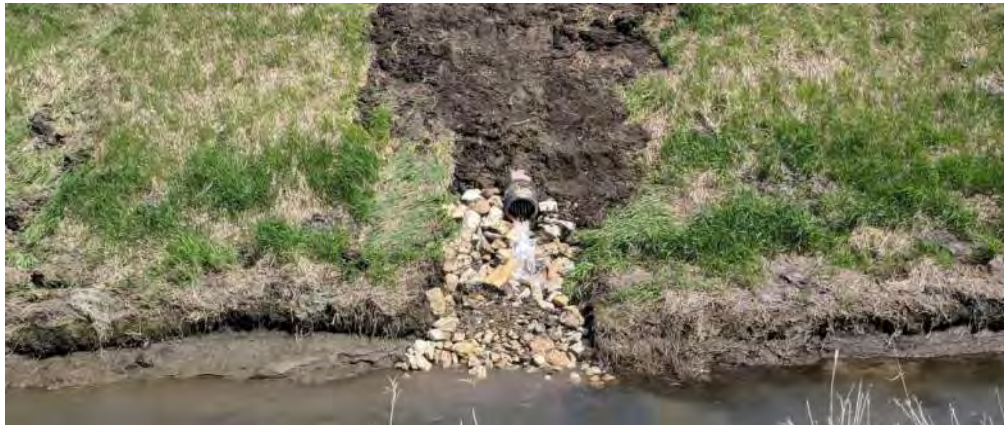
*Figure 13: Typical Tile Outlet Repair*

Several tile outlets into the open ditch are creating erosion within the ditch bank. These will be replaced or repaired as part of a repair project. Some of the tile outlets may be in good shape and only require riprap protection on geotextile fabric. However, some tiles are damaged or are causing erosion to the ditch banks. The repair of damaged tiles will consist of replacing the damaged outlets into the ditch with a section of new tile and protecting the tile from erosion (Figure 13). Only dual wall HDPE or PVC pipe are allowed for tile outlet repairs.

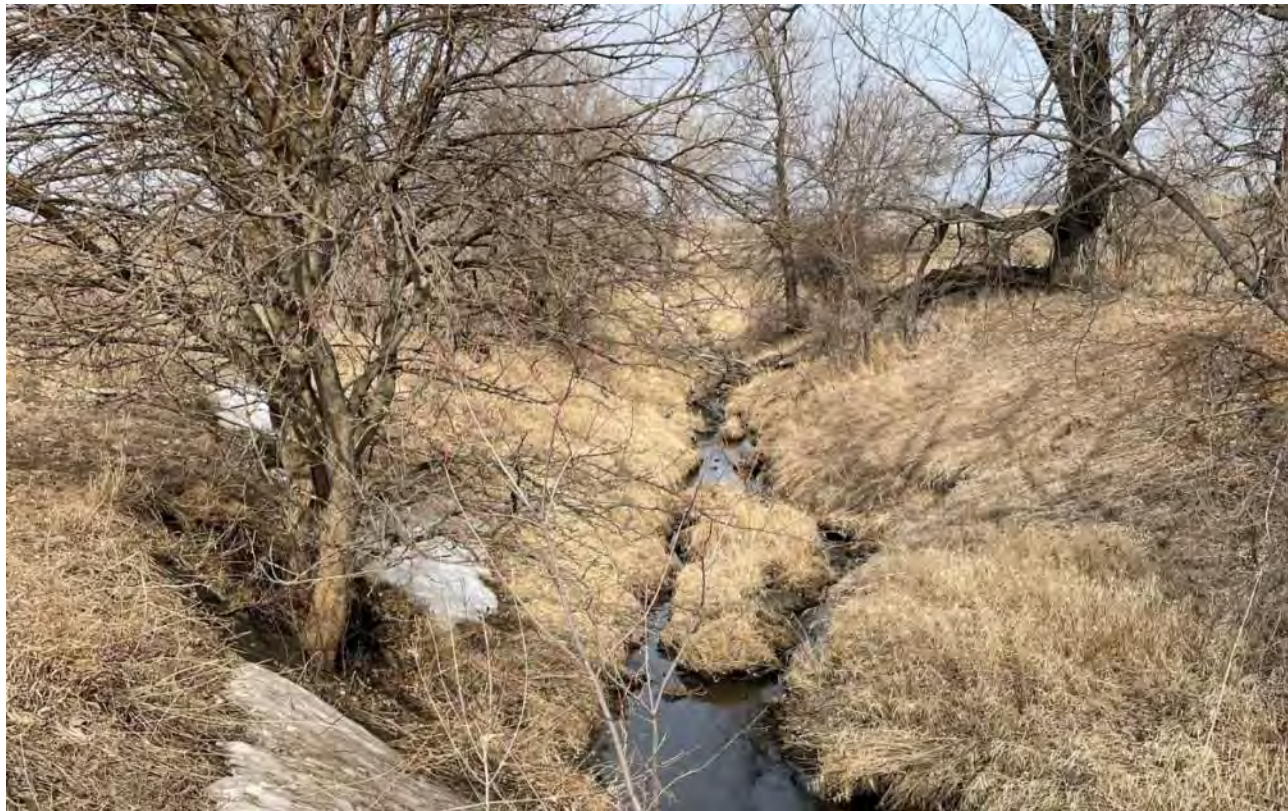
*Figure 14: Spot Cleaning Example of Sediment Island*

As described previously, the majority of CD 64 has down cut over the years, thus the existing channel grade is at or below the legal (repairable) ditch grade. Furthermore, most of the channel is relatively stable when considering the channel grade, fluvial process, and established riffles. However, there are some areas where sediment islands have formed and are creating bank erosions. In these areas as shown in Figure 14, only the sediment island will be removed to help direct flow down the center of the channel and helping reduce erosion. Approximately 3 percent of the CD 64 open ditch contains these islands that will be removed during construction.

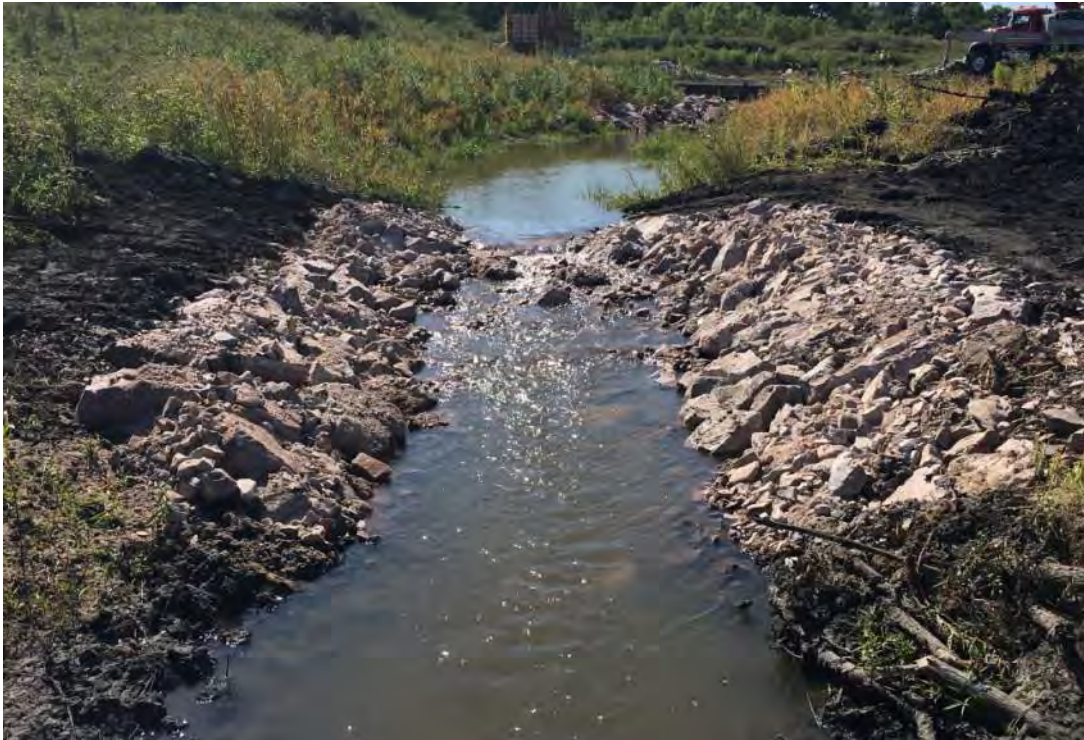
*Figure 16: Example Rock Rillfe*

Throughout the CD 64 open channel, there are multiple riffle and pools that have naturally formed and have created stability. However there are other areas, specifically in Section 7 of Kiester Township where the channel bottom is still downcutting and not stable. One way to stabilize the channel in this area is to construct large rock riffles to help stair-step the channel bottom down in elevation.

A total of 8-rock riffles are proposed along CD 64 in Section 7. Rock riffles vary in size depending upon the cross-sectional geometry of the streambed location in question but are generally 4 to 6 feet wide on the bottom width, 30-feet wide across the top, and between 40 to 60-feet in length. Each riffle is designed to have a water elevation drop of 6-inches across the riffle. These riffle structures are central to reducing flow velocities and aim to reduce the relatively steep open channel grade. Figure 16 shows an example constructed rock riffle while the preliminary construction plans in Appendix A show full details of the proposed riffle structures.

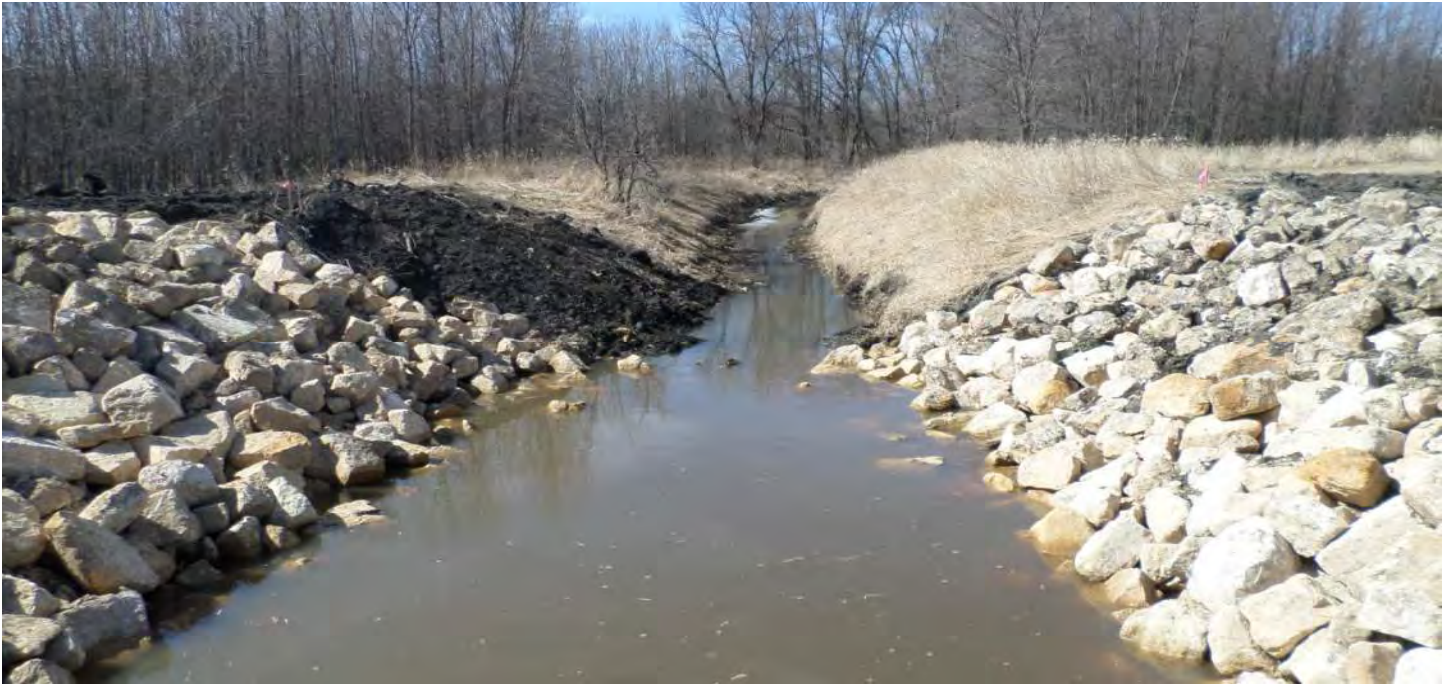
Figure 20: Example Stilling Basin

In an effort to control upstream flowrates, velocities, and channel downcutting; a series of three rip rap stilling basins would be installed along the grassed waterway. These structures would include lengthy stilling basins spanning up to 500 feet upstream of the plunge pool. These basins are designed to dissipate energy from the surface flow waterways and stair step them down into the plunge pool. Basin lengths could span up to 75 feet in length along the alignment. Option 2 requires much more grading and rip rap and will also require more maintenance in the future. Figure 20 shows an example rip rap stilling basin along an open channel.

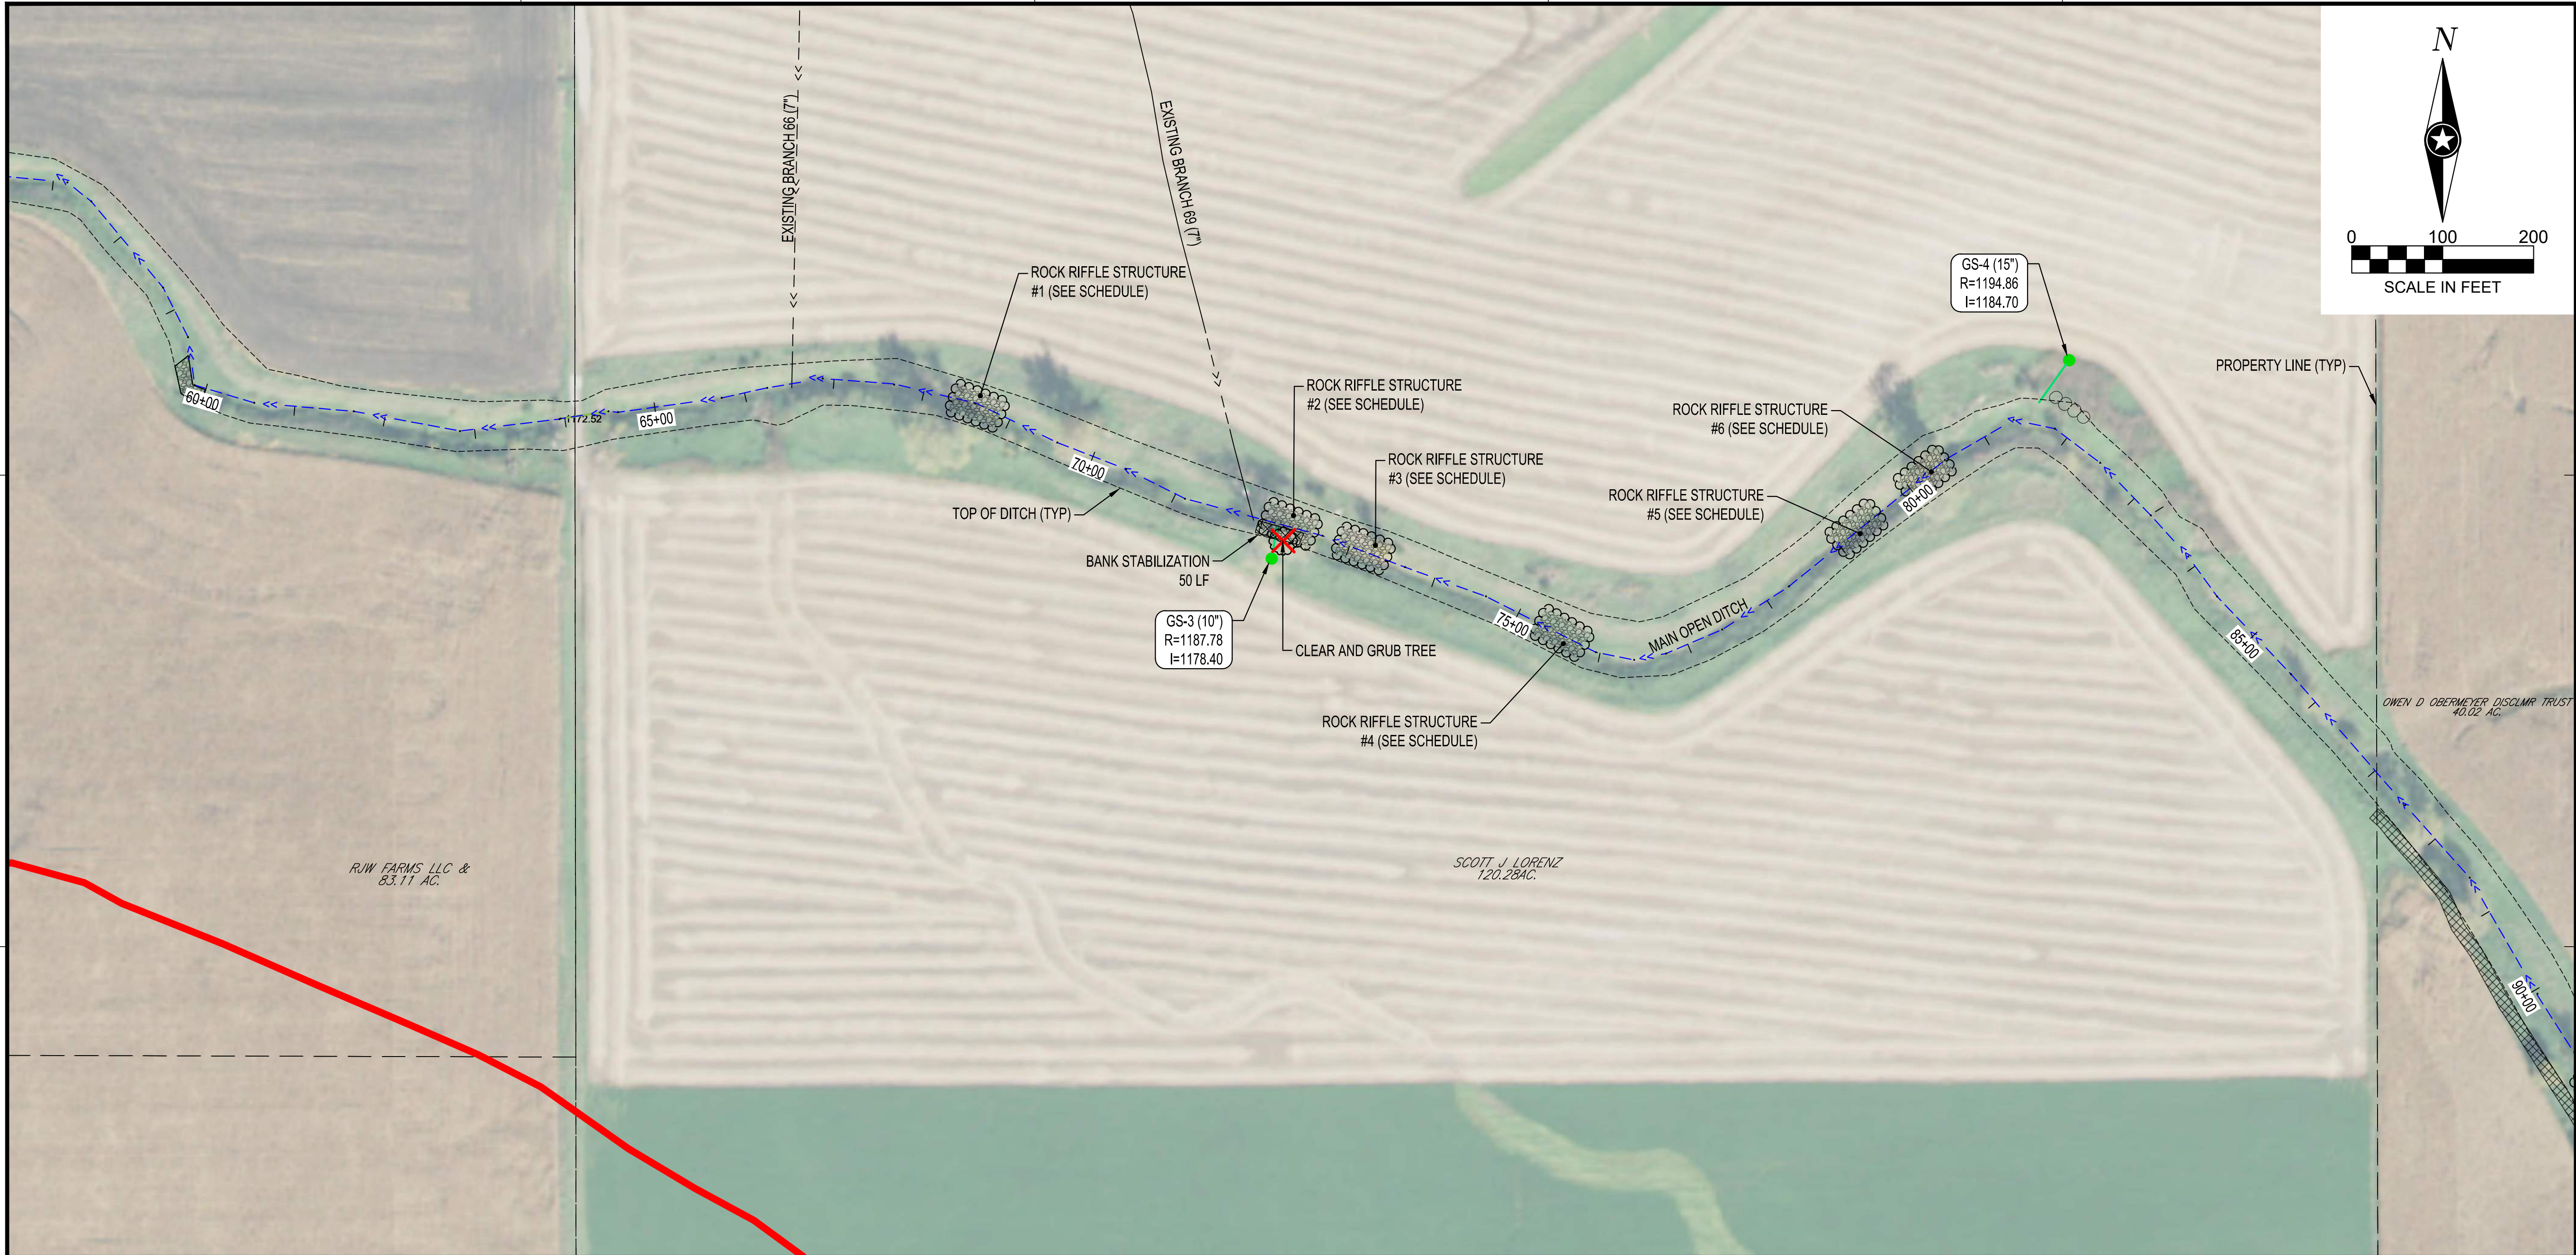
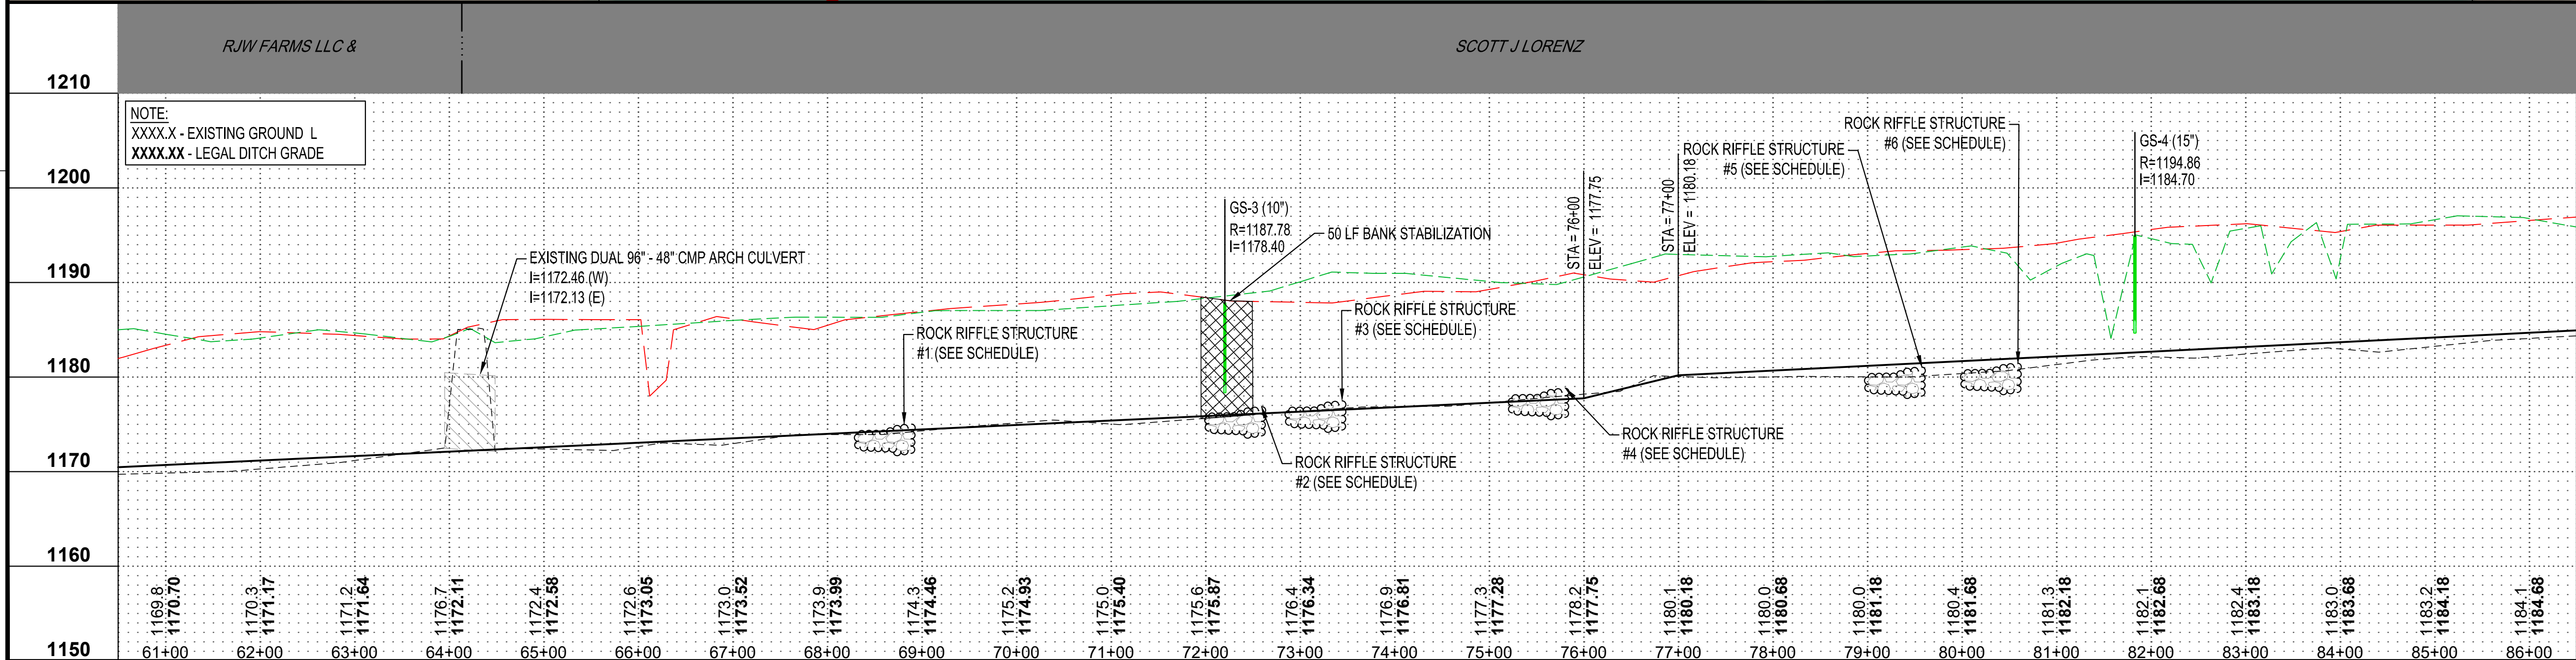
| SHEET<br><b>19</b><br>OF 21 |

| TITLE<br><b>UPSTREAM<br/>PLAN-PROFILE<br/>(MAINLINE)</b> |
