REESTABLISHMENT OF RECORDS JCD 301-HUEPER BRANCH

Faribault County, Minnesota

Date: November 19, 2020

ISG Project No.: 17-20487

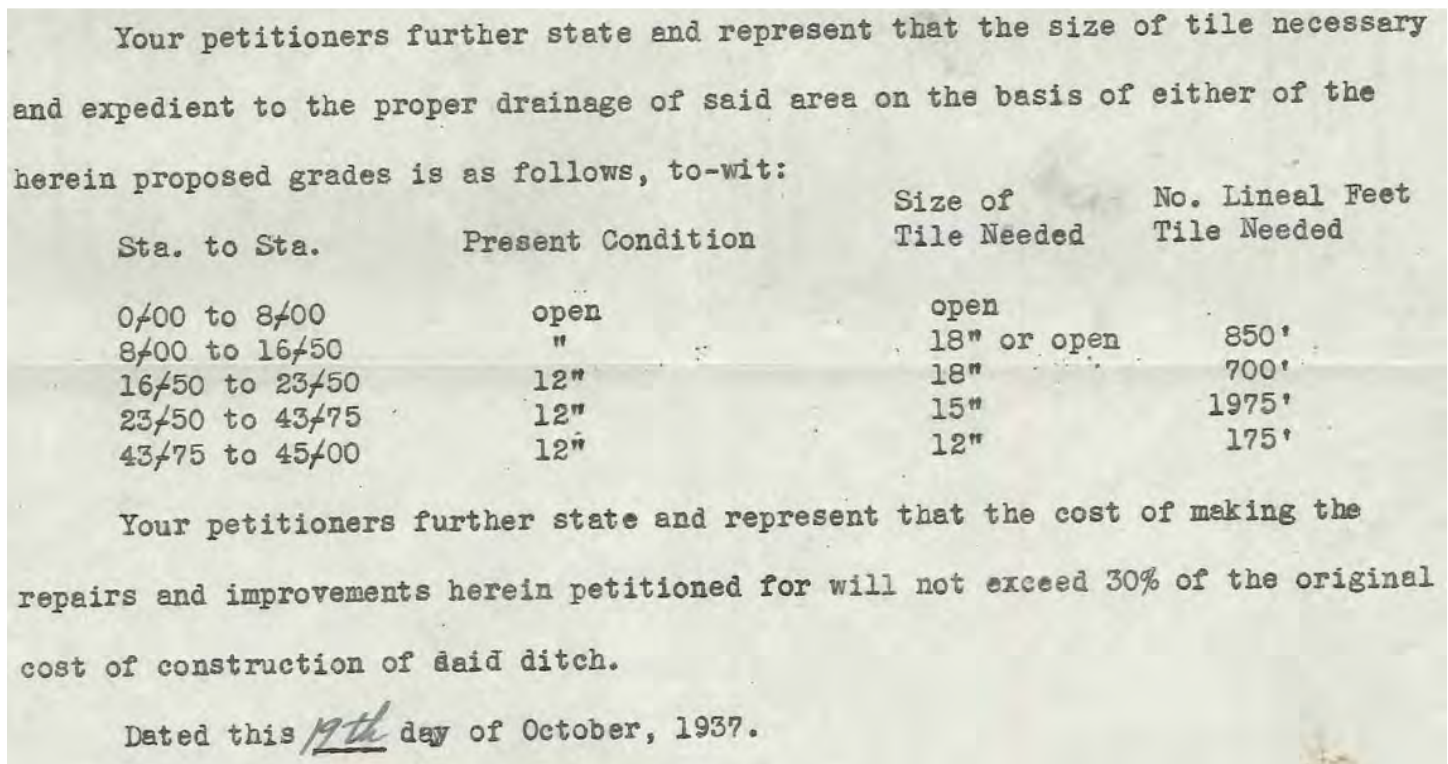
Figure 1: 1937 Petition for Tile Improvement

A landowner petition dated October 19, 1937 was filed with the Faribault County Board of Commissioners for the “repair and improvement” of the Hueper Branch. The petition described the existing and proposed conditions of the Hueper Branch, as shown in Figure 1. The system is described as open ditch in the lower 1,650 feet (Station 0+00 to 16+50) and 12” tile upstream of Station 16+50. The petition proposed increasing the tile size from stations 16+50 to 43+75 and optionally converting the open ditch from Station 8+00 to 16+50 to an 18” tile. The petition record indicates that it was presented to the Faribault County Board of Commissioners on November 1, 1937 and that the petition was “accepted and order filed.” There are no records indicating whether any portion of the proposed project was constructed.

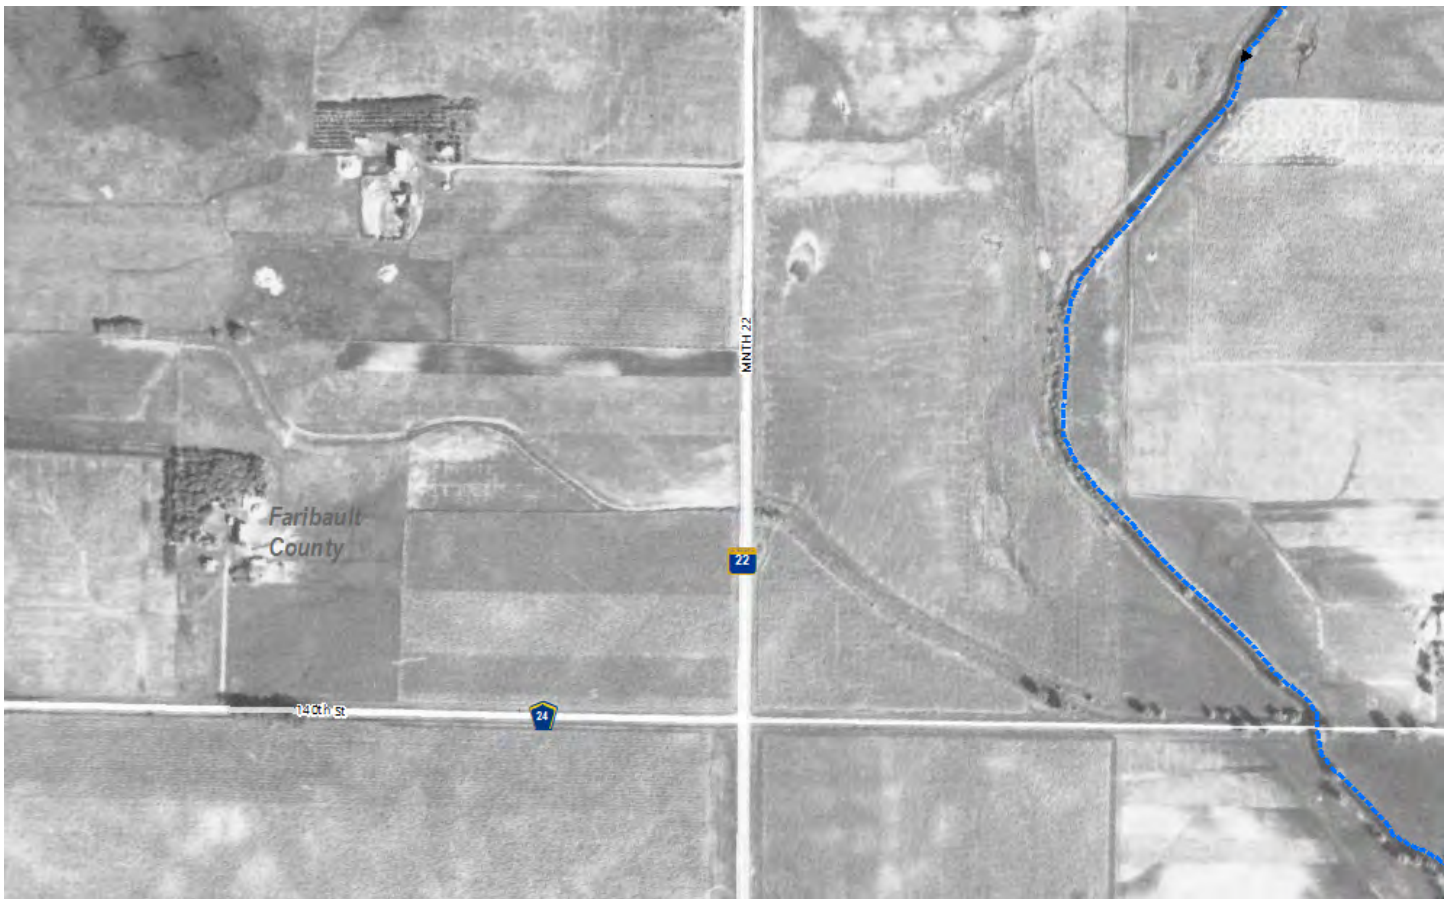
Figure 2: 1938 Historical Aerial Photo

Aerial imagery from October 1938 (Figure 2) appears to show an open ditch extending from the SE ¼ of Section 29 of Clark Township, flowing east-southeast toward present-day MN TH 22, where it flowed beneath present-day TH 22 (and into Section 28 of Clark Township) approximately 775 feet north of 140th Street. From TH 22, the open ditch flowed southeast toward 140th Street to a point approximately 1,300 feet east of TH 22, where it turned straight east and flowed approximately 750 feet to its confluence with the main branch of JCD 301. The confluence with the mainline open ditch of JCD 301 is immediately upstream of 140th Street and approximately 2,050 feet east of present-day TH 22.

The length of the open ditch in the 1938 aerial imagery is approximately 4,500 feet, which is consistent with the stationing and overall length indicated in the 1937 landowner petition. However, the open ditch shown in the 1938 aerial imagery is inconsistent with both the existing and proposed conditions outlined in the 1937 petition; the petition indicated that the ditch above Station 16+50 was tiled, while the 1938 aerial appears to show an open ditch. It is unclear if the construction of the tile occurred as described in either 1937 or 1938 in response to the petition. It is also unclear how the existing conditions of the tile and open ditch in the petition were determined, as they do not line up with the historical aerial evidence.

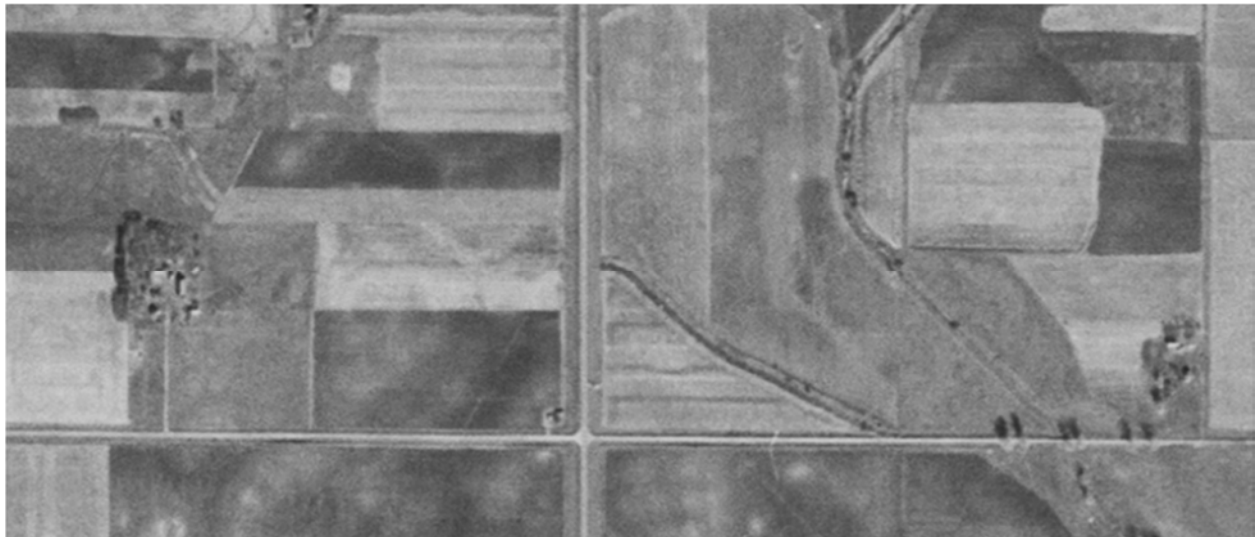
Figure 3: 1949 Historical Aerial Photo

Aerial imagery from October of 1949 (Figure 3) shows that the portion of the Hueper Branch upstream of TH 22 appears to have been converted to tile; row crops have been planted over portions of the previous open ditch upstream of TH 22. The photo indicates that the open ditch begins on the east side of TH 22 and flows in a southeasterly direction into CD 301. This includes 2,275 linear feet of open ditch.

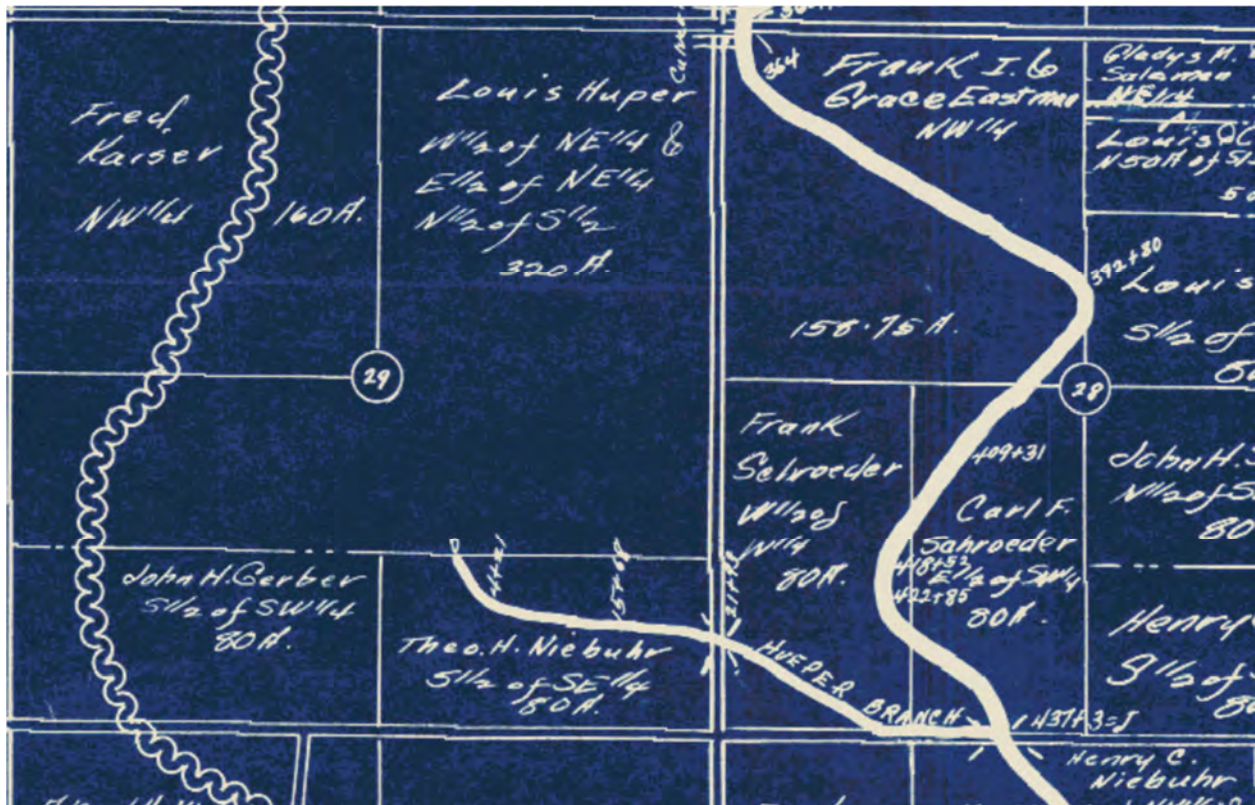
Figure 4: 1950 Repair Map

JCD 301 repair documents from 1950 include a repair of the Hueper Branch. The repair map as shown in Figure 4 is the earliest available document showing the alignment of the Hueper Branch, which begins near the border of the SW $\frac{1}{4}$ SE $\frac{1}{4}$ and the NW $\frac{1}{4}$ SE $\frac{1}{4}$ of Section 29 in Clark Township. The channel flows eastward through the S $\frac{1}{2}$ SE $\frac{1}{4}$ of Section 29 toward present-day TH 22; from TH 22 it flows southeast before turning straight east along present-day 140th Street toward its confluence with the mainline open ditch. The total length of the Hueper Branch shown in the report documents is 4,300 feet. Note that the stationing used in the 1950 repair documents shows Station 0+00 at the upstream end and Station 43+00 at the confluence with the mainline open ditch, which is the reverse of present-day stationing convention.

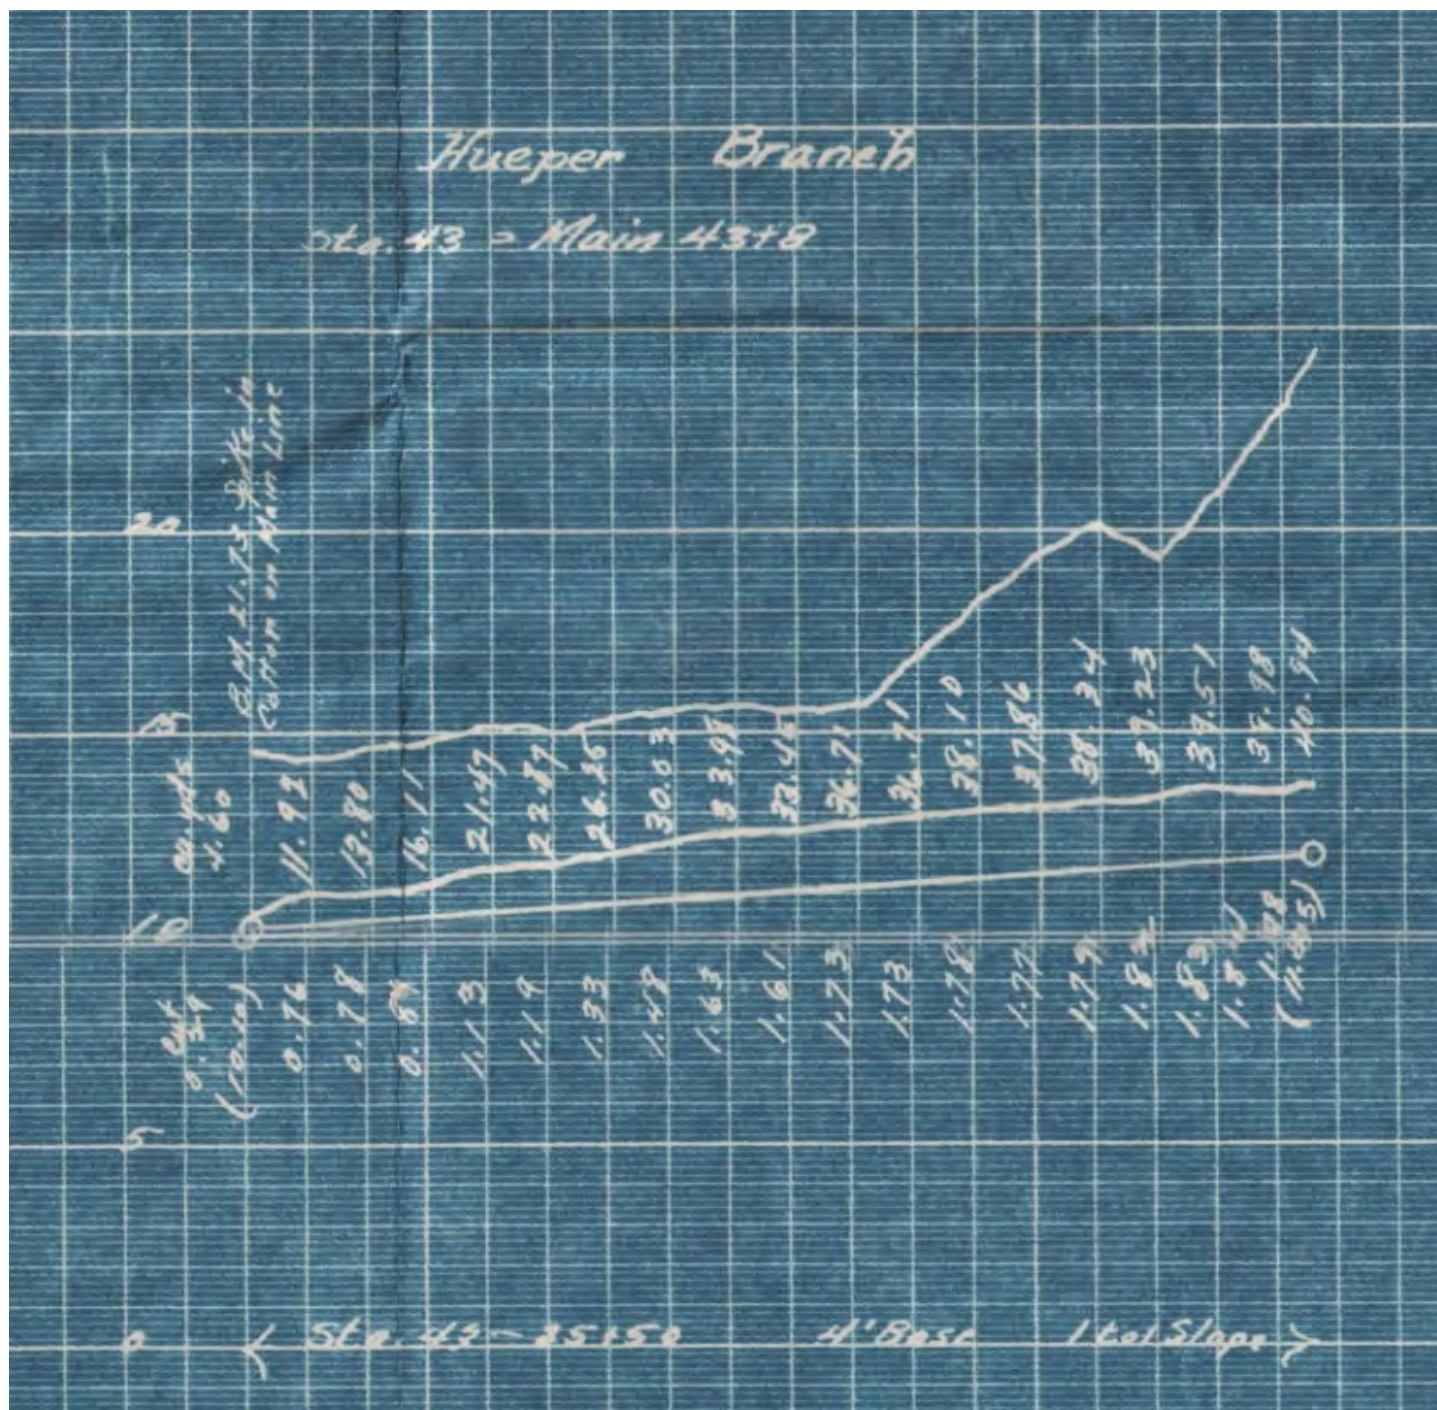
Figure 5: 1950 Hueper Branch Repair Profile

The engineer's report proposes 1,650 feet of open ditch repair (Stations 43+00 to 26+50) in the lowest portion of the Hueper Branch. The report profile (Figure 5) shows the open ditch repair extending an additional 100 feet upstream (Stations 43+00 to 25+50), for a total length of 1,750 feet. The grade shown on the profile is 0.10%, based on a drop of 1.75 feet over 1,750 feet. The profile shows a channel bottom width of 4 feet and 1:1 side slopes. Based on the repair profile, the entire 2,275 linear feet of open ditch was not cleaned as a portion downstream of HWY 22 was not cleaned. It is also evident that the alignment shown in the 1950 repair map does not precisely follow the physical alignment of the ditch to the historical aerial photos.

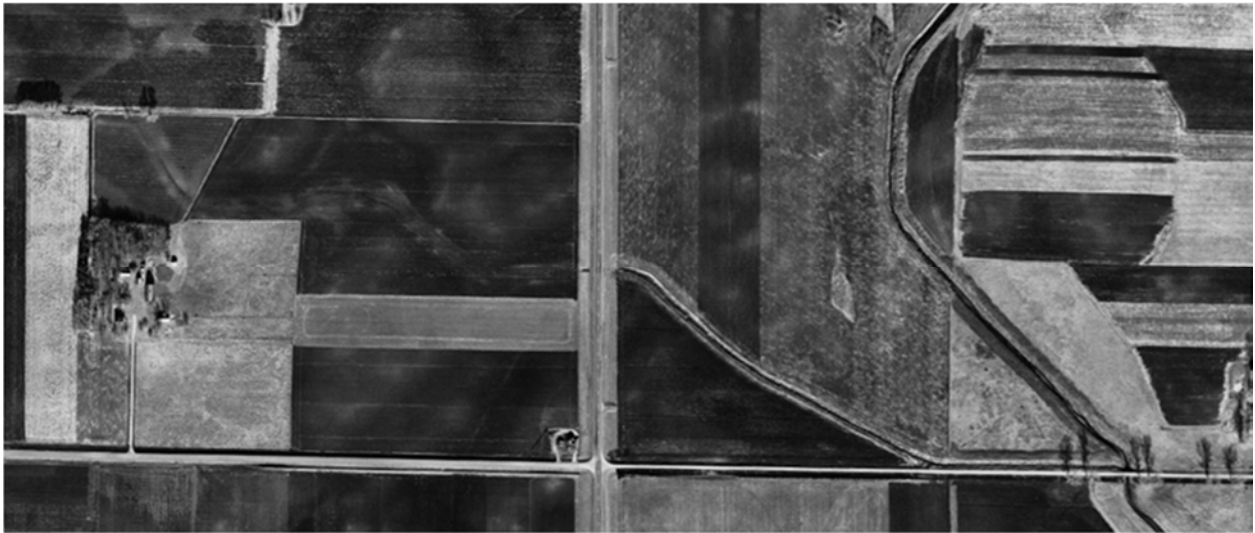
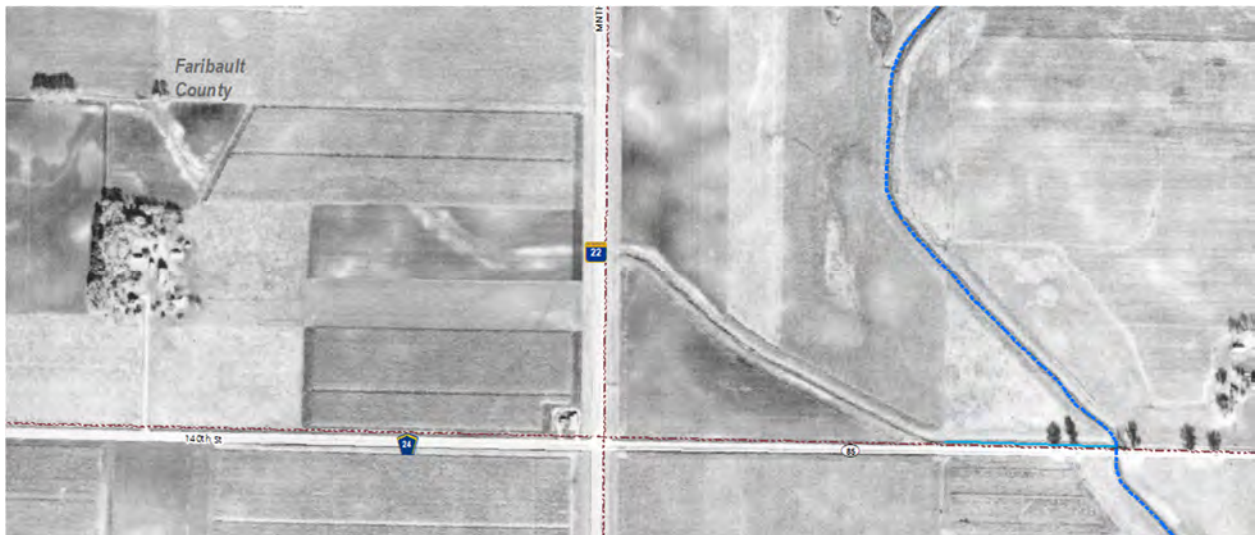
Historical aerial photos from 1953 and 1954 (Figure 6 and Figure 7) show a well-defined open ditch from HWY 22 downstream to the junction of the CD 301 mainline open ditch. This is likely the result of the repair from 1950. It is unclear if the entire 2,275 feet of open ditch or just the 1,750 feet as specified in the repair was cleaned.

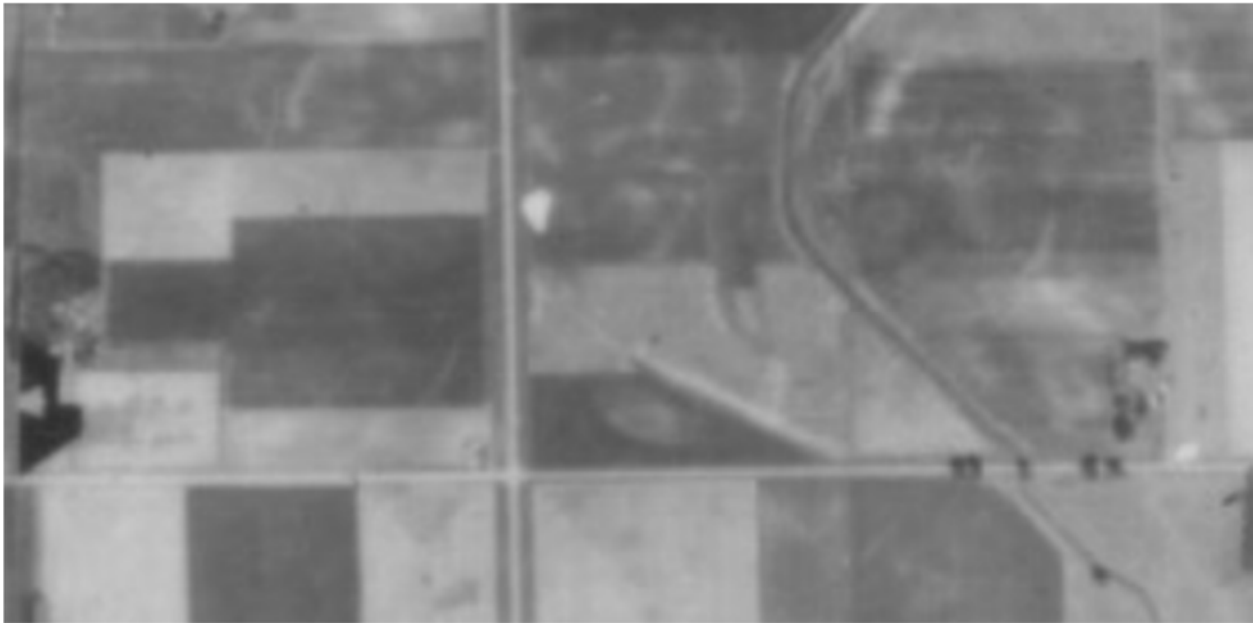
Figure 8: 1962 Historical Aerial Photo

Historical aerial photos from 1962 (Figure 8) shows that 625 linear feet of open ditch from HWY 22 downstream was filled in and replaced with a buried tile. The remaining portion of open ditch includes 1,650 linear feet which extends east to the junction of CD 301 mainline open ditch. There are no records on file for this ditch work.

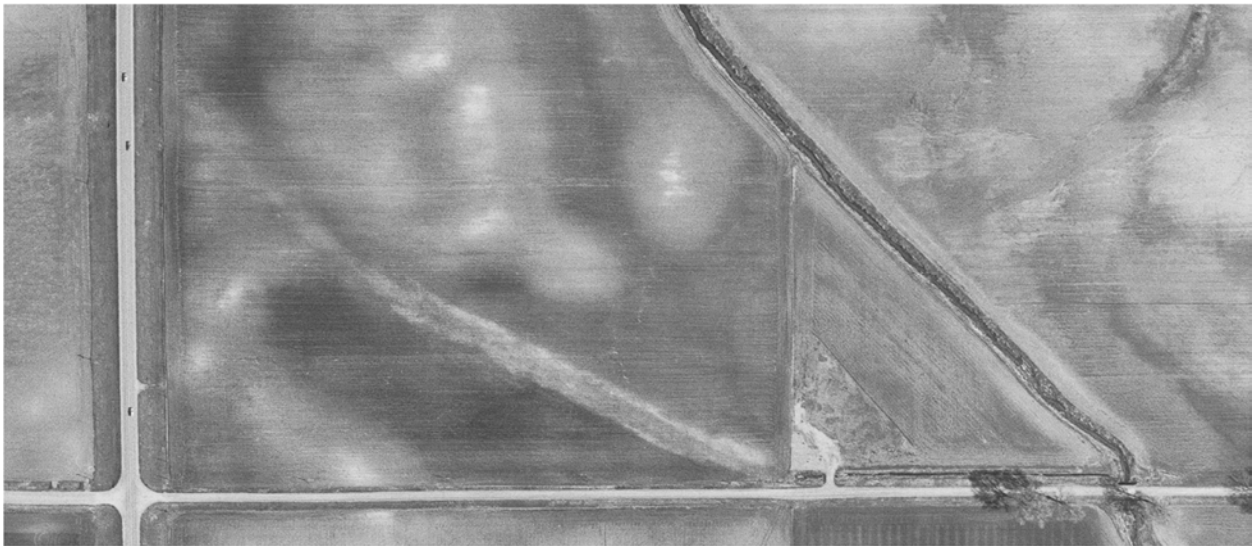
Figure 9: 1979 Historical Aerial Photo

As shown in Figure 9, the 1979 historical aerial photo shows the open ditch only extending for 675 linear feet straight west along the 140th Street roadway. Scars from filling the ditch and replacing it with a buried tile are visible in this photo.

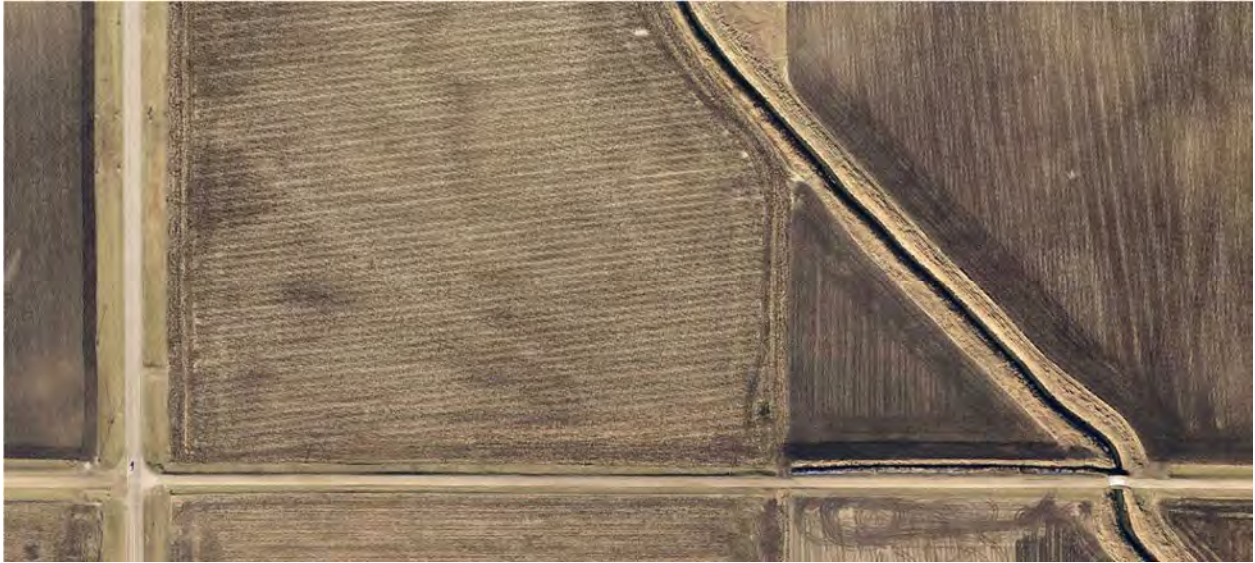
Figure 10: 2019 Historical Aerial Photo

The 2019 aerial imagery (Figure 10) shows the same length of open ditch as indicated in the 1979 photo. A field crossing at the very beginning of the open ditch was moved to the west since 1979 to the property line.

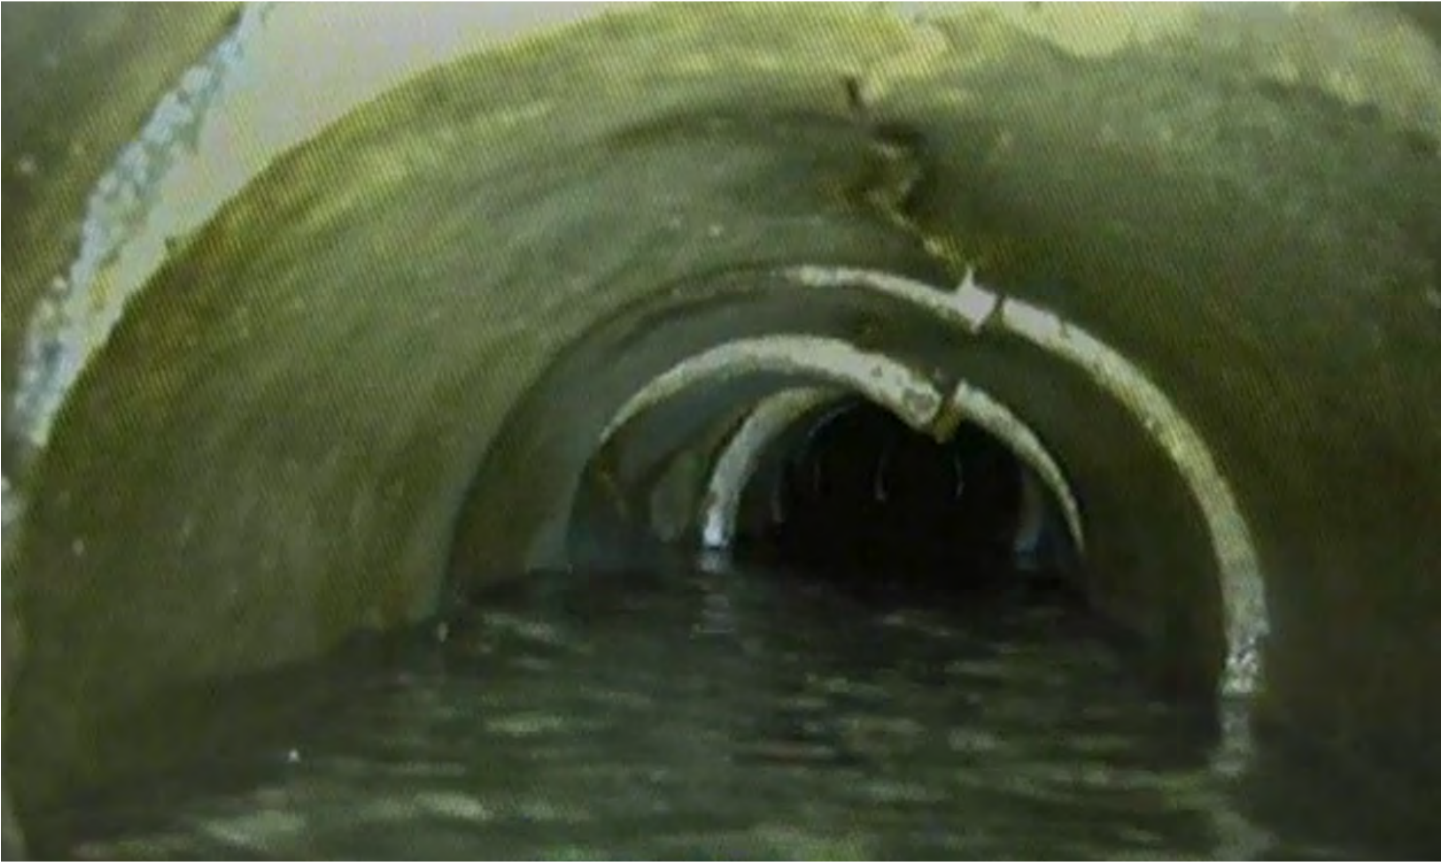
Figure 17: Televising 650 Feet Upstream of Tile Outlet

The condition of the buried tile was also documented during the televising. Overall, the existing tile is in poor condition with offset joints, cracking in the pipe sections, bellies in the pipe where the pipe has sunk, and other blockages. A full televising report is included in Appendix D while Figure 16 through Figure 20 show images of the televising throughout the Hueper Branch.

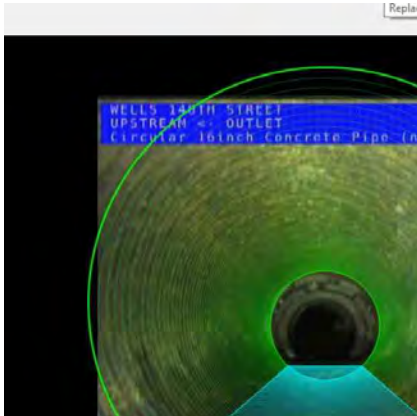
HUEPER BRANCH OUTLET (US)
UPSTREAM_155ca975-5c34-4dbb-95db-422dbcbb4cba_2020
0911_093227_907.jpg, 00:00:00, 0.00ft
Water Level, 15% of the vertical dimension / 13%

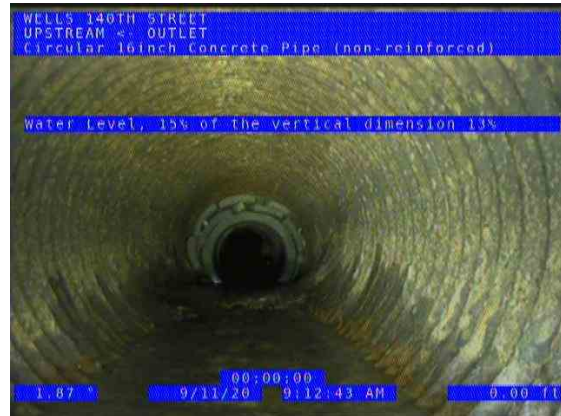
HUEPER BRANCH OUTLET (US)
UPSTREAM_b1071d64-9288-4e8d-bc28-ba920c803ed5_202
00911_093310_676.jpg, 00:00:00, 0.00ft
Water Level, 15% of the vertical dimension / 13%

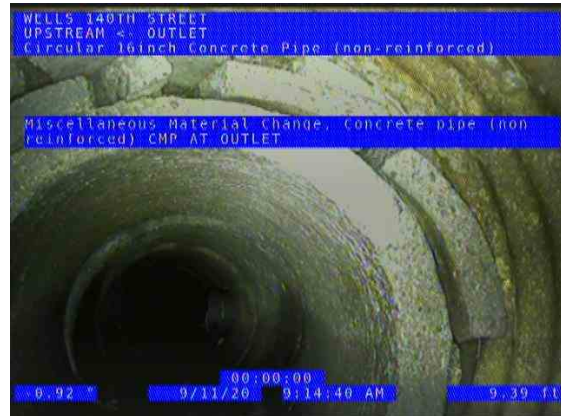
HUEPER BRANCH OUTLET (US)
UPSTREAM_a0409254-b129-4b20-bdd1-06134a1efa4b_2020
0911_093508_397.jpg, 00:00:51, 9.39ft
Miscellaneous Material Change, Concrete pipe (non
reinforced) / CMP AT OUTLET

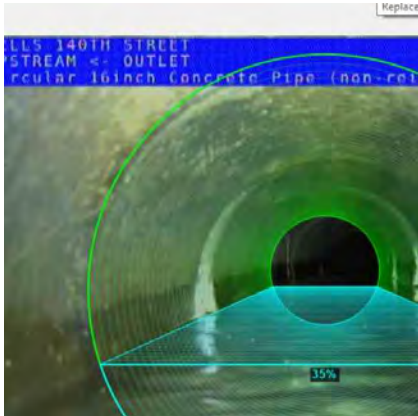
HUEPER BRANCH OUTLET (US)
UPSTREAM_62ef70e4-26b6-430d-8e0b-3b5aa36e61d0_2020
0911_093937_252.jpg, 00:04:36, 68.26ft
Water Level, 35% of the vertical dimension

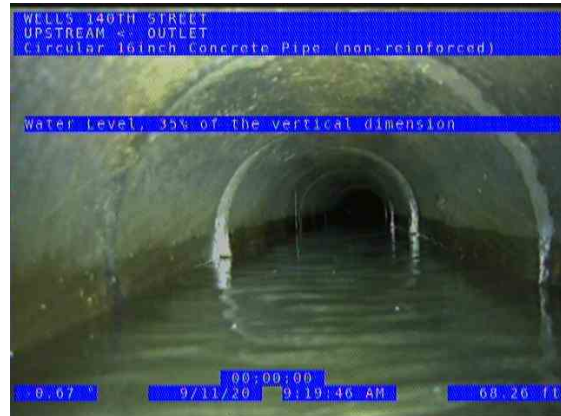
HUEPER BRANCH OUTLET (US)
UPSTREAM_065b5f9c-ac80-4b16-8ce2-ec5bf9a899de_20200
911_094013_678.jpg, 00:04:36, 68.26ft
Water Level, 35% of the vertical dimension

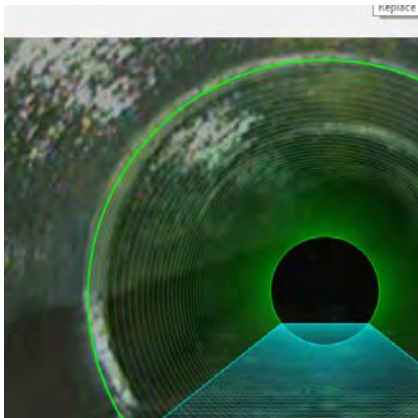
HUEPER BRANCH OUTLET (US)
UPSTREAM_e36e9093-cd24-4839-9463-e9d84e1c7267_202
00911_094814_505.jpg, 00:08:20, 154.44ft
Water Level, 20% of the vertical dimension

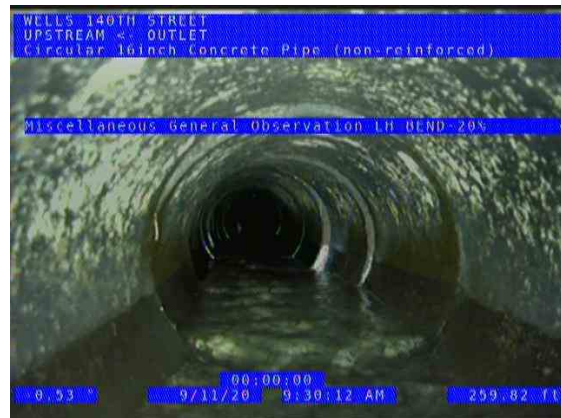
HUEPER BRANCH OUTLET (US)
UPSTREAM_572a1319-5e8e-4d50-9850-9efaf6adcbe9_2020
0911_095039_603.jpg, 00:09:56, 259.82ft
Miscellaneous General Observation / LH BEND-20%

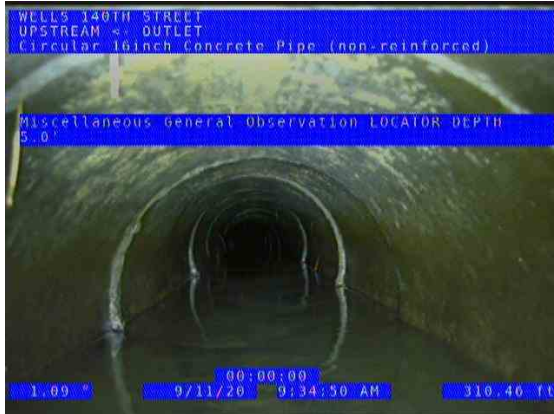
HUEPER BRANCH OUTLET (US)
UPSTREAM_9bd990cb-1f28-4448-921f-3cf3eca67780_20200911_095517_829.jpg, 00:12:34, 310.46ft
Miscellaneous General Observation / LOCATOR DEPTH 5.0'

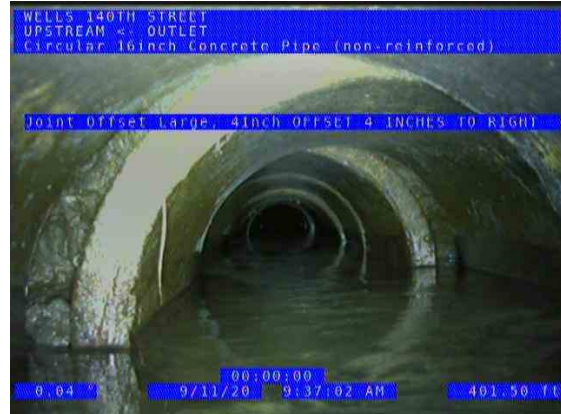
HUEPER BRANCH OUTLET (US)
UPSTREAM_2a984b08-27c4-480c-8a30-1bf05978b7ae_20200911_095729_160.jpg, 00:14:18, 401.50ft
Joint Offset Large, 4Inch / OFFSET 4 INCHES TO RIGHT

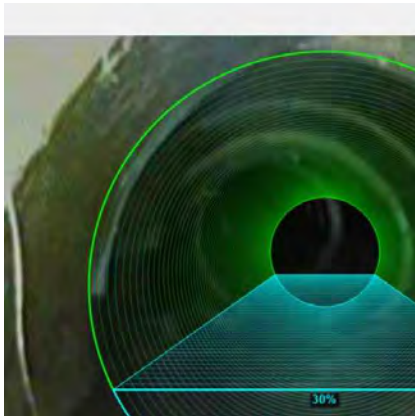
HUEPER BRANCH OUTLET (US)
UPSTREAM_515911f4-e13e-4412-9808-db9053ab968d_20200911_095820_636.jpg, 00:14:34, 401.50ft
Water Level, 30% of the vertical dimension / LOCATOR DEPTH 5' 3"

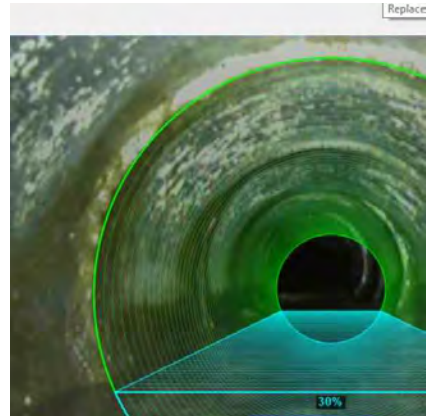
HUEPER BRANCH OUTLET (US)
UPSTREAM_f01b3b67-6801-47a5-ab99-5f9d2760b3d8_20200911_100152_289.jpg, 00:17:17, 499.64ft
Water Level, 30% of the vertical dimension / LOCATOR DEPTH 5' 6"

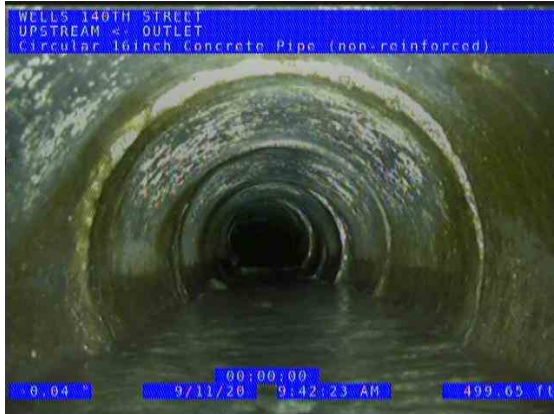
HUEPER BRANCH OUTLET (US)
UPSTREAM_668641c2-2fcd-4986-bc7f-fc9da7c5b44e_20200911_100250_705.jpg, 00:17:17, 499.64ft
Water Level, 30% of the vertical dimension / LOCATER DEPTH 5'6"

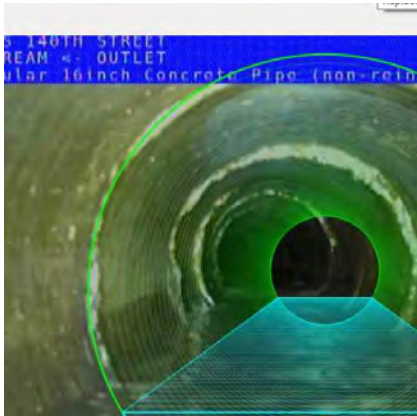
HUEPER BRANCH OUTLET (US)
UPSTREAM_0cdae51b-e24f-491c-8cdf-a82c532d19db_20200911_100735_782.jpg, 00:20:00, 600.10ft
Water Level, 25% of the vertical dimension / LOCATER DEPTH 6'6"

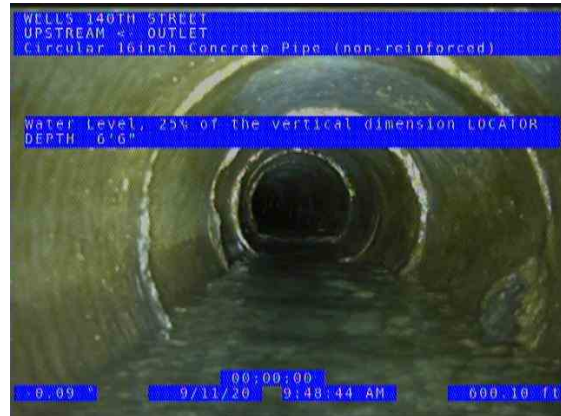
HUEPER BRANCH OUTLET (US)
UPSTREAM_12813a7a-e575-4610-8c47-6ae36065cfbf_20200911_100911_594.jpg, 00:20:00, 600.10ft
Water Level, 25% of the vertical dimension / LOCATER DEPTH 6'6"

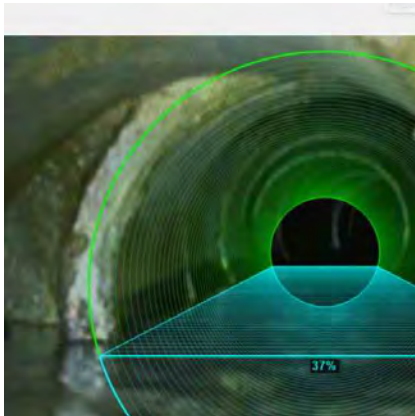
637.9	B	Broken from 11 o'clock to 1 o'clock, length: 10inch, intruding: 4inch / MULTIPLE TILE FAILING	00:21:16	HUEPER BRANCH OUTLET	S4
		641.5	MWL	Water Level, 35% of the vertical dimension / LOCATOR DEPTH 7'0"	00:21:53	HUEPER BRANCH OUTLET

HUEPER BRANCH OUTLET (US)
UPSTREAM_3b568f21-6a70-40d5-8e59-8e856d9981bf_2020
0911_101239_020.jpg, 00:21:53, 641.50ft
Water Level, 35% of the vertical dimension / LOCATOR
DEPTH 7'0"

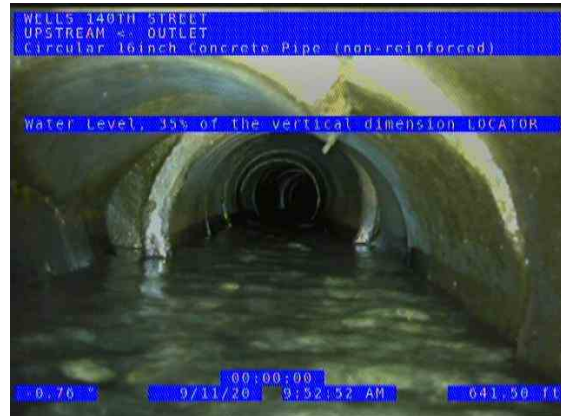
HUEPER BRANCH OUTLET (US)
UPSTREAM_044baaa9-b90c-4020-a1d1-4f5517bcfee3_2020
0911_101320_023.jpg, 00:21:53, 641.50ft
Water Level, 35% of the vertical dimension / LOCATOR
DEPTH 7'0"

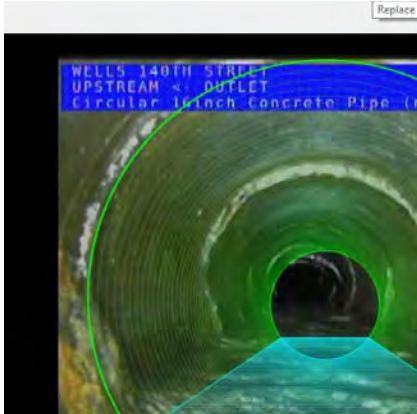
700.6	MWL	Water Level, 20% of the vertical dimension / LOCATOR DEPTH 6' 7"	00:24:19	HUEPER BRANCH OUTLET	
		713.2	B	Broken from 11 o'clock to 1 o'clock, length: 10inch, intruding: 4inch / COLLAPSING	00:24:59	HUEPER BRANCH OUTLET	S4

HUEPER BRANCH OUTLET (US)
UPSTREAM_5c98c27b-93b0-4851-8bc0-c3c4a418890a_2020
0911_101548_766.jpg, 00:24:19, 700.55ft
Water Level, 20% of the vertical dimension / LOCATOR
DEPTH 6' 7"

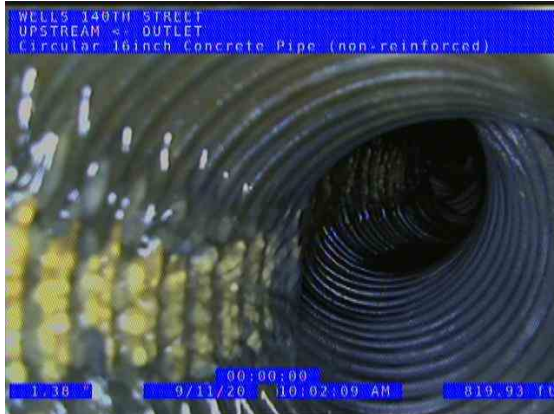
HUEPER BRANCH OUTLET (US)
UPSTREAM_34100971-3f49-4d13-abc5-d08c42a46781_2020
0911_102236_744.jpg, 00:29:02, 818.50ft
Tap Break-in Activity at 10 o'clock, dia/height: 4inch /
INTRUDING, COLLAPSING IN THE PRIVATE TILE

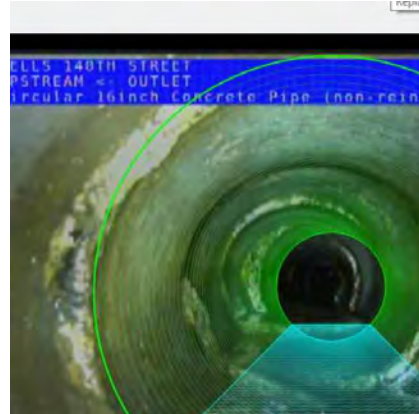
HUEPER BRANCH OUTLET (US)
UPSTREAM_94e32cdc-5014-4502-a7df-6ec7e45904c3_2020
0911_102335_952.jpg, 00:30:12, 819.93ft
Water Level, 15% of the vertical dimension / LOCATOR
DEPTH 5'8"

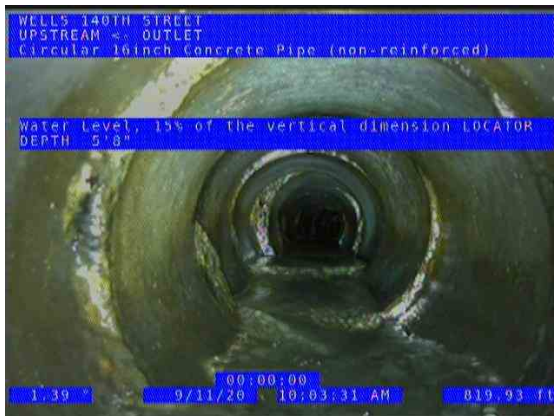
HUEPER BRANCH OUTLET (US)
UPSTREAM_99fb7927-23d7-4091-9302-7aae308feb40_2020
0911_102358_512.jpg, 00:30:12, 819.93ft
Water Level, 15% of the vertical dimension / LOCATOR
DEPTH 5'8"

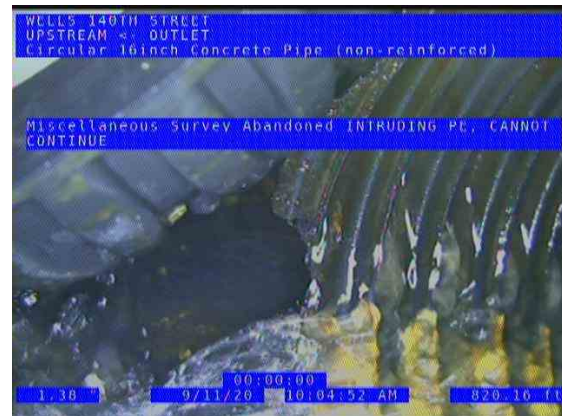
HUEPER BRANCH OUTLET (US)
UPSTREAM_3efdb1d3-9e10-4ad2-b597-5755230bc17f_2020
0911_102519_138.jpg, 00:30:55, 820.16ft
Miscellaneous Survey Abandoned / INTRUDING PE, CANNOT
CONTINUE

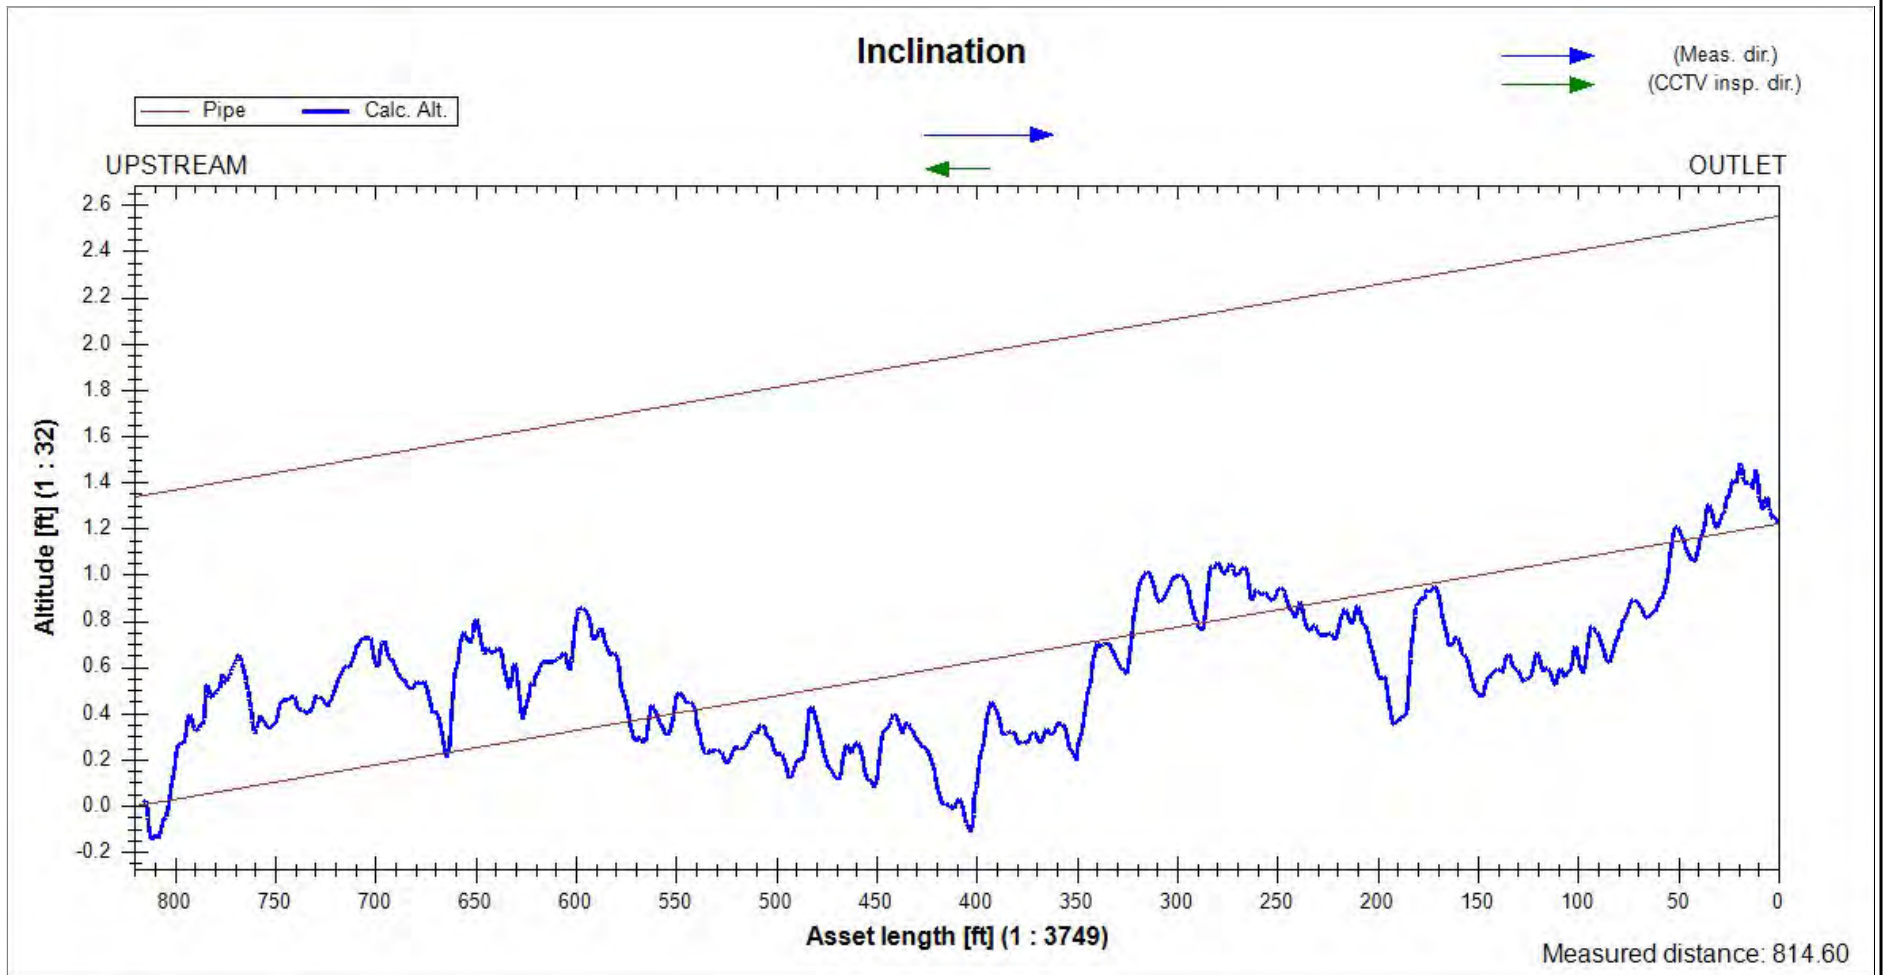
Section Inclination - 9/11/2020 - HUEPER

Pipe Segment Reference	Date	Time	Surveyed By	City	Street	Direction	Length Surveyed
HUEPER BRANCH OUTLET (UPSTREAM)	9/11/2020	9:29 AM	JOHN MEYER	WELLS	140TH STREET	Upstream	814.60
Shape	Height	Width	Upstream MH	Downstream MH	Start altitude	End altitude	Measured Inc
Circular	16	16	UPSTREAM	OUTLET	0.008	1.220	0.490 %

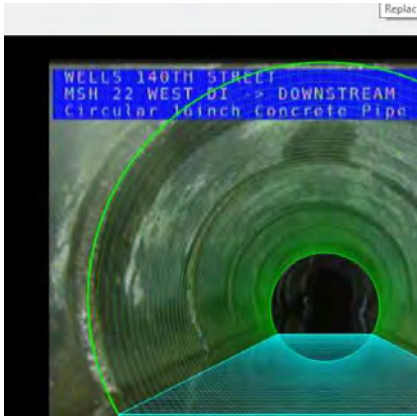
MSH 22 WEST DI (DS)
DOWNSTREAM_b8bdc120-1f4f-4969-9485-239ecac54731_2
0200911_110207_500.jpg, 00:00:00, 0.00ft
Water Level, 25% of the vertical dimension / LOCATER
DEPTH 7' 5"

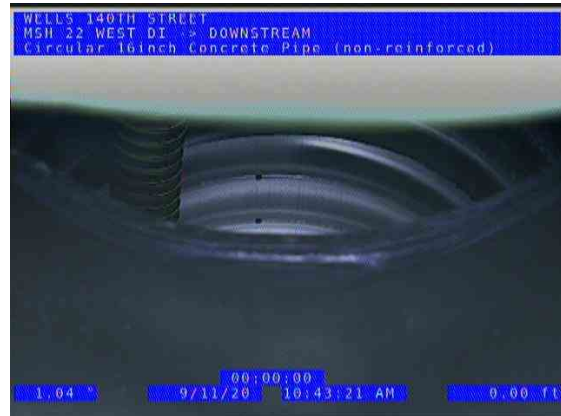
MSH 22 WEST DI (DS)
DOWNSTREAM_435148a7-e80e-4a37-97a2-1466341d1716_
20200911_110347_833.jpg, 00:00:00, 0.00ft
Water Level, 25% of the vertical dimension / LOCATER
DEPTH 7' 5"

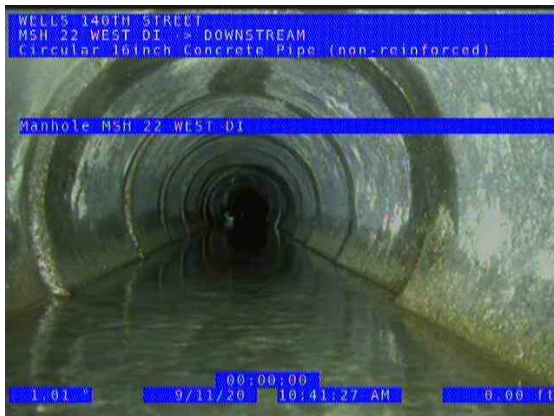
MSH 22 WEST DI (DS)
DOWNSTREAM_97e4cca0-9143-4c4c-80b0-27b07a852c44_
20200911_110153_881.jpg, 00:31:16, 0.00ft
Manhole / MSH 22 WEST DI

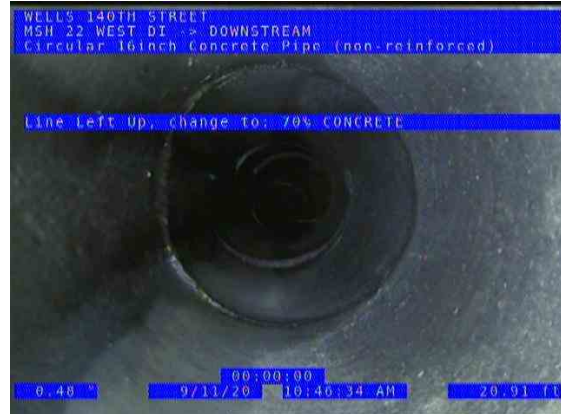
MSH 22 WEST DI (DS)
DOWNSTREAM_2db46f63-ece5-451b-8f3c-84c46c1d92f8_20200911_110702_056.jpg, 00:02:11, 20.91ft
Line Left Up, change to: 70% / CONCRETE

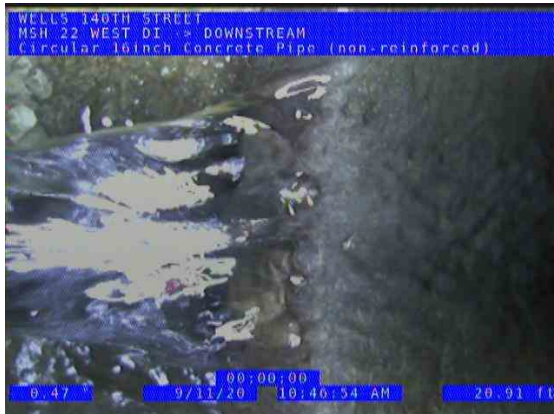
MSH 22 WEST DI (DS)
DOWNSTREAM_33176324-8f5f-4e53-b5d2-2210f55fa073_20200911_110721_184.jpg, 00:02:11, 20.91ft
Line Left Up, change to: 70% / CONCRETE

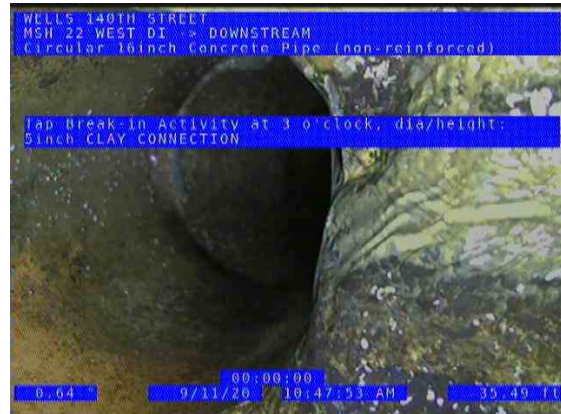
MSH 22 WEST DI (DS)
DOWNSTREAM_db00fba8-2ea8-44e9-8324-38796641c0a0_20200911_110819_870.jpg, 00:03:09, 35.49ft
Tap Break-in Activity at 3 o'clock, dia/height: 5inch / CLAY CONNECTION

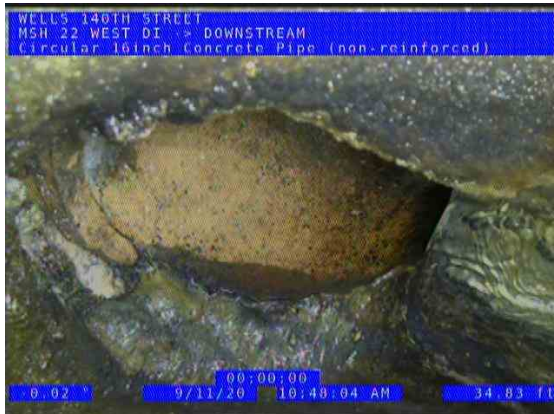
MSH 22 WEST DI (DS)
DOWNSTREAM_c14a6d1d-11d1-463b-99f4-fa088e9b1db4_2
0200911_110831_608.jpg, 00:03:09, 35.49ft
Tap Break-in Activity at 3 o'clock, dia/height: 5inch / CLAY
CONNECTION

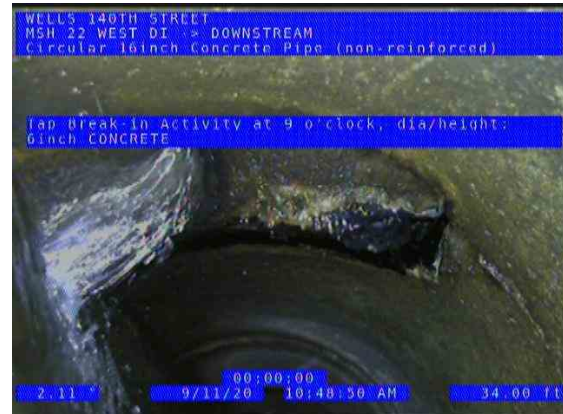
MSH 22 WEST DI (DS)
DOWNSTREAM_4239c331-6457-4d58-bb7b-c30842aa8c7b_
20200911_110918_303.jpg, 00:03:42, 35.50ft
Tap Break-in Activity at 9 o'clock, dia/height: 6inch /
CONCRETE

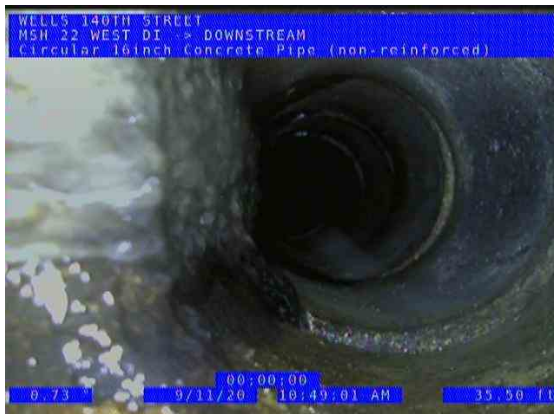
MSH 22 WEST DI (DS)
DOWNSTREAM_5f0b4e20-2ff8-4939-833e-635333ce17e8_2
0200911_110927_927.jpg, 00:03:42, 35.50ft
Tap Break-in Activity at 9 o'clock, dia/height: 6inch /
CONCRETE

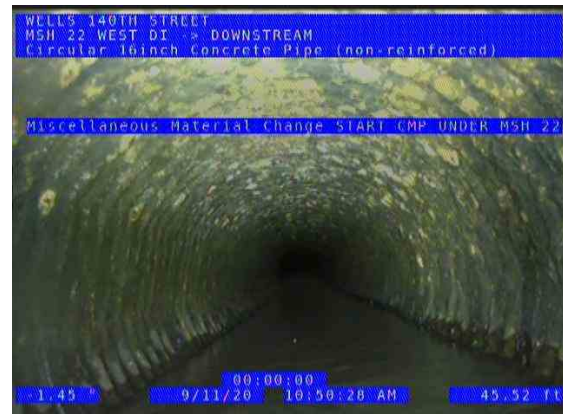
MSH 22 WEST DI (DS)
DOWNSTREAM_feb5b991-4280-4fae-9e94-9756aeab935e_2
0200911_111055_659.jpg, 00:05:00, 45.89ft
Miscellaneous Material Change / START CMP UNDER MSH
22
