REESTABLISHMENT OF RECORDS JCD 301-HUEPER BRANCH

Faribault County, Minnesota

Date: November 19, 2020

ISG Project No.: 17-20487

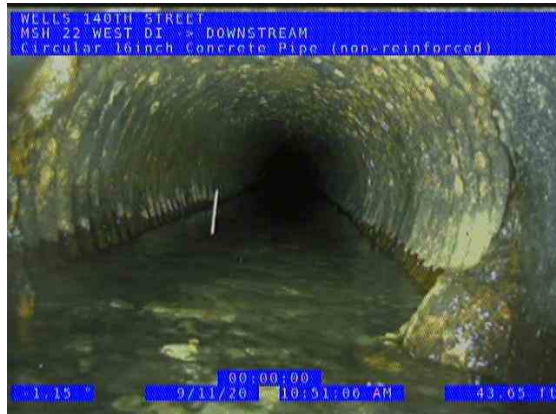
MSH 22 WEST DI (DS)
DOWNSTREAM_f45805a8-62ec-4ea4-9556-dceeb676a5c6_2
0200911_111133_120.jpg, 00:05:00, 45.89ft
Miscellaneous Material Change / START CMP UNDER MSH
22

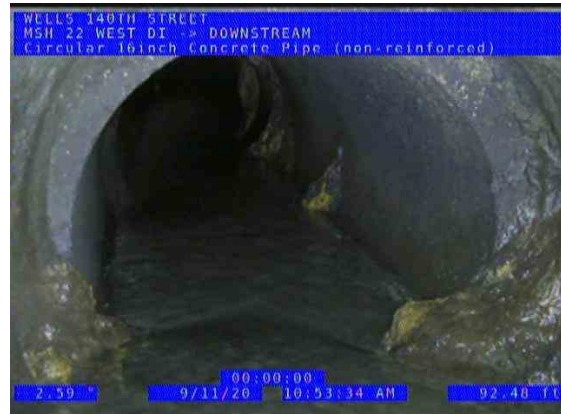
MSH 22 WEST DI (DS)
DOWNSTREAM_4c92aa14-10ef-4d35-b7b0-b0a79ce63b28_2
0200911_111400_919.jpg, 00:07:45, 92.48ft
Miscellaneous Material Change / END OF CMP UNDER MSH
22

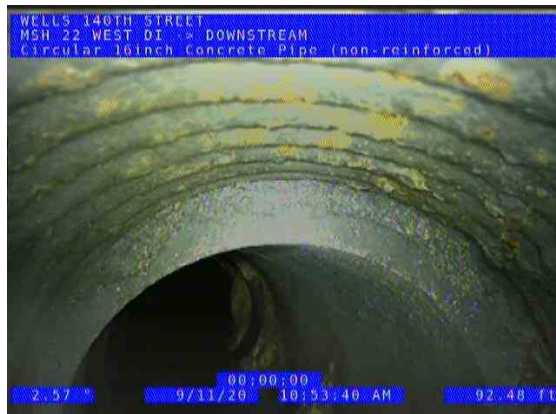
MSH 22 WEST DI (DS)
DOWNSTREAM_069aa29c-f19d-4c5d-8770-02d194556b6c_2
0200911_111407_542.jpg, 00:07:45, 92.48ft
Miscellaneous Material Change / END OF CMP UNDER MSH
22

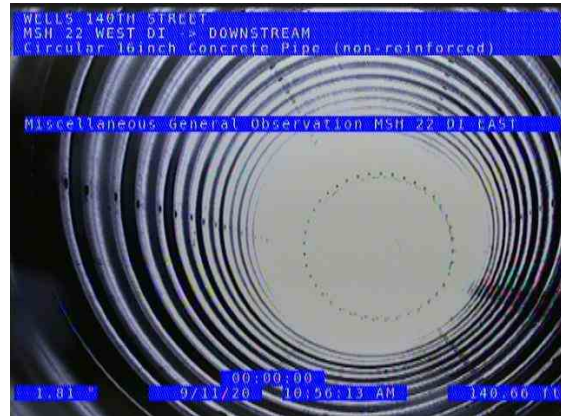
MSH 22 WEST DI (DS)
DOWNSTREAM_1c28fef9-3867-4eda-b2d7-5e1849701ed4_2
0200911_111639_775.jpg, 00:09:23, 140.66ft
Miscellaneous General Observation / MSH 22 DI EAST

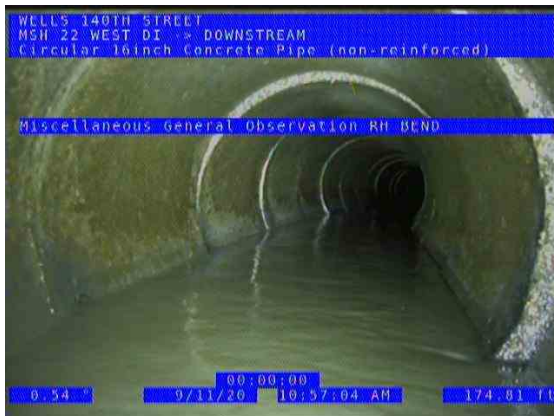
MSH 22 WEST DI (DS)
DOWNSTREAM_5baa9b8d-a35e-4303-b9ce-3d64b6c16973_
20200911_111731_670.jpg, 00:10:07, 174.81ft
Miscellaneous General Observation / RH BEND

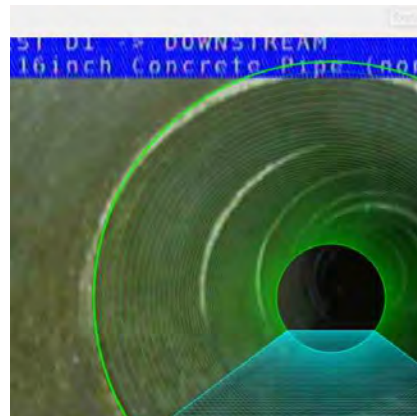
MSH 22 WEST DI (DS)
DOWNSTREAM_d41ab64a-81e5-4286-978e-cef6bd5e29ee_2
0200911_111822_839.jpg, 00:10:41, 201.64ft
Water Level, 20% of the vertical dimension / LOCATER
DEPTH 9' 4"

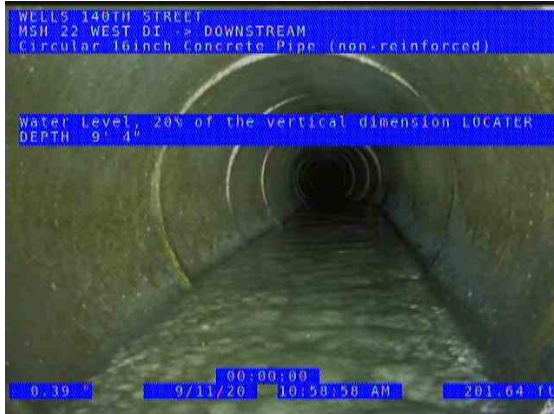
MSH 22 WEST DI (DS)
DOWNSTREAM_395dad04-3482-4912-964a-9d9d7e94acc8_
20200911_111925_370.jpg, 00:10:41, 201.64ft
Water Level, 20% of the vertical dimension / LOCATER
DEPTH 9' 4"

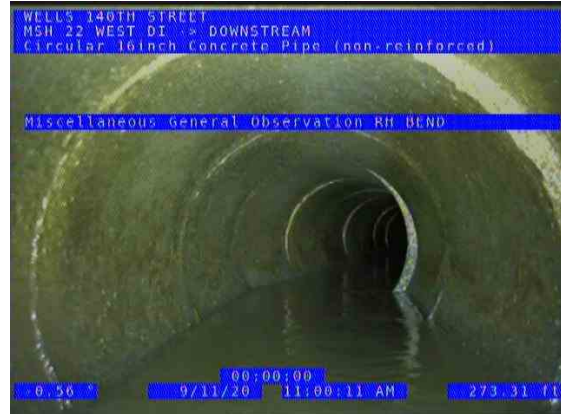
MSH 22 WEST DI (DS)
DOWNSTREAM_1dcfe3cb-e873-4dba-b054-ba3f56f4a64a_20
200911_112038_251.jpg, 00:11:47, 279.82ft
Miscellaneous General Observation / RH BEND LOCATER
DEPTH 10' 4"

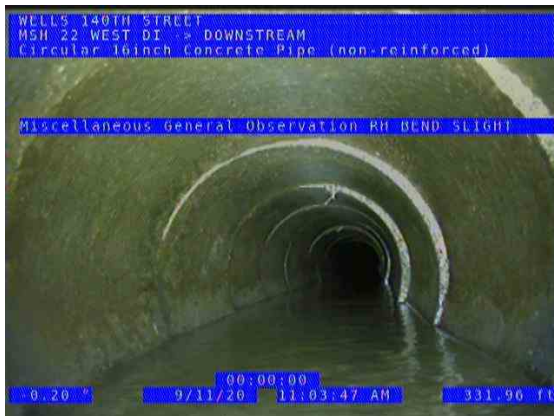
MSH 22 WEST DI (DS)
DOWNSTREAM_4a801da2-e5af-4aed-bdac-494b294579a7_2
0200911_112414_303.jpg, 00:15:08, 331.96ft
Miscellaneous General Observation / RH BEND SLIGHT

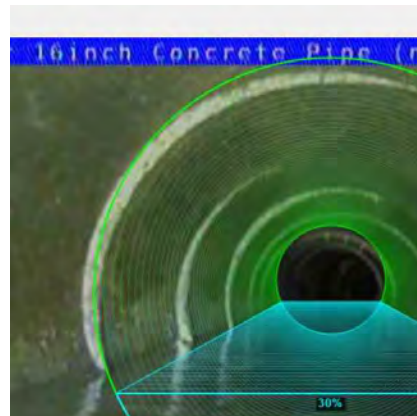
MSH 22 WEST DI (DS)
DOWNSTREAM_36ecaecc-f5a6-4843-b4db-565012ccc0a5_2
0200911_112612_228.jpg, 00:16:57, 436.97ft
Water Level, 30% of the vertical dimension / LOCATER
DEPTH 10'

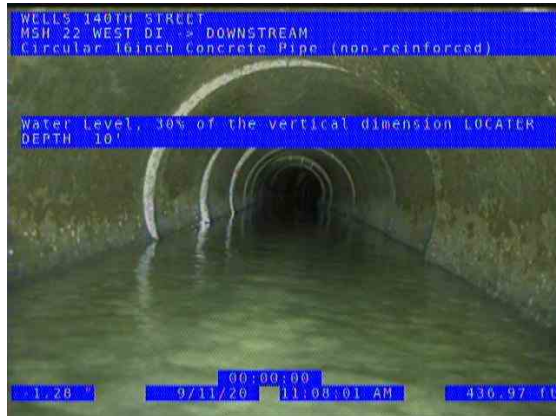
MSH 22 WEST DI (DS)
DOWNSTREAM_ac0e8f26-a22d-484e-9e22-8cabbf0ae780_2
0200911_112829_153.jpg, 00:16:57, 436.97ft
Water Level, 30% of the vertical dimension / LOCATER
DEPTH 10'

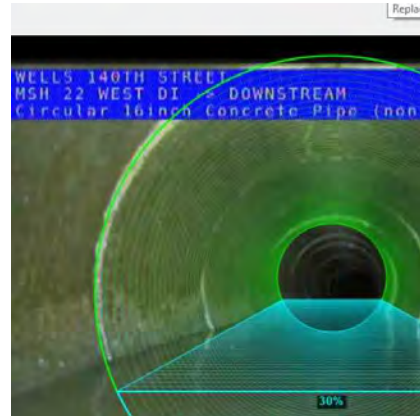
MSH 22 WEST DI (DS)
DOWNSTREAM_fb962a3a-89e4-4a1c-8c23-803cc864345e_2
0200911_112953_419.jpg, 00:18:12, 500.53ft
Water Level, 30% of the vertical dimension / LOCATER
DEPTH

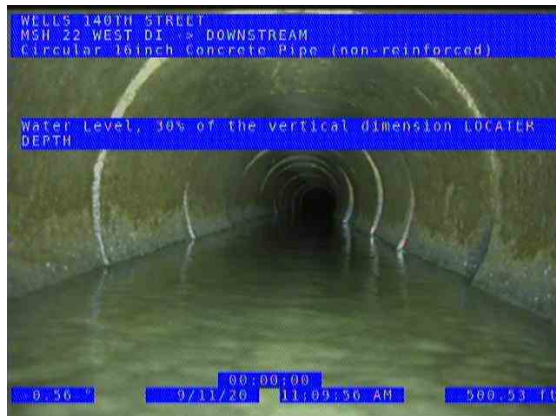
MSH 22 WEST DI (DS)
DOWNSTREAM_808e009f-0061-494d-9953-a43c3b84d83a_2
0200911_113022_945.jpg, 00:18:12, 500.53ft
Water Level, 30% of the vertical dimension / LOCATER
DEPTH

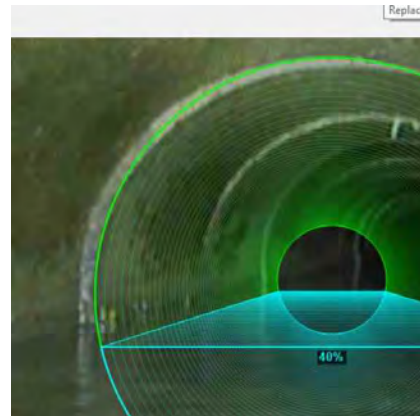
MSH 22 WEST DI (DS)
DOWNSTREAM_73862ba5-dd6f-4c7d-89a7-87d5c7ae55f6_2
0200911_113239_399.jpg, 00:20:21, 600.28ft
Water Level, 40% of the vertical dimension / LOCATER
DEPTH 8' 4"

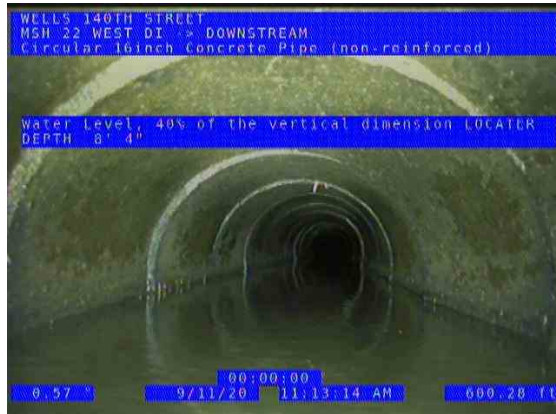
MSH 22 WEST DI (DS)
DOWNSTREAM_c106f42c-75e0-4119-9c7e-4848ae146b94_2
0200911_113342_367.jpg, 00:20:21, 600.28ft
Water Level, 40% of the vertical dimension / LOCATER
DEPTH 8' 4"

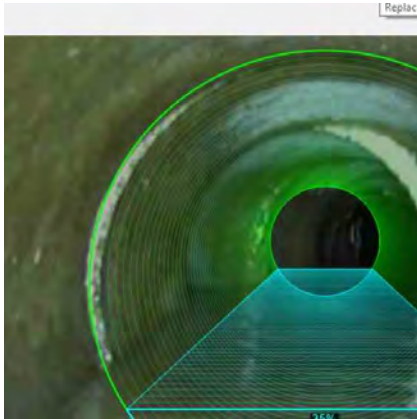
MSH 22 WEST DI (DS)
DOWNSTREAM_aca57ff7-6b81-4a16-800b-f86bc02197cb_20
200911_113910_983.jpg, 00:24:30, 709.50ft
Water Level, 25% of the vertical dimension / LOCATER
DEPTH 7' 2"

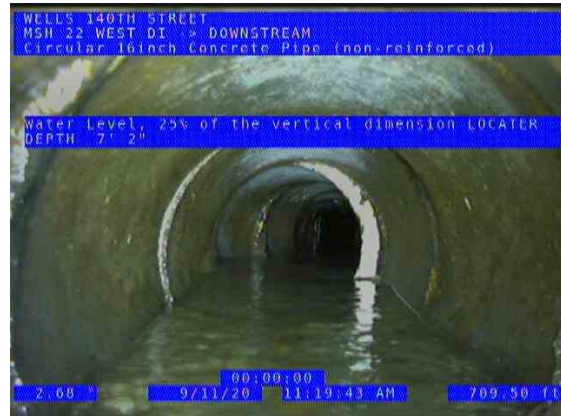
MSH 22 WEST DI (DS)
DOWNSTREAM_fe720a86-5251-417d-a5cc-0053f7799f50_20
200911_114010_165.jpg, 00:24:30, 709.50ft
Water Level, 25% of the vertical dimension / LOCATER
DEPTH 7' 2"

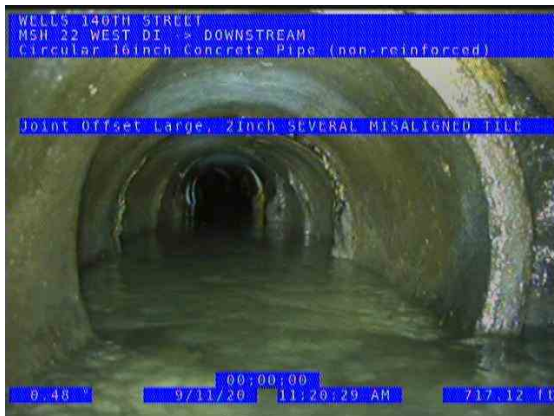
MSH 22 WEST DI (DS)
DOWNSTREAM_1b0de49a-3c50-43ad-860d-2fce74c2a0fd_2
0200911_114056_027.jpg, 00:24:58, 717.12ft
Joint Offset Large, 2Inch / SEVERAL MISALIGNED TILE

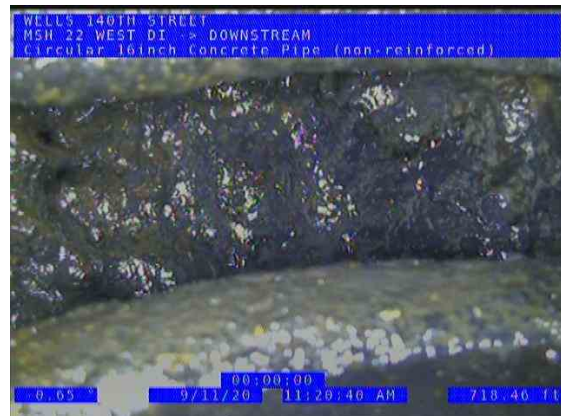
MSH 22 WEST DI (DS)
DOWNSTREAM_225ea995-58b2-4ca1-a784-ad9921b512bd_
20200911_114107_242.jpg, 00:24:58, 717.12ft
Joint Offset Large, 2Inch / SEVERAL MISALIGNED TILE

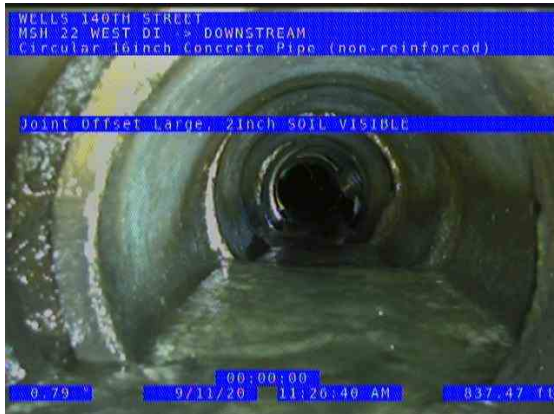
720.6	B	Broken at 1 o'clock, length: 2inch / SOIL VISIBLE	00:25:31		S4		
	837.5	JOL	Joint Offset Large, 2Inch / SOIL VISIBLE	00:28:46	MSH 22 WEST DI (DS)	S4

MSH 22 WEST DI (DS)
DOWNSTREAM_8cedb893-2e46-458c-9dc5-98feb45ce5c0_20200911_114707_546.jpg, 00:28:46, 837.47ft
Joint Offset Large, 2Inch / SOIL VISIBLE

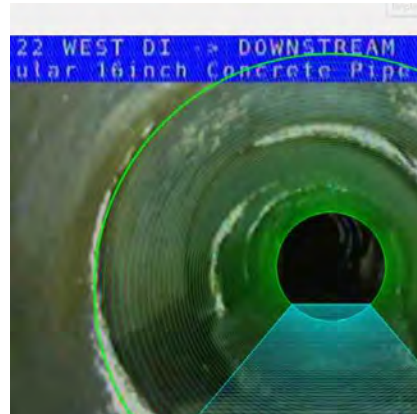
MSH 22 WEST DI (DS)
DOWNSTREAM_49e1c3c7-08a6-408c-b13a-300979d90761_20200911_114933_502.jpg, 00:29:33, 846.63ft
Water Level, 15% of the vertical dimension / LOCATER DEPTH 7' 4"

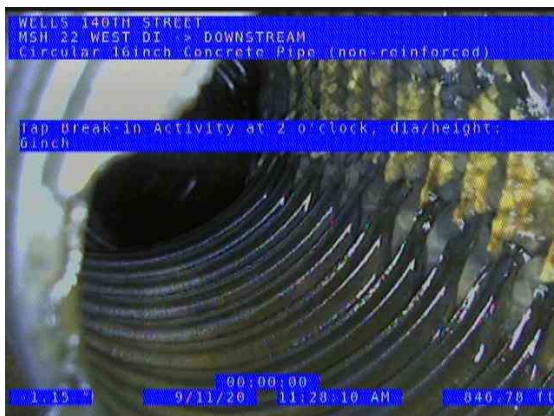
MSH 22 WEST DI (DS)
DOWNSTREAM_3228d2a5-0b44-48cc-b0c3-b5825887554a_20200911_114836_497.jpg, 00:29:12, 846.78ft
Tap Break-in Activity at 2 o'clock, dia/height: 6inch

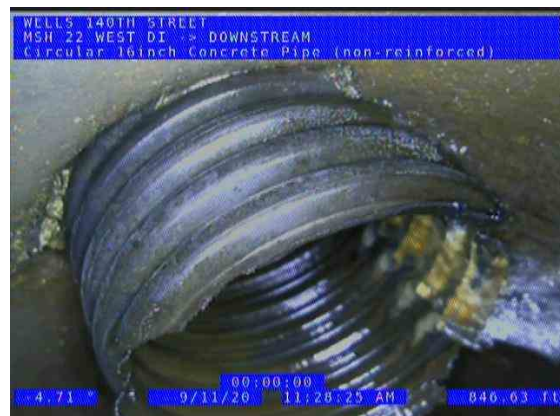
MSH 22 WEST DI (DS)
DOWNSTREAM_b861e18b-0801-442d-b114-d78911b5e7a3_20200911_114852_430.jpg, 00:29:12, 846.78ft
Tap Break-in Activity at 2 o'clock, dia/height: 6inch

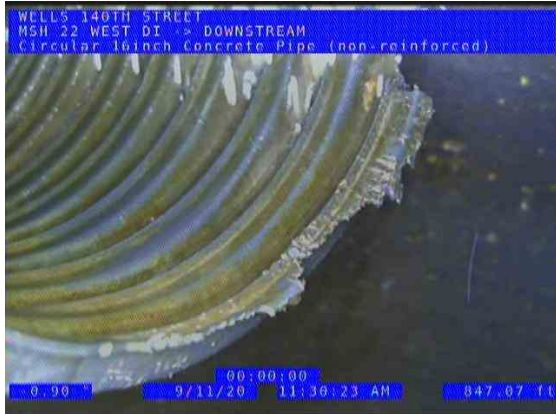
MSH 22 WEST DI (DS)
DOWNSTREAM_fdb0aa5c-bfad-4024-986b-3aeaf848ce6a_20
200911_115050_124.jpg, 00:29:44, 847.07ft
Miscellaneous Survey Abandoned / RUN OVERLAP

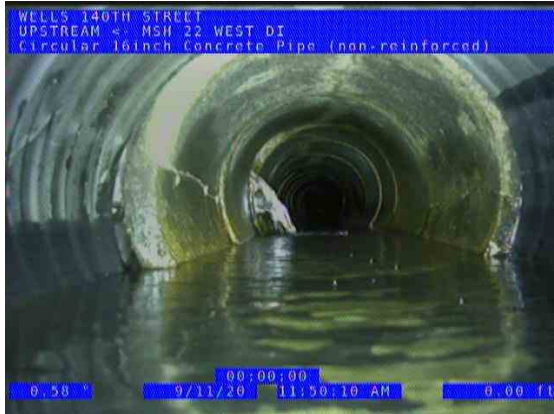
MSH 22 WEST (US)
UPSTREAM_02e17e0b-9a9d-4a2a-8244-bbfde9267269_2020
0911_121037_158.jpg, 00:29:57, 0.00ft
Manhole / MSH 22 WEST DI

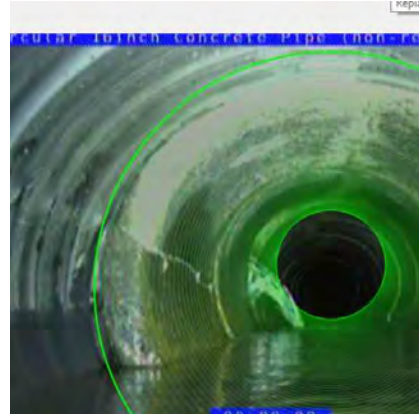
MSH 22 WEST (US)
UPSTREAM_f1b16bcd-f6cb-4963-ae66-48ea894ae322_2020
0911_121059_277.jpg, 00:29:57, 0.00ft
Water Level, 30% of the vertical dimension

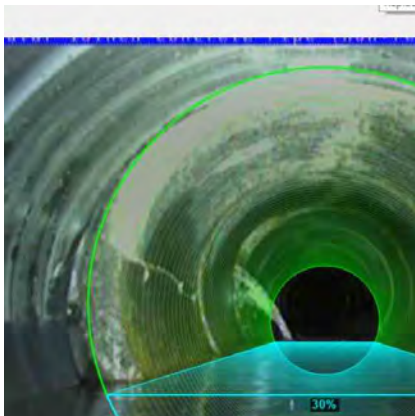
MSH 22 WEST (US)
UPSTREAM_1d91e5b0-76b6-4172-a9ef-a15471b74a8b_2020
0911_121111_547.jpg, 00:29:57, 0.00ft
Water Level, 30% of the vertical dimension

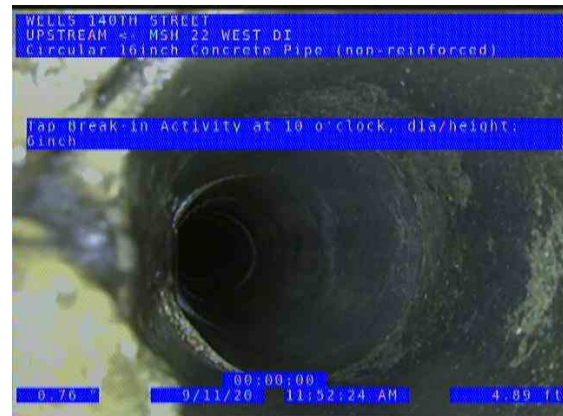
MSH 22 WEST (US)
UPSTREAM_3c8ffe67-2462-4380-a25f-d4166ba99795_20200
911_121250_869.jpg, 00:29:57, 4.89ft
Tap Break-in Activity at 10 o'clock, dia/height: 6inch

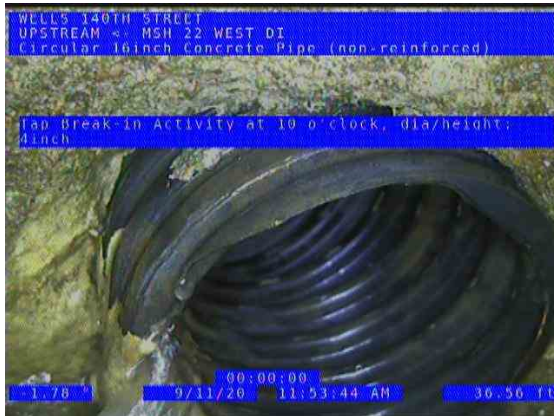
MSH 22 WEST (US)
UPSTREAM_cb150d80-c8cd-4664-838c-e87b292d293e_2020
0911_121410_651.jpg, 00:29:57, 36.56ft
Tap Break-in Activity at 10 o'clock, dia/height: 4inch

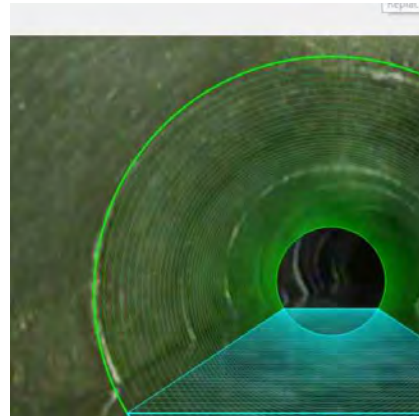
MSH 22 WEST (US)
UPSTREAM_bd721081-941a-446f-97b8-b601e8247376_2020
0911_121605_393.jpg, 00:29:57, 100.26ft
Water Level, 25% of the vertical dimension / LOCATER
DEPTH 7' 10"

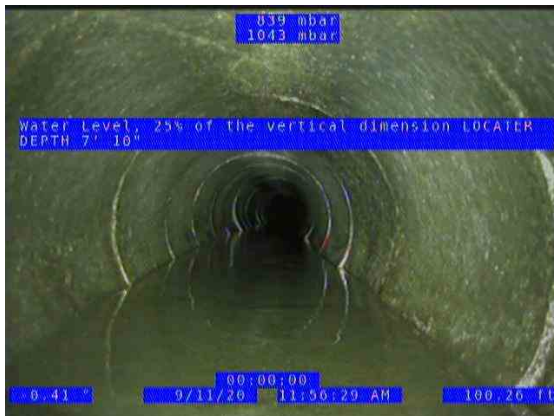
MSH 22 WEST (US)
UPSTREAM_5d5a549e-b193-43d7-8cce-99789ad4464c_2020
0911_121655_486.jpg, 00:29:57, 100.26ft
Water Level, 25% of the vertical dimension / LOCATER
DEPTH 7' 10"

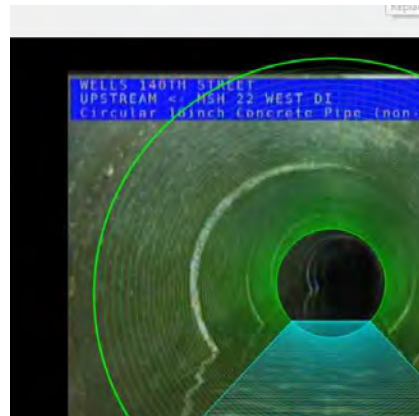
MSH 22 WEST (US)
UPSTREAM_014d88d7-a137-4498-ac89-7eb22664e7f4_2020
0911_121900_996.jpg, 00:29:57, 198.84ft
Water Level, 15% of the vertical dimension / LOCATER
DEPTH 7' 6"
there is a hump in pipe here

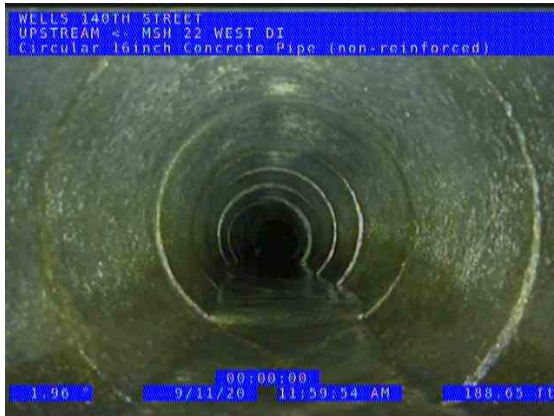
MSH 22 WEST (US)
UPSTREAM_e9891966-3569-4c24-9a00-47efb314d858_2020
0911_122020_432.jpg, 00:29:57, 198.84ft
Water Level, 15% of the vertical dimension / LOCATER
DEPTH 7' 6"
there is a hump in pipe here

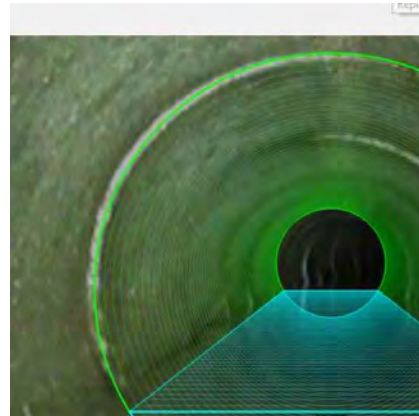
MSH 22 WEST (US)
UPSTREAM_443e0ec2-9561-4525-9b40-002c8c349b8a_2020
0911_122216_043.jpg, 00:29:57, 300.02ft
Water Level, 25% of the vertical dimension / LOCATER
DEPTH 8' 3"

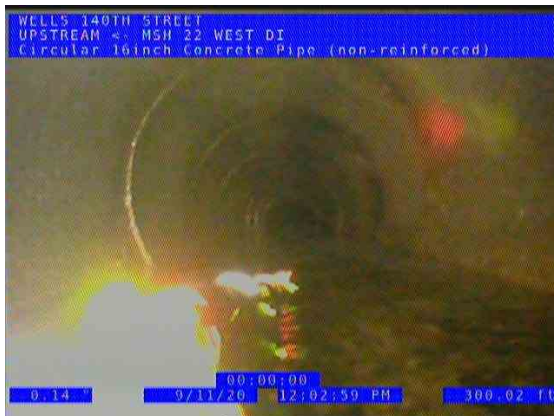
MSH 22 WEST (US)
UPSTREAM_48578027-55c7-4b90-9177-0ef629f8a5fe_20200
911_122327_462.jpg, 00:29:57, 300.02ft
Water Level, 25% of the vertical dimension / LOCATER
DEPTH 8' 3"

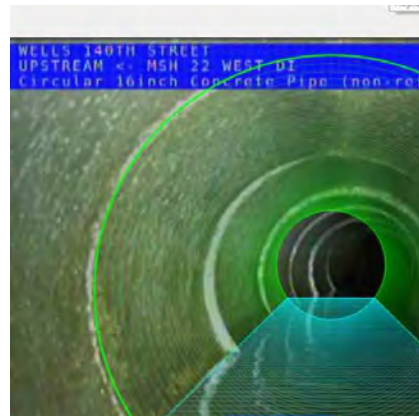
MSH 22 WEST (US)
UPSTREAM_ca32a305-b085-4236-ae0a-a335007e3385_202
00911_122503_984.jpg, 00:29:57, 400.72ft
Water Level, 20% of the vertical dimension / LOCATER
DEPTH 8' 5"

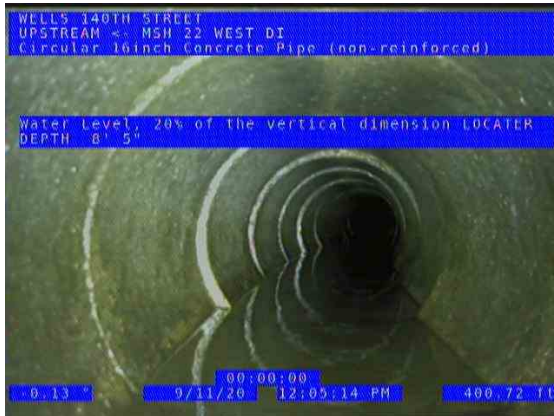
MSH 22 WEST (US)
UPSTREAM_d02004f2-de31-45b6-9842-19acd4368742_2020
0911_122540_883.jpg, 00:29:57, 400.72ft
Water Level, 20% of the vertical dimension / LOCATER
DEPTH 8' 5"

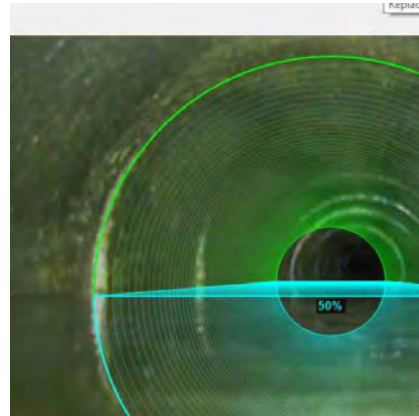
MSH 22 WEST (US)
UPSTREAM_726a6fda-efc3-45c4-ae88-623d48469b2e_2020
0911_122749_545.jpg, 00:29:57, 498.96ft
Water Level, 50% of the vertical dimension / LOCATER
DEPTH 10' 1"

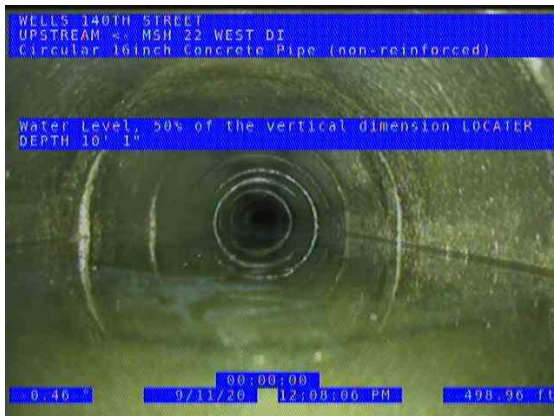
MSH 22 WEST (US)
UPSTREAM_7694e5a2-c69b-4aec-bdc1-2e674d9b5b1f_2020
0911_122832_374.jpg, 00:29:57, 498.96ft
Water Level, 50% of the vertical dimension / LOCATER
DEPTH 10' 1"

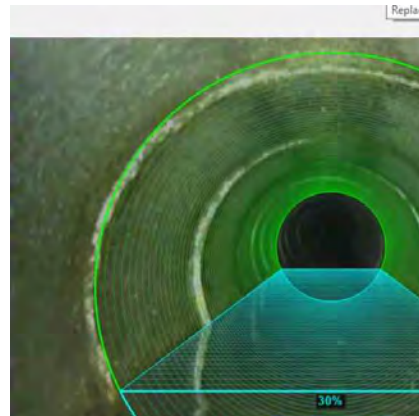
MSH 22 WEST (US)
UPSTREAM_8bad4184-4052-46a6-bcb6-a0d48d365e20_202
00911_123038_955.jpg, 00:29:57, 597.75ft
Water Level, 30% of the vertical dimension / LOCATER
DEPTH

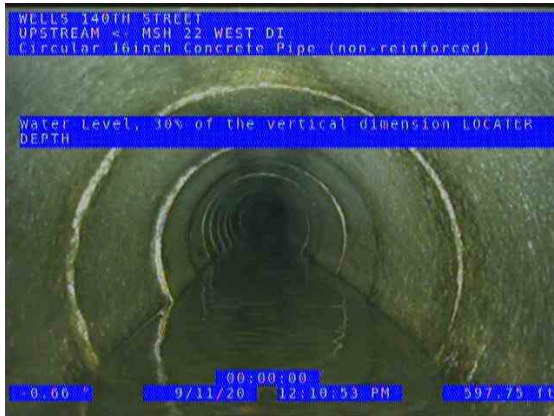
MSH 22 WEST (US)
UPSTREAM_0b44f384-49e4-4401-99b7-7fa61ddf8d73_20200911_123120_181.jpg, 00:29:57, 597.75ft
Water Level, 30% of the vertical dimension / LOCATER DEPTH

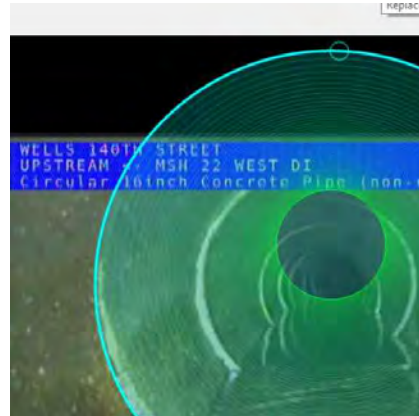
MSH 22 WEST (US)
UPSTREAM_3fe1f803-bb5f-42f6-9cf6-0e2bec271971_20200911_123249_375.jpg, 00:29:57, 638.61ft
Joint Offset Large, 2Inch / 9.7% OBSTRUCTED

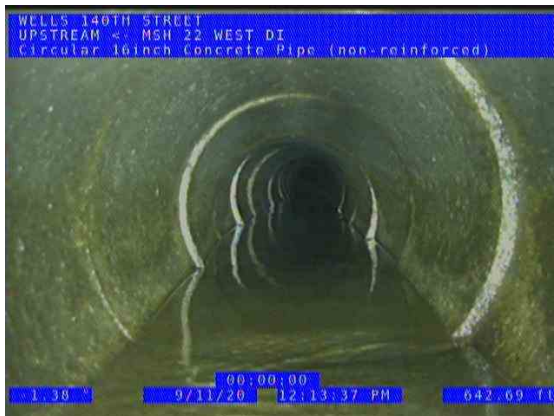
MSH 22 WEST (US)
UPSTREAM_7cc917a1-7919-4a3e-9972-5ae500c03969_20200911_123403_798.jpg, 00:29:57, 638.61ft
Joint Offset Large, 2Inch / 9.7% OBSTRUCTED

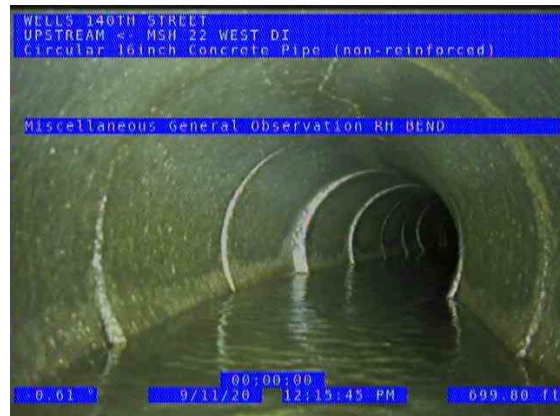
MSH 22 WEST (US)
UPSTREAM_ffdf3937-b51f-4605-afd6-8f23b4b81b0a_20200911_123611_270.jpg, 00:29:57, 699.80ft
Miscellaneous General Observation / RH BEND

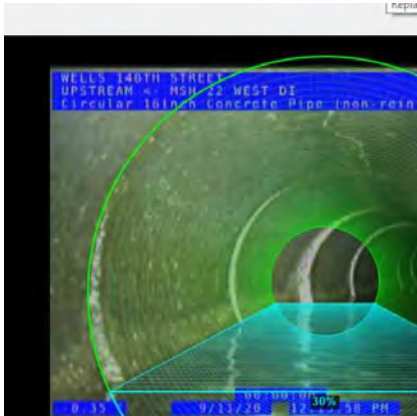
MSH 22 WEST (US)
UPSTREAM_1a33eab2-1b12-4ea0-9732-d5e044b00965_20200911_123625_336.jpg, 00:29:57, 700.23ft
Water Level, 30% of the vertical dimension / LOCATER DEPTH 11' 6"

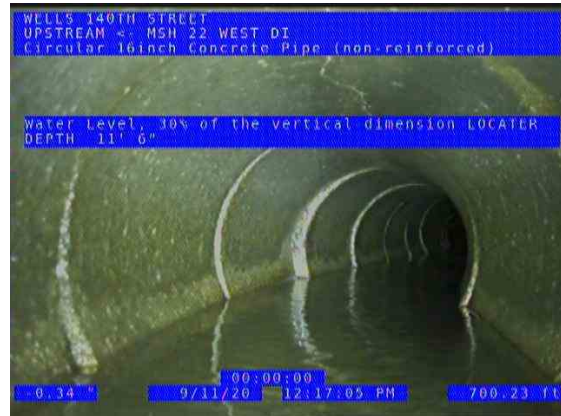
MSH 22 WEST (US)
UPSTREAM_a53adef2-8ed7-46f5-a476-6b3a85f07253_20200911_123731_340.jpg, 00:29:57, 700.23ft
Water Level, 30% of the vertical dimension / LOCATER DEPTH 11' 6"

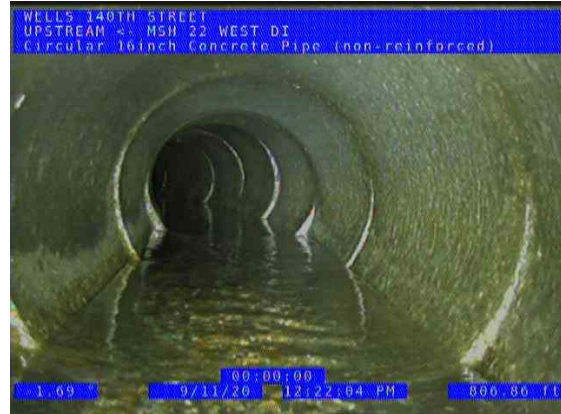
MSH 22 WEST (US)
UPSTREAM_384bd8e1-30f5-43c3-8b31-ef7d30c03714_20200911_124231_007.jpg, 00:29:57, 806.86ft
Miscellaneous General Observation / LH BEND

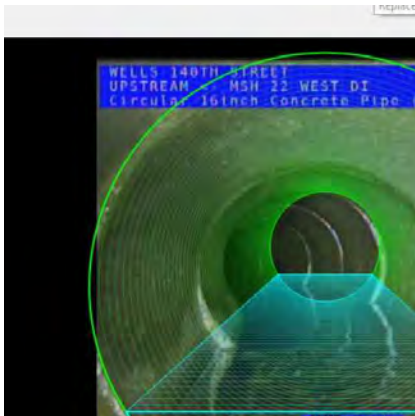
MSH 22 WEST (US)
UPSTREAM_42119e54-b94c-4ea9-a286-c0f3ab8fc2ba_20200911_124302_426.jpg, 00:29:57, 808.66ft
Water Level, 25% of the vertical dimension / LOCATER DEPTH 9' 8"

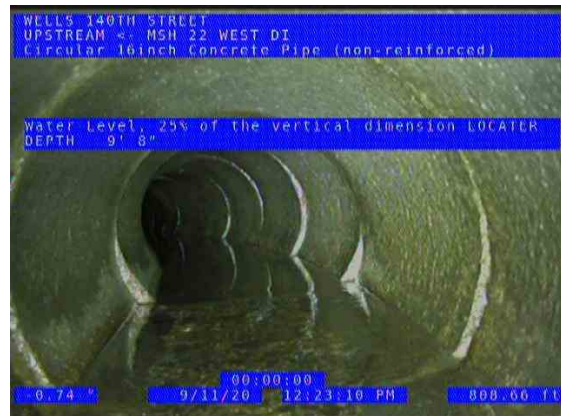
MSH 22 WEST (US)
UPSTREAM_b24caf9b-a3f2-43ed-a966-91550912e4b8_20200911_124336_737.jpg, 00:29:57, 808.66ft
Water Level, 25% of the vertical dimension / LOCATER DEPTH 9' 8"

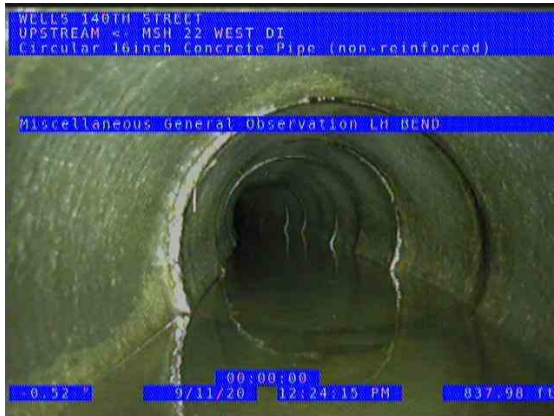
MSH 22 WEST (US)
UPSTREAM_e93e03b4-3f1d-4f0e-902f-26ab7cf556f0_20200911_124441_709.jpg, 00:29:57, 837.97ft
Miscellaneous General Observation / LH BEND

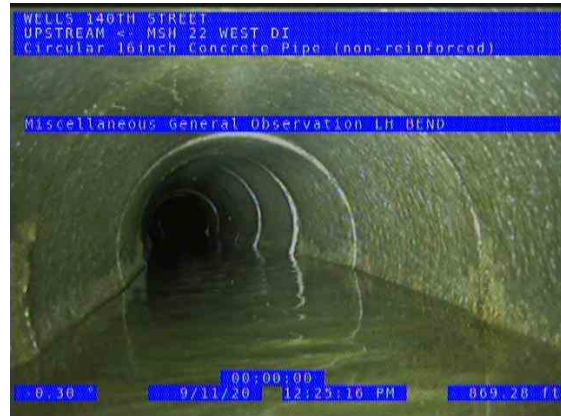
MSH 22 WEST (US)
UPSTREAM_0db4eeb7-56b8-4d53-bf95-725b697fb9ec_20200911_124543_057.jpg, 00:29:57, 869.28ft
Miscellaneous General Observation / LH BEND

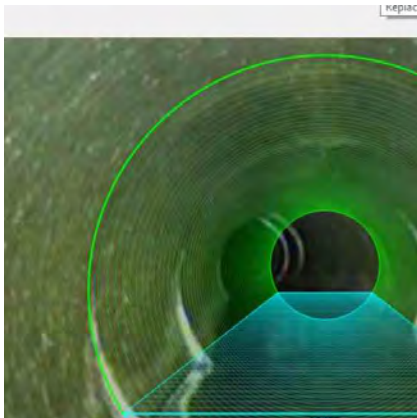
MSH 22 WEST (US)
UPSTREAM_7f0572c7-9fa8-4367-a158-f5b34901e124_20200911_124652_715.jpg, 00:29:57, 900.33ft
Water Level, 25% of the vertical dimension / LOCATER
DEPTH 9' 7"

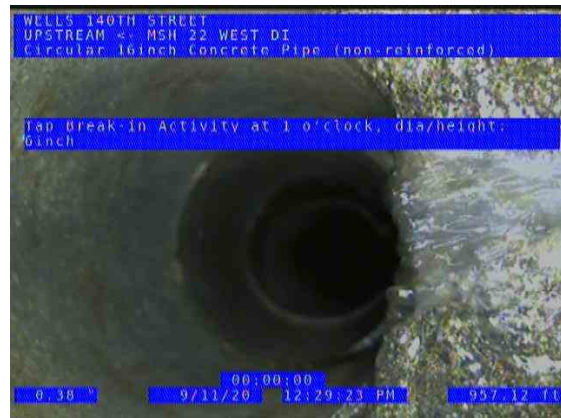
MSH 22 WEST (US)
UPSTREAM_e2cf924a-5df1-4f93-9ccd-e9851e0f23c1_20200911_124950_262.jpg, 00:29:57, 957.12ft
Tap Break-in Activity at 1 o'clock, dia/height: 6inch

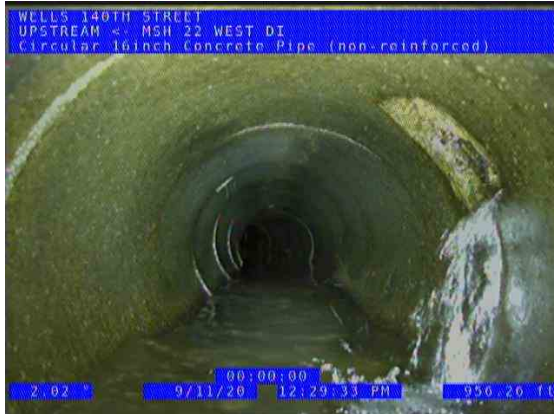
MSH 22 WEST (US)
UPSTREAM_6e45c733-1664-4f55-92b2-ad2e1fc85749_2020
0911_125000_166.jpg, 00:29:57, 957.12ft
Tap Break-in Activity at 1 o'clock, dia/height: 6inch

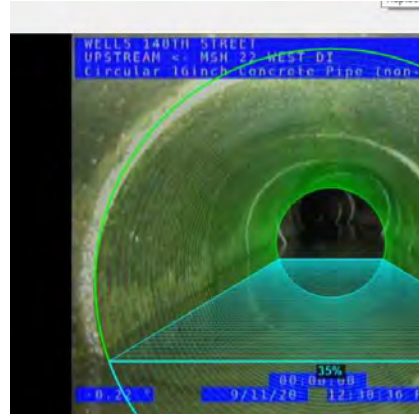
MSH 22 WEST (US)
UPSTREAM_7cffb3b3-086f-4572-b2f5-51180392b909_20200
911_125102_986.jpg, 00:29:57, 975.04ft
Water Level, 35% of the vertical dimension / LOCATER
DEPTH 9' 7"

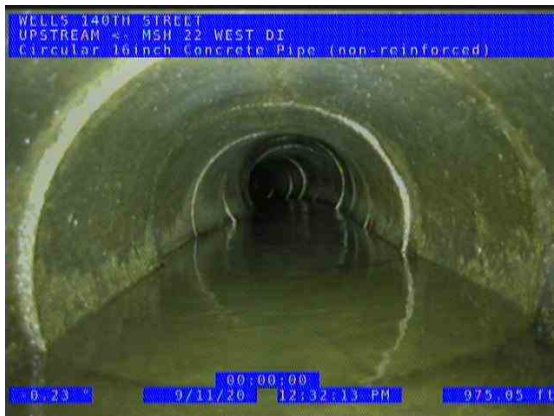
MSH 22 WEST (US)
UPSTREAM_961ca001-1351-45cf-98e5-e8cb173609e4_2020
0911_125239_766.jpg, 00:29:57, 975.04ft
Water Level, 35% of the vertical dimension / LOCATER
DEPTH 9' 7"

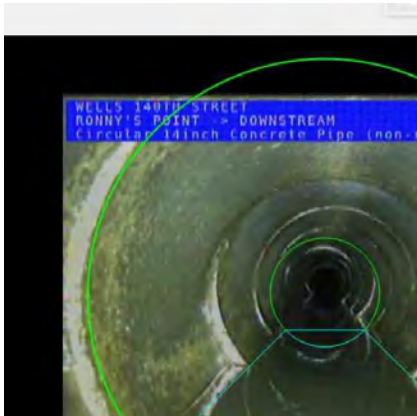
RONNY'S POINT (DS)
DOWNSTREAM_d818a505-b5b5-4241-8a89-dbe3dfa04af_2
0200924_095048_046.jpg, 00:01:58, 100.59ft
Water Level, 15% of the vertical dimension / DEPTH 9' 6"

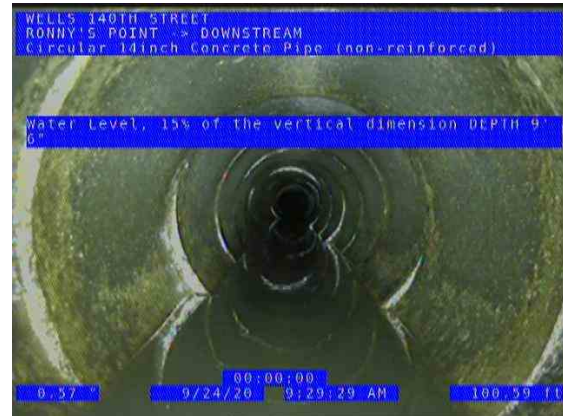
RONNY'S POINT (DS)
DOWNSTREAM_ef1f15d3-9a07-454a-8dbd-5363770222ad_2
0200924_095148_266.jpg, 00:01:58, 100.59ft
Water Level, 15% of the vertical dimension / DEPTH 9' 6"

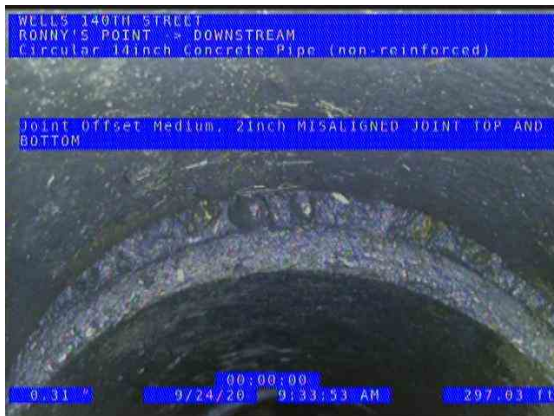
RONNY'S POINT (DS)
DOWNSTREAM_bc74da77-9c9f-4795-a618-f5af7dfec002_20
200924_095611_542.jpg, 00:05:04, 297.03ft
Joint Offset Medium, 2Inch / MISALIGNED JOINT TOP AND
BOTTOM

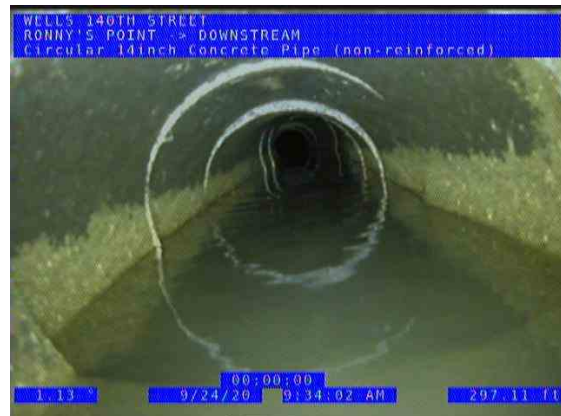
RONNY'S POINT (DS)
DOWNSTREAM_5ad2dfc0-9d05-4da9-aa06-d874e3514351_2
0200924_095619_945.jpg, 00:05:04, 297.03ft
Joint Offset Medium, 2Inch / MISALIGNED JOINT TOP AND
BOTTOM

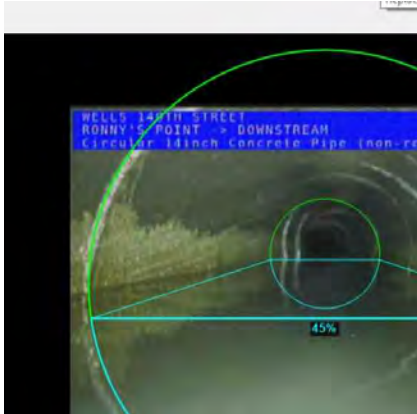
RONNY'S POINT (DS)
DOWNSTREAM_21bf10a9-26aa-43e9-82ef-d29a59f1e248_2
0200924_095646_291.jpg, 00:05:27, 300.81ft
Water Level, 45% of the vertical dimension / 9' 3" DEPTH

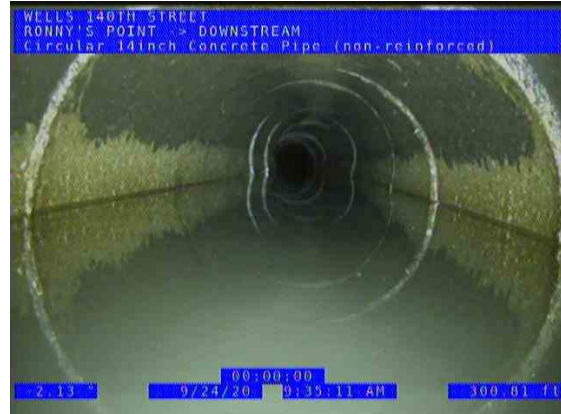
RONNY'S POINT (DS)
DOWNSTREAM_2a4bd338-38cb-4dff-819c-dd2ffb2fd2ad_202
00924_095730_039.jpg, 00:05:27, 300.81ft
Water Level, 45% of the vertical dimension / 9' 3" DEPTH

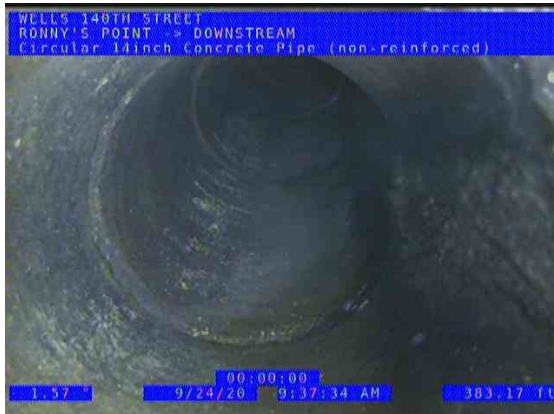
RONNY'S POINT (DS)
DOWNSTREAM_c31bd52d-3618-445d-b6c8-a78baa86844f_2
0200924_095952_784.jpg, 00:06:56, 382.02ft
Tap Break-in Activity at 2 o'clock, dia/height: 8inch / PRIVATE
FROM INTAKE TO SOUTH

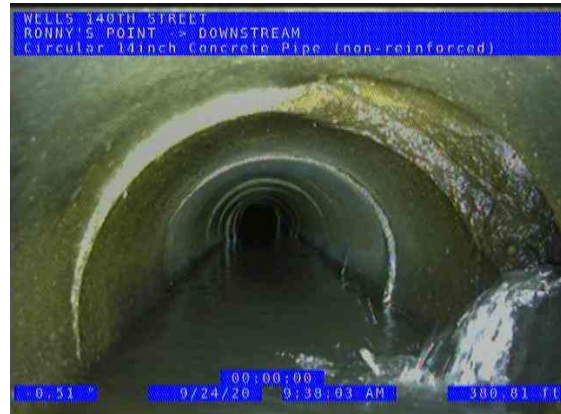
RONNY'S POINT (DS)
DOWNSTREAM_b6e2e23b-1056-42be-b9aa-237690aed570_
20200924_100020_826.jpg, 00:06:56, 382.02ft
Tap Break-in Activity at 2 o'clock, dia/height: 8inch / PRIVATE
FROM INTAKE TO SOUTH

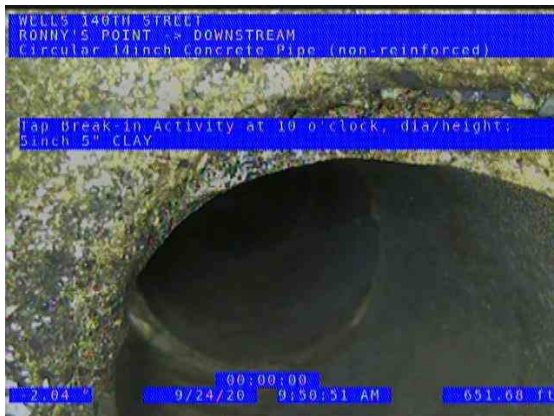
RONNY'S POINT (DS)
DOWNSTREAM_17c21c9d-e368-4a52-931d-e44d33640a13_
20200924_101309_203.jpg, 00:15:30, 651.68ft
Tap Break-in Activity at 10 o'clock, dia/height: 5inch / 5" CLAY

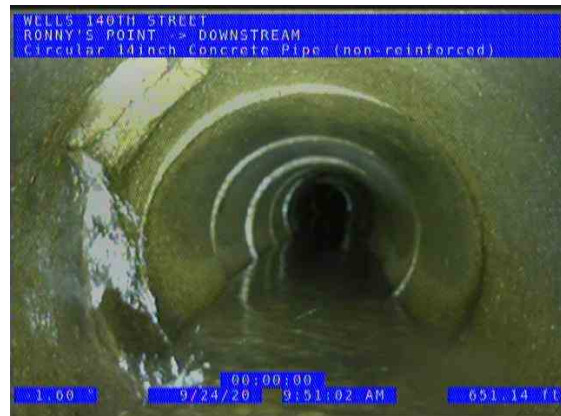
RONNY'S POINT (DS)
DOWNSTREAM_6f94e5b0-7713-420b-84cb-a15ea3dd3c85_2
0200924_101320_685.jpg, 00:15:30, 651.68ft
Tap Break-in Activity at 10 o'clock, dia/height: 5inch / 5" CLAY

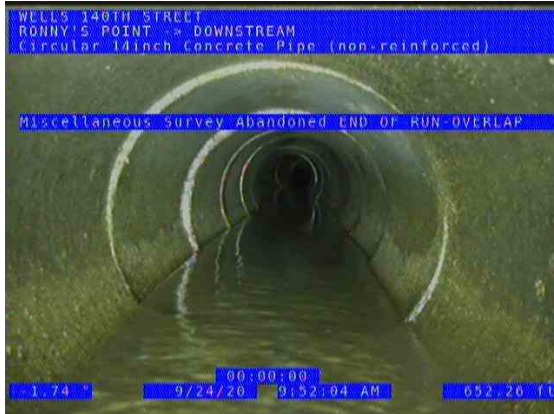
RONNY'S POINT (DS)
DOWNSTREAM_81c01547-7a8c-458c-b6f3-e615263fc8ce_2
0200924_101422_149.jpg, 00:15:54, 652.26ft
Miscellaneous Survey Abandoned / END OF RUN-OVERLAP

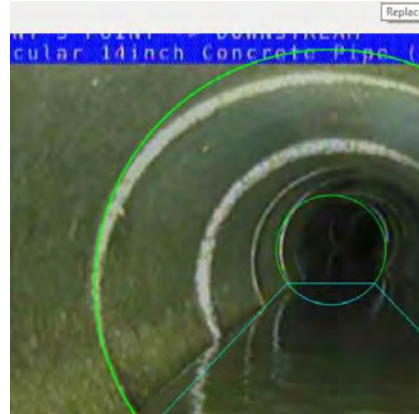
RONNY'S POINT (DS)
DOWNSTREAM_98547b51-e8ec-47a2-a904-ba8919e76957_
20200924_101338_273.jpg, 00:15:49, 652.26ft
Water Level, 20% of the vertical dimension / DEPTH 8' 9"

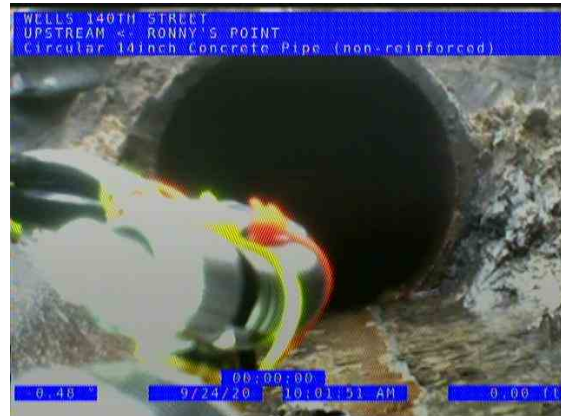
RONNY'S POINT (US)
UPSTREAM_4f10dee5-0c9a-42a0-95aa-606b32b0f837_2020
0924_102409_584.jpg, 00:00:05, 0.00ft
Manhole / RONNY'S POINT

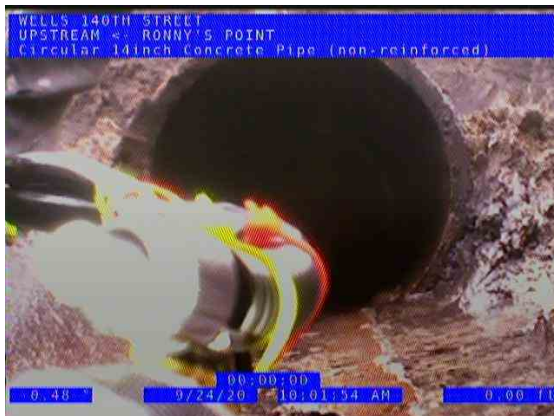
RONNY'S POINT (US)
UPSTREAM_38ab2809-13b2-4a3a-a765-8bb9ad416c29_202
00924_102412_104.jpg, 00:00:07, 0.00ft
Water Level, 5% of the vertical dimension

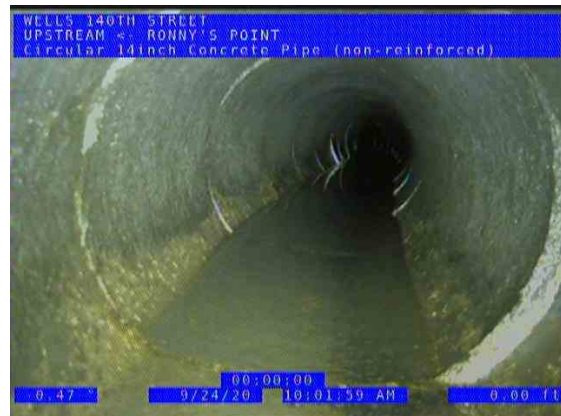
RONNY'S POINT (US)
UPSTREAM_fcb3e791-adb1-481f-b8da-6ae5d68040c6_2020
0924_102417_239.jpg, 00:00:07, 0.00ft
Water Level, 5% of the vertical dimension

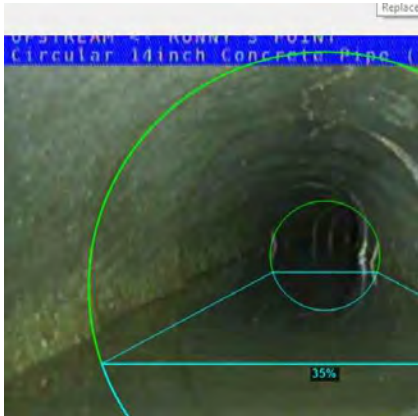
RONNY'S POINT (US)
UPSTREAM_3e84878b-1f19-4574-a767-dce9ee0e9c32_2020
0924_102525_487.jpg, 00:01:27, 27.18ft
Water Level, 35% of the vertical dimension

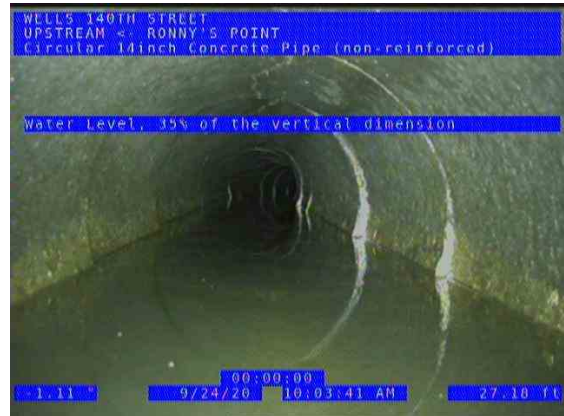
RONNY'S POINT (US)
UPSTREAM_c44aad47-09bf-4aa0-a196-fe6b5fd4003b_20200
924_102559_853.jpg, 00:01:27, 27.18ft
Water Level, 35% of the vertical dimension

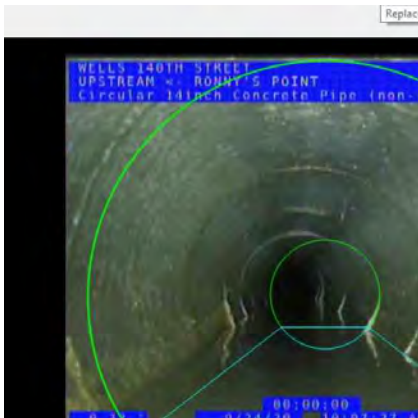
RONNY'S POINT (US)
UPSTREAM_5e890a27-9c69-4290-969b-3739b59a44eb_202
00924_102945_662.jpg, 00:05:09, 100.24ft
Water Level, 20% of the vertical dimension / DEPTH 7' 5"

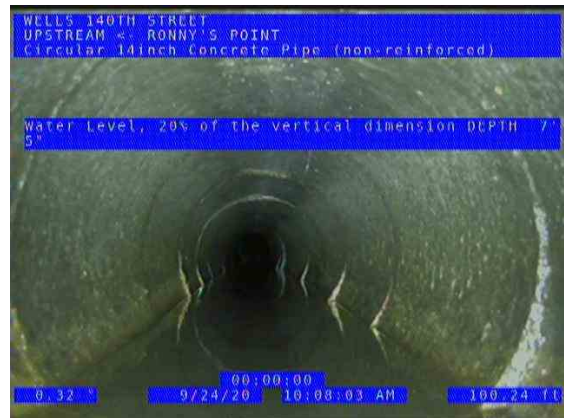
RONNY'S POINT (US)
UPSTREAM_9425705f-d2ae-4d64-bcb2-1022bf8bfe16_20200
924_103021_693.jpg, 00:05:09, 100.24ft
Water Level, 20% of the vertical dimension / DEPTH 7' 5"

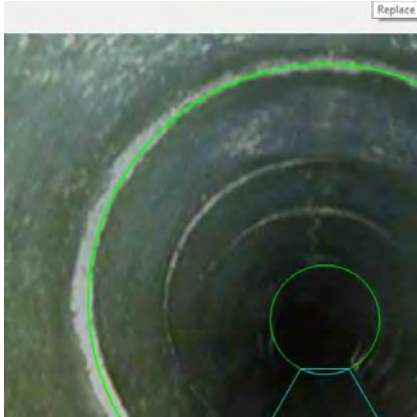
RONNY'S POINT (US)
UPSTREAM_71b192e9-1c9f-437a-9024-d9fda2622007_2020
0924_103134_505.jpg, 00:06:20, 165.25ft
Water Level, 5% of the vertical dimension / DEPTH 6' 6"

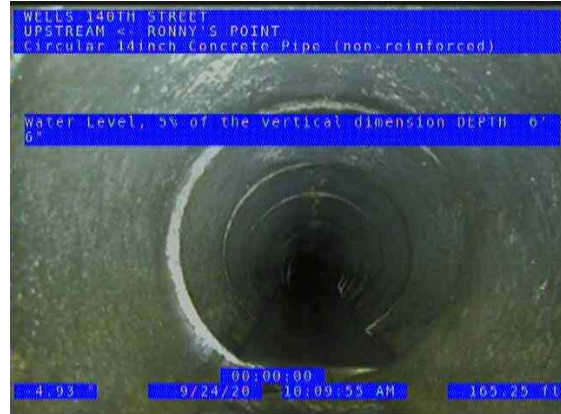
RONNY'S POINT (US)
UPSTREAM_9bcee977-fada-4dd3-94db-8d8cf2e44f8f_2020
924_103214_010.jpg, 00:06:20, 165.25ft
Water Level, 5% of the vertical dimension / DEPTH 6' 6"

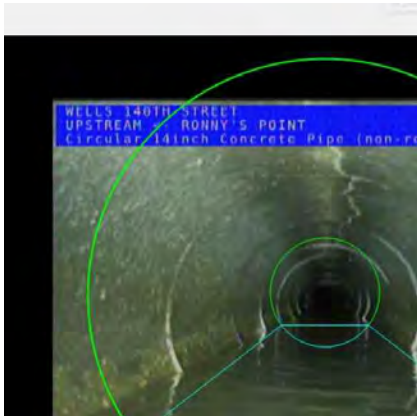
RONNY'S POINT (US)
UPSTREAM_399ced17-e592-45b3-97ae-8b0b08561528_202
00924_103250_611.jpg, 00:06:54, 199.62ft
Water Level, 20% of the vertical dimension / DEPTH 6' 7"

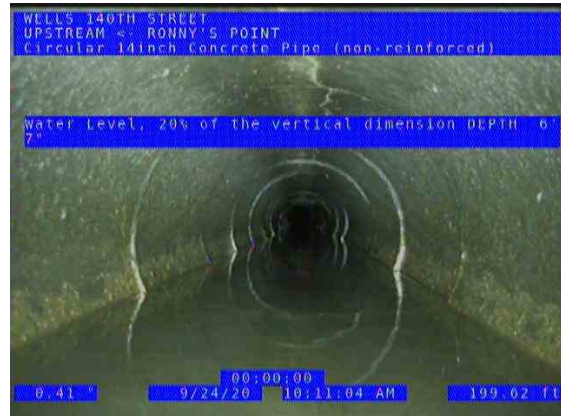
RONNY'S POINT (US)
UPSTREAM_21c49a0a-b7d8-4f46-8a9f-84ab6851bb36_202
0924_103322_949.jpg, 00:06:54, 199.62ft
Water Level, 20% of the vertical dimension / DEPTH 6' 7"

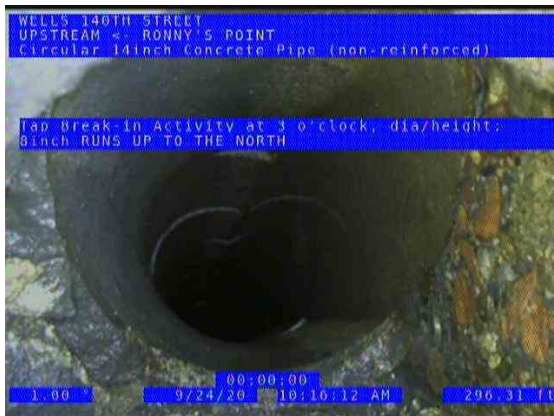
289.3	B	Broken at 12 o'clock / START OF BROKEN TILE DEPTH 5' 9"	00:09:24	RONNY'S POINT (US)	S4
	296.3	TBA	Tap Break-in Activity at 3 o'clock, dia/height: 8inch / RUNS UP TO THE NORTH	00:10:02	RONNY'S POINT (US)

RONNY'S POINT (US)
UPSTREAM_c9ad6c2b-abba-43d6-8f98-f6687e889642_2020
0924_103831_240.jpg, 00:10:02, 296.31ft
Tap Break-in Activity at 3 o'clock, dia/height: 8inch / RUNS UP TO THE NORTH

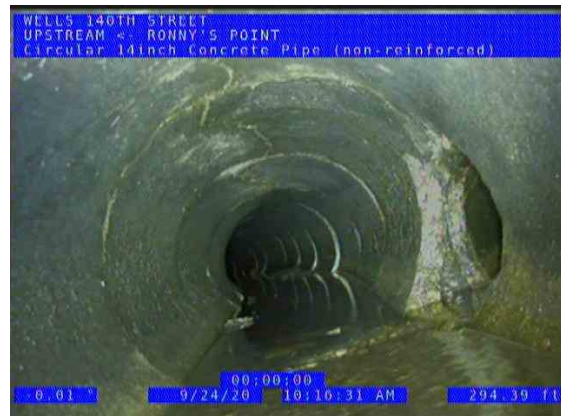
RONNY'S POINT (US)
UPSTREAM_c8a3e2e7-f3c8-41d9-af15-b246e8f881b5_20200
924_103849_134.jpg, 00:10:02, 296.31ft
Tap Break-in Activity at 3 o'clock, dia/height: 8inch / RUNS UP TO THE NORTH

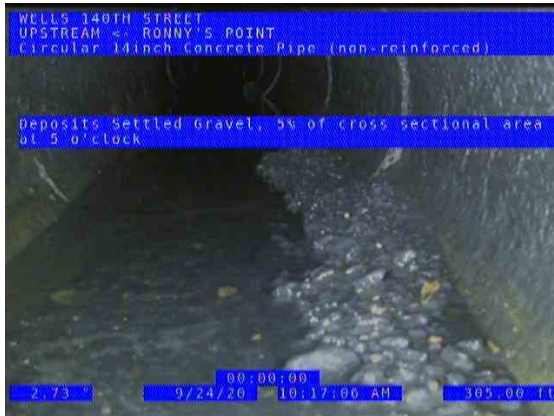
RONNY'S POINT (US)
UPSTREAM_1df92873-2d35-4379-af25-858b25836c2d_2020
0924_103923_835.jpg, 00:10:45, 305.00ft
Deposits Settled Gravel, 5% of cross sectional area
at 5 o'clock

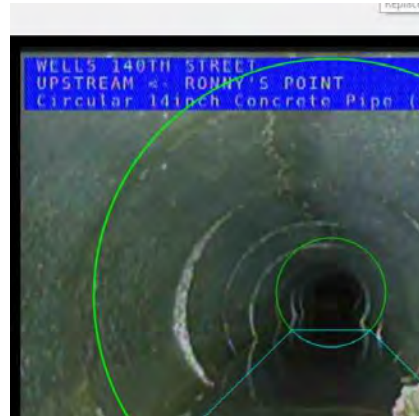
RONNY'S POINT (US)
UPSTREAM_0124fd27-80ba-4df0-9130-53837ef63d06_20200
924_103950_067.jpg, 00:11:08, 310.76ft
Water Level, 15% of the vertical dimension / DEPTH 5' 5" 7"

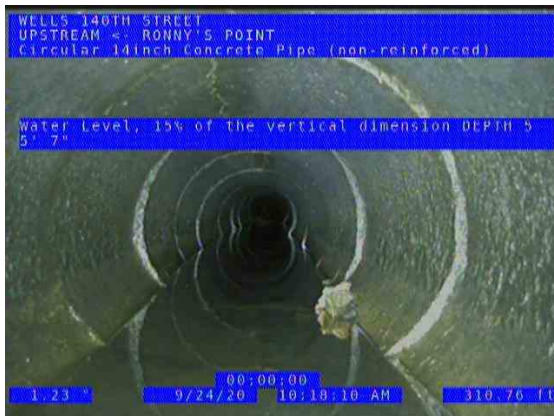
RONNY'S POINT (US)
UPSTREAM_5205a8e1-407b-4426-a342-61df361cbd41_2020
0924_104028_489.jpg, 00:11:08, 310.76ft
Water Level, 15% of the vertical dimension / DEPTH 5' 5" 7"

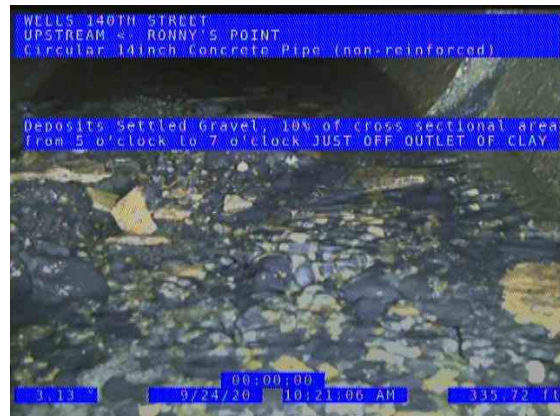
RONNY'S POINT (US)
UPSTREAM_fa0b7912-a67b-4285-a6a3-2cd3f7516eb5_2020
0924_104324_336.jpg, 00:12:49, 335.72ft
Deposits Settled Gravel, 10% of cross sectional area from 5
o'clock to 7 o'clock / JUST OFF OUTLET OF CLAY

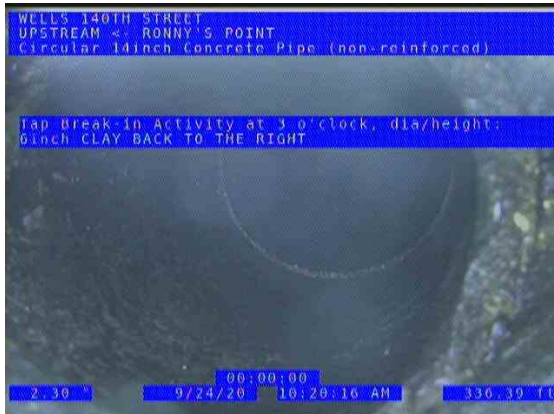
RONNY'S POINT (US)
UPSTREAM_25a97eac-e7c5-498a-b782-ec34f1a1fbfa_20200924_104234_763.jpg, 00:12:16, 336.39ft
Tap Break-in Activity at 3 o'clock, dia/height: 6inch / CLAY BACK TO THE RIGHT

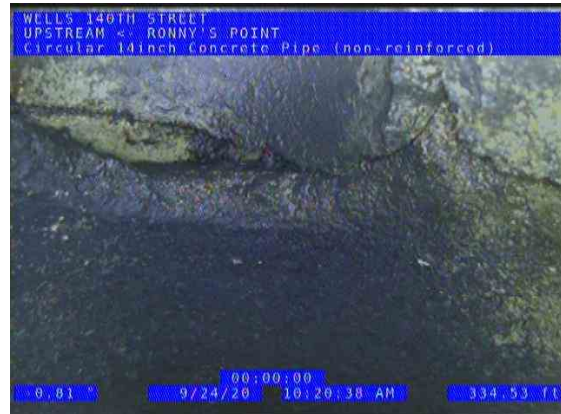
RONNY'S POINT (US)
UPSTREAM_1f801f72-8a5b-4421-b018-c4ccc3c00d65_20200924_104256_049.jpg, 00:12:16, 336.39ft
Tap Break-in Activity at 3 o'clock, dia/height: 6inch / CLAY BACK TO THE RIGHT
