REESTABLISHMENT OF RECORDS JCD 301-HUEPER BRANCH

Faribault County, Minnesota

Date: November 19, 2020

ISG Project No.: 17-20487

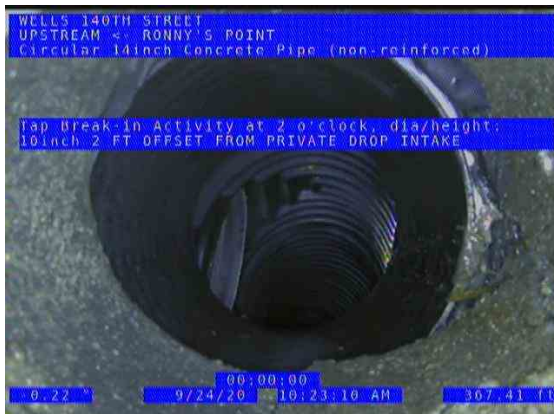
RONNY'S POINT (US)
UPSTREAM_b2c5559d-1751-4e12-a06b-f65eda491a81_20200924_104528_821.jpg, 00:14:03, 367.41ft
Tap Break-in Activity at 2 o'clock, dia/height: 10inch / 2 FT OFFSET FROM PRIVATE DROP INTAKE

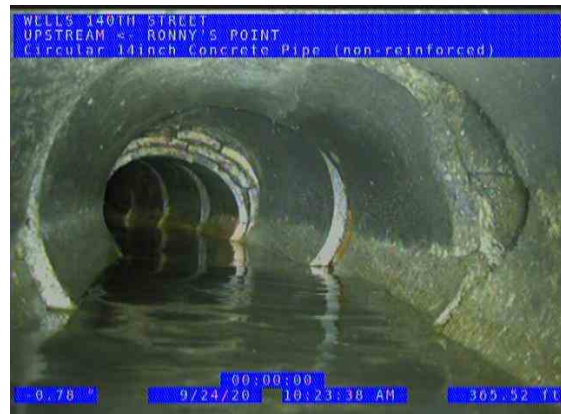
RONNY'S POINT (US)
UPSTREAM_1a5df952-1228-47c1-89f2-3fd578278d69_20200924_104556_546.jpg, 00:14:03, 367.41ft
Tap Break-in Activity at 2 o'clock, dia/height: 10inch / 2 FT OFFSET FROM PRIVATE DROP INTAKE

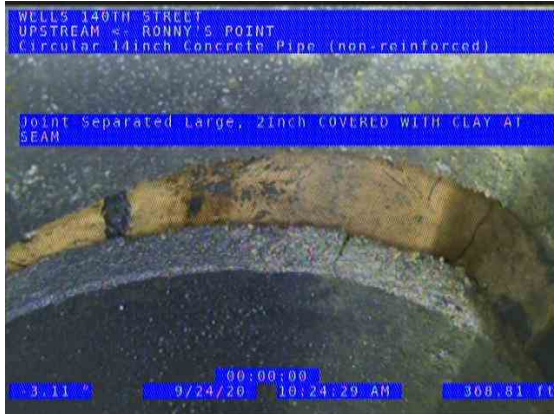
RONNY'S POINT (US)
UPSTREAM_bb63fa9a-0620-4617-a6c9-6abe49611074_2020
0924_104647_593.jpg, 00:15:01, 368.81ft
Joint Separated Large, 2Inch / COVERED WITH CLAY AT
SEAM

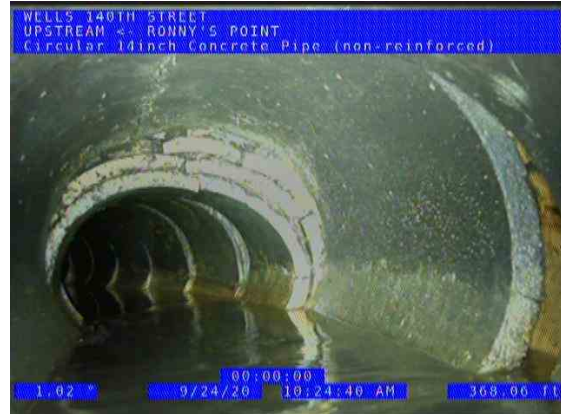
RONNY'S POINT (US)
UPSTREAM_bde5e63e-16d8-4939-ad0f-a879f5b9c353_2020
0924_104658_501.jpg, 00:15:01, 368.81ft
Joint Separated Large, 2Inch / COVERED WITH CLAY AT
SEAM

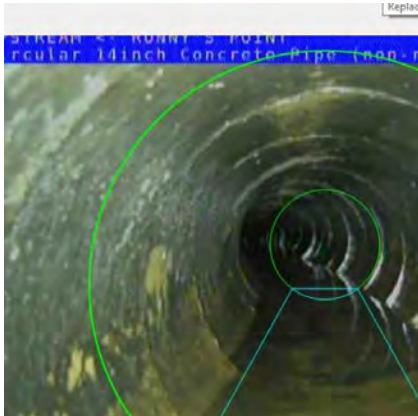
RONNY'S POINT (US)
UPSTREAM_9e395046-a00c-4bdf-84c0-6fe072be308c_2020
0924_104911_155.jpg, 00:16:59, 399.15ft
Water Level, 10% of the vertical dimension / DEPTH 5' 8"

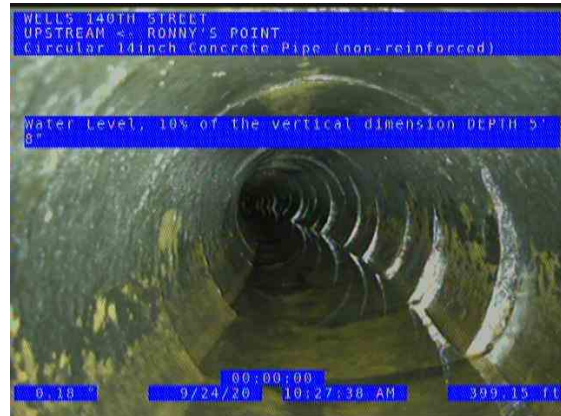
RONNY'S POINT (US)
UPSTREAM_2646cc8a-245a-49a2-86ee-10bea5eb9939_202
00924_104956_869.jpg, 00:16:59, 399.15ft
Water Level, 10% of the vertical dimension / DEPTH 5' 8"

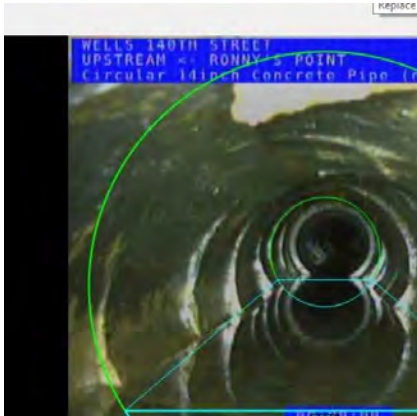
RONNY'S POINT (US)
UPSTREAM_666f0ac7-93ba-4e0b-bf1a-f62f463c566e_20200924_105219_434.jpg, 00:18:56, 427.49ft
Water Level, 25% of the vertical dimension

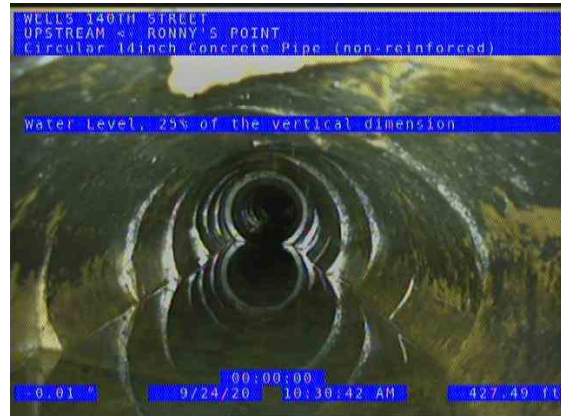
RONNY'S POINT (US)
UPSTREAM_4432ea83-3f4d-4f93-a2b6-87c6aa2c97cc_20200924_105300_997.jpg, 00:18:56, 427.49ft
Water Level, 25% of the vertical dimension

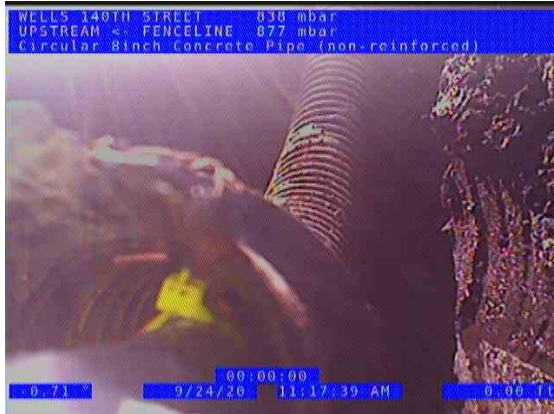
FENCELINE POINT (US)
UPSTREAM_c1dbd586-bae8-4492-9151-c3cdef1d84dd_2020
0924_113958_208.jpg, 00:00:02, 0.00ft
Manhole / FENCELINE POINT

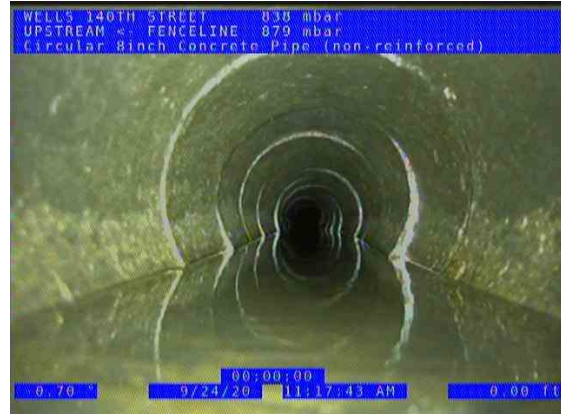
FENCELINE POINT (US)
UPSTREAM_651a4237-19ae-475e-8fbb-b7fafccdefc0_20200
924_114002_905.jpg, 00:00:02, 0.00ft
Manhole / FENCELINE POINT

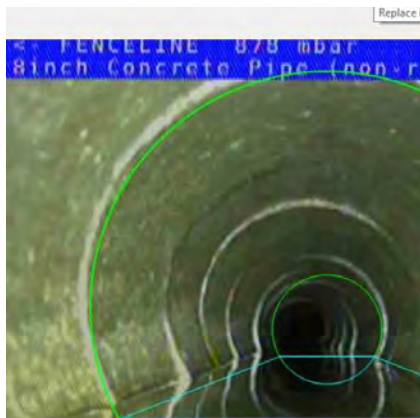
FENCELINE POINT (US)
UPSTREAM_73d56c79-e184-48cb-be7c-f95b3025b429_2020
0924_114009_492.jpg, 00:00:20, 0.00ft
Water Level, 25% of the vertical dimension

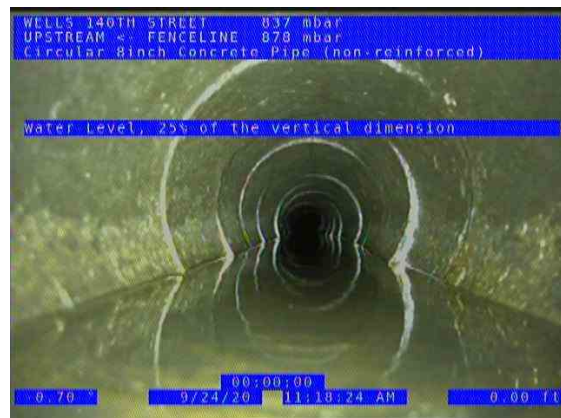
FENCELINE POINT (US)
UPSTREAM_1dcac2ab-b491-4ccc-9483-22c4efc65ee1_2020
0924_114043_359.jpg, 00:00:20, 0.00ft
Water Level, 25% of the vertical dimension

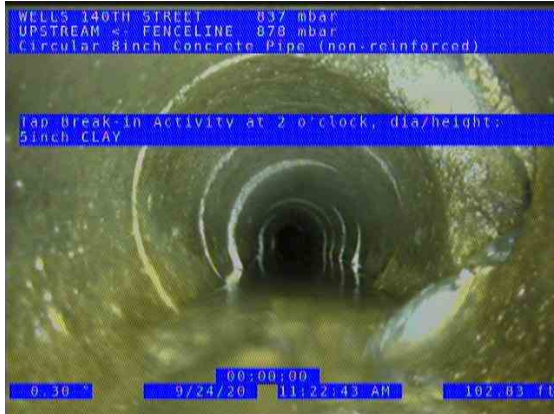
102.8	TBA	Tap Break-in Activity at 2 o'clock, dia/height: 5inch / CEMENT	00:03:47	FENCELIN E POINT (US)	
	103.9	MWL	Water Level, 15% of the vertical dimension / DEPTH 5' 8"	00:03:36	FENCELIN E POINT (US)

FENCELINE POINT (US)
UPSTREAM_bd06800b-a3b2-49c1-b621-314e4227e21f_2020
0924_114502_201.jpg, 00:03:47, 102.83ft
Tap Break-in Activity at 2 o'clock, dia/height: 5inch / CEMENT

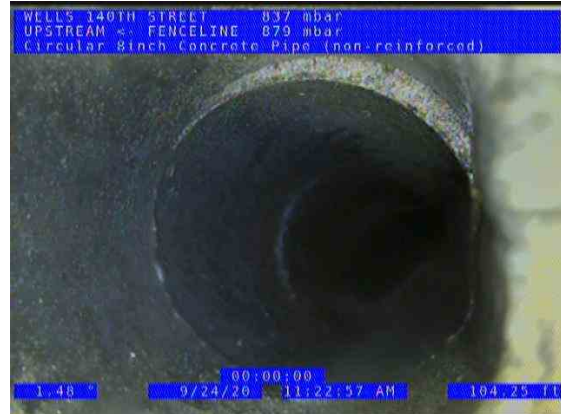
FENCELINE POINT (US)
UPSTREAM_cd41253a-83c5-4676-bb6e-82c7940ec7f4_2020
0924_114516_747.jpg, 00:03:47, 102.83ft
Tap Break-in Activity at 2 o'clock, dia/height: 5inch / CEMENT

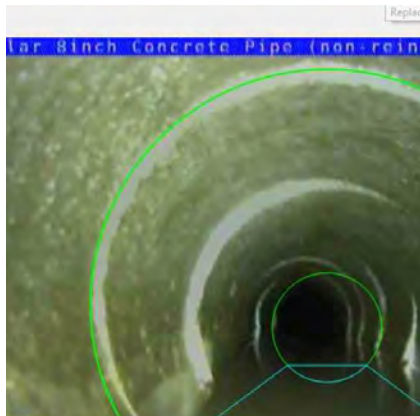
FENCELINE POINT (US)
UPSTREAM_ed6b9700-3d4c-4b75-9dd6-d65c4009ec2f_2020
0924_114412_262.jpg, 00:03:36, 103.94ft
Water Level, 15% of the vertical dimension / DEPTH 5' 8"

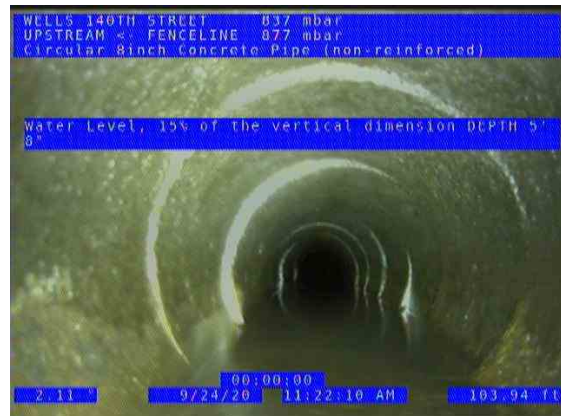
FENCELINE POINT (US)
UPSTREAM_750ce619-4ff4-47f7-b6a3-eabacdbfeec3_20200
924_114429_321.jpg, 00:03:36, 103.94ft
Water Level, 15% of the vertical dimension / DEPTH 5' 8"

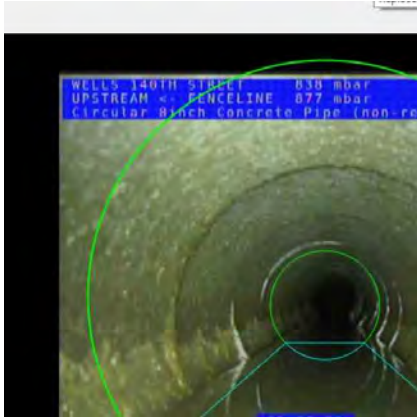
FENCELINE POINT (US)
UPSTREAM_76d393c1-c690-4a58-b422-edfbbdb328a1_2020
0924_114725_438.jpg, 00:06:06, 200.46ft
Water Level, 15% of the vertical dimension / DEPTH 7" 1"

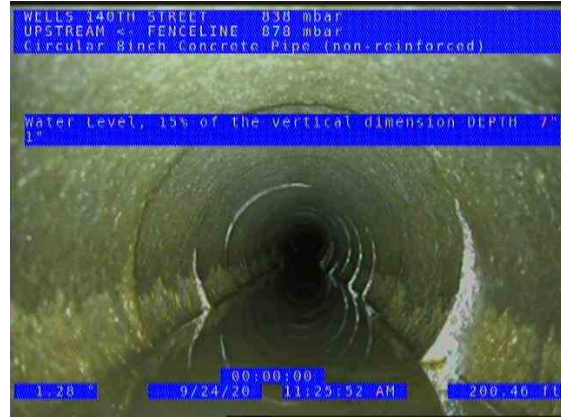
FENCELINE POINT (US)
UPSTREAM_75c6ef38-44ed-4421-a65c-ed163a308056_2020
0924_114811_441.jpg, 00:06:06, 200.46ft
Water Level, 15% of the vertical dimension / DEPTH 7" 1"

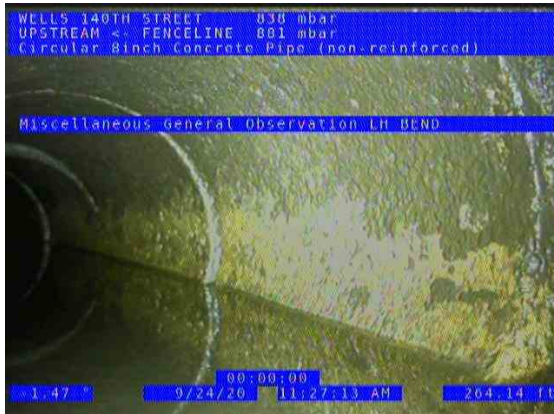
FENCELINE POINT (US)
UPSTREAM_5cc3dc3c-849b-4201-92ed-bcc711c71ec7_2020
0924_114933_185.jpg, 00:07:15, 264.14ft
Miscellaneous General Observation / LH BEND DEPTH 7' 5"

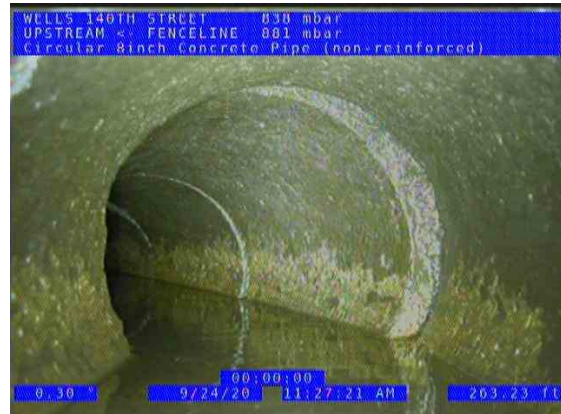
FENCELINE POINT (US)
UPSTREAM_c6b030dd-a1bf-4760-a5f3-7ef85b69e781_2020
924_114941_752.jpg, 00:07:15, 264.14ft
Miscellaneous General Observation / LH BEND DEPTH 7' 5"

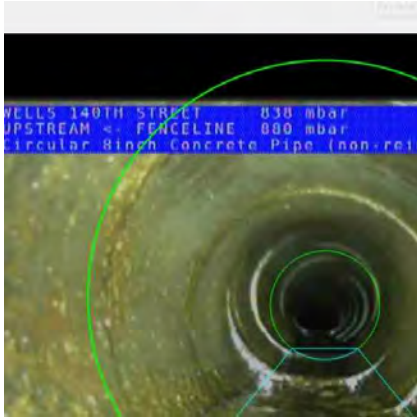
FENCELINE POINT (US)
UPSTREAM_16706eee-b8b1-4b11-bf42-a256eef4e605_2020
0924_115108_196.jpg, 00:08:47, 306.46ft
Water Level, 10% of the vertical dimension / DEPTH 8' 3 "

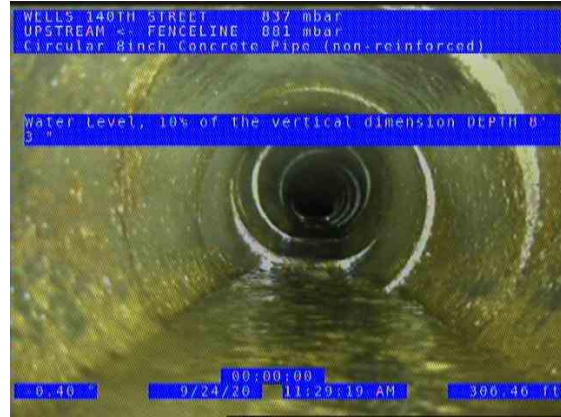
FENCELINE POINT (US)
UPSTREAM_caf3f41d-e45d-4b4b-8a15-2331daf04ce6_2020
924_115139_245.jpg, 00:08:47, 306.46ft
Water Level, 10% of the vertical dimension / DEPTH 8' 3 "

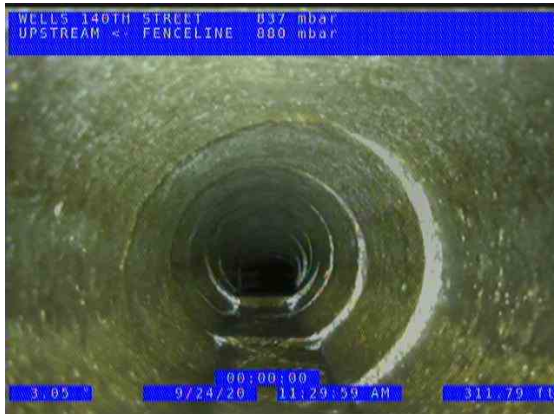
FENCELINE POINT (US)
UPSTREAM_46529899-ff49-47cc-bd4d-410136e5981c_2020
0924_115218_848.jpg, 00:09:00, 311.79ft
Water Level, 5% of the vertical dimension / HUMP IN PIPE

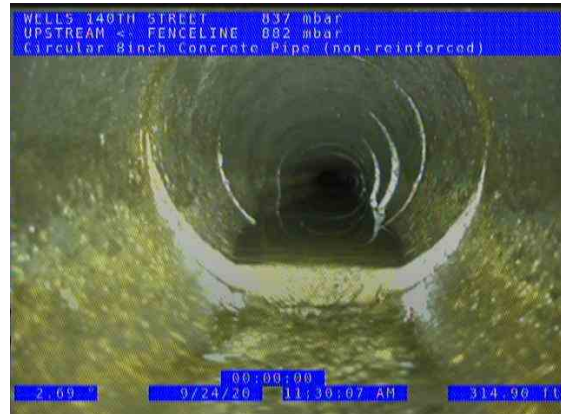
FENCELINE POINT (US)
UPSTREAM_d19612e0-6dd7-4217-826c-3bd70d86f5e1_2020
0924_115226_949.jpg, 00:09:00, 311.79ft
Water Level, 5% of the vertical dimension / HUMP IN PIPE

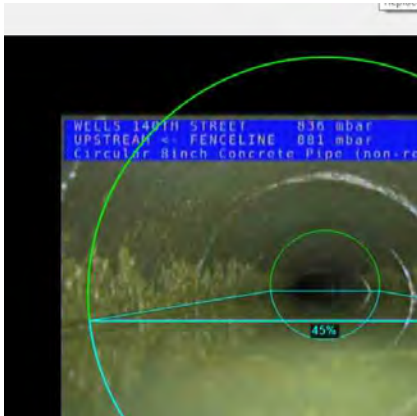
FENCELINE POINT (US)
UPSTREAM_e1205acf-2fbc-4fef-9ce6-5cf5a28f9540_20200924_115301_673.jpg, 00:09:34, 320.65ft
Miscellaneous Water Level, Sag, 45% of the vertical dimension / UPSTREAM FROM A LARGE HUMPS

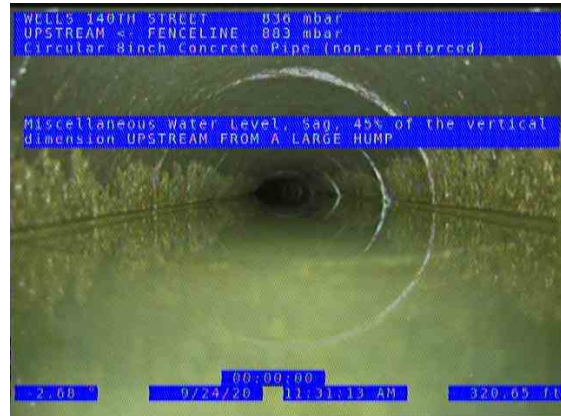
FENCELINE POINT (US)
UPSTREAM_ccd425f4-2265-4a7f-b251-49792cea78a8_20200924_115332_828.jpg, 00:09:34, 320.65ft
Miscellaneous Water Level, Sag, 45% of the vertical dimension / UPSTREAM FROM A LARGE HUMPS

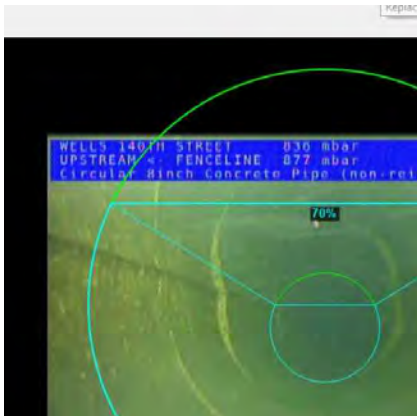
FENCELINE POINT (US)
UPSTREAM_6959f7ad-d023-47e0-b298-b14d59eabdd_20200924_115520_398.jpg, 00:11:04, 400.51ft
Water Level, 70% of the vertical dimension / DEPTH 10'

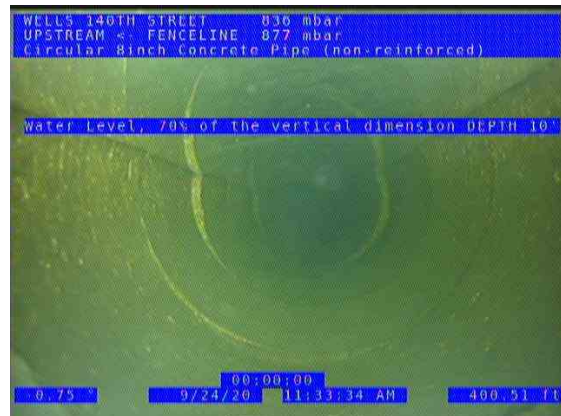
FENCELINE POINT (US)
UPSTREAM_d1661635-ae2c-4e8b-931e-0a02994c9979_20200924_115554_309.jpg, 00:11:04, 400.51ft
Water Level, 70% of the vertical dimension / DEPTH 10'

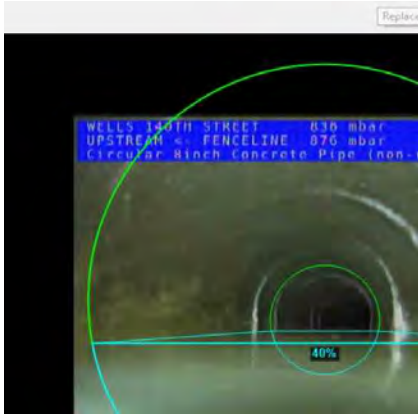
FENCELINE POINT (US)
UPSTREAM_526d18d5-8dc1-4079-b23d-1f06cae820e5_2020
0924_115753_719.jpg, 00:13:01, 501.15ft
Water Level, 40% of the vertical dimension / DEPTH 8' 10"

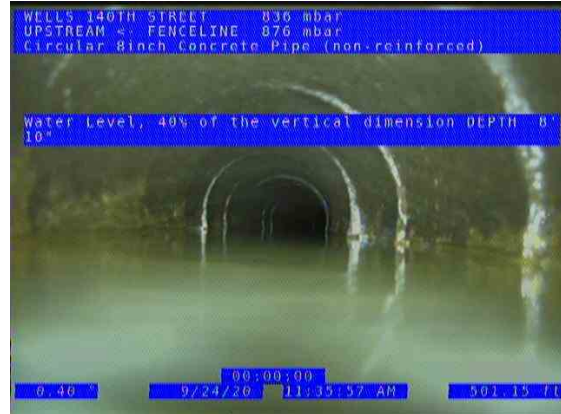
FENCELINE POINT (US)
UPSTREAM_6821c268-038e-417e-9a25-d38b031e7b0e_202
00924_115816_223.jpg, 00:13:01, 501.15ft
Water Level, 40% of the vertical dimension / DEPTH 8' 10"

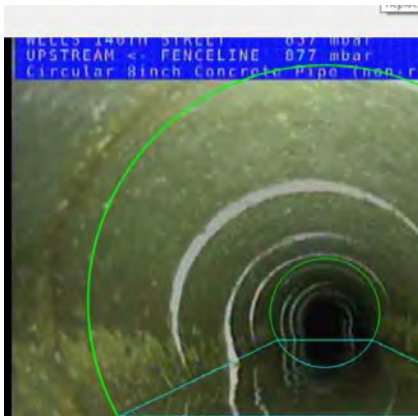
FENCELINE POINT (US)
UPSTREAM_7de2b54c-62cd-40f2-afd8-afac93c8a69e_20200
924_120022_579.jpg, 00:15:05, 600.65ft
Water Level, 25% of the vertical dimension / DEPTH 8' 4"

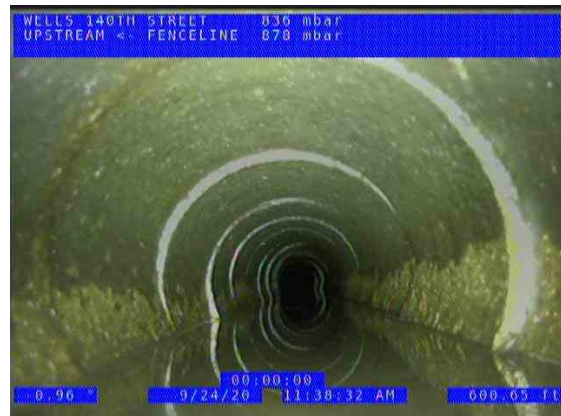
FENCELINE POINT (US)
UPSTREAM_ebcc9ad3-440b-4ae0-95de-b7817c2c3648_2020
0924_120052_495.jpg, 00:15:05, 600.65ft
Water Level, 25% of the vertical dimension / DEPTH 8' 4"

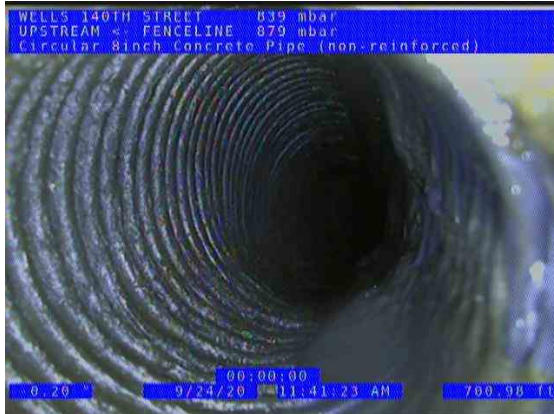
FENCELINE POINT (US)
UPSTREAM_5283c6b1-3c85-4e7c-80f1-634038d44782_2020
0924_120344_062.jpg, 00:17:23, 700.98ft
Tap Break-in Activity at 2 o'clock, dia/height: 5inch / PUT IN
2015-PRIVATE

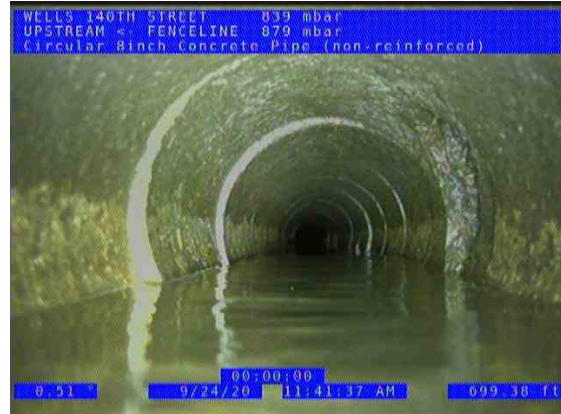
FENCELINE POINT (US)
UPSTREAM_9aef5376-e8f9-491d-b1b8-c62922ad16d3_2020
0924_120356_995.jpg, 00:17:23, 700.98ft
Tap Break-in Activity at 2 o'clock, dia/height: 5inch / PUT IN
2015-PRIVATE

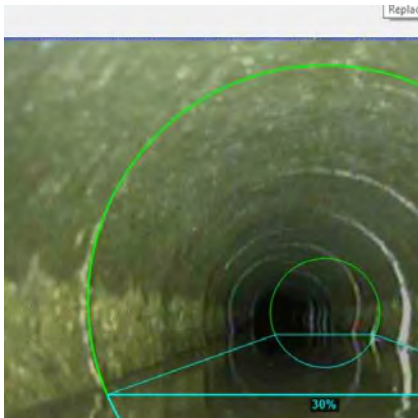
FENCELINE POINT (US)
UPSTREAM_6b851c5d-c45c-4851-a6b1-b379e17d4a5c_2020
0924_120415_265.jpg, 00:17:52, 701.16ft
Water Level, 30% of the vertical dimension / DEPTH 6' 8"

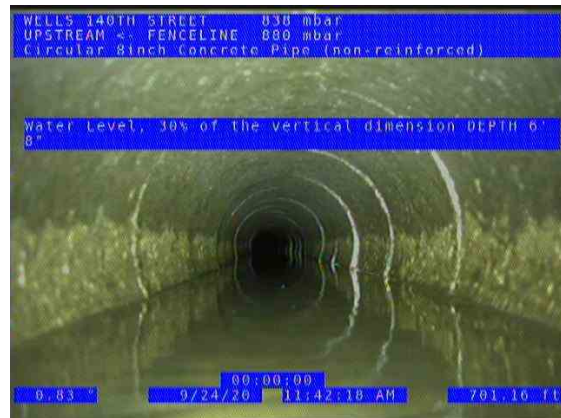
FENCELINE POINT (US)
UPSTREAM_be5c8ddc-d576-4cde-93c1-13728a6ceff7_20200
924_120437_917.jpg, 00:17:52, 701.16ft
Water Level, 30% of the vertical dimension / DEPTH 6' 8"

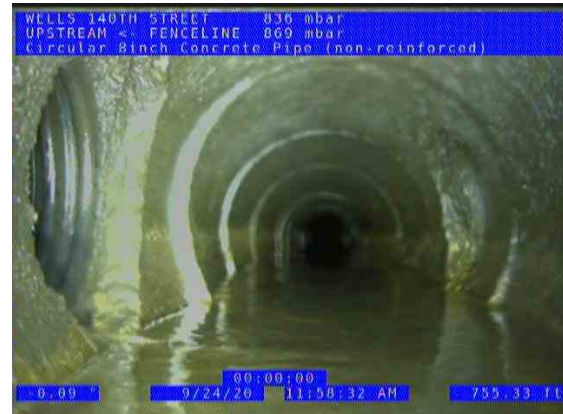
FENCELINE POINT (US)
UPSTREAM_037e6d6c-d017-4ede-b073-6a55621c08f5_2020
0924_122051_591.jpg, 00:26:06, 757.30ft
Tap Break-in Activity at 3 o'clock, dia/height: 5inch / PRIVATE

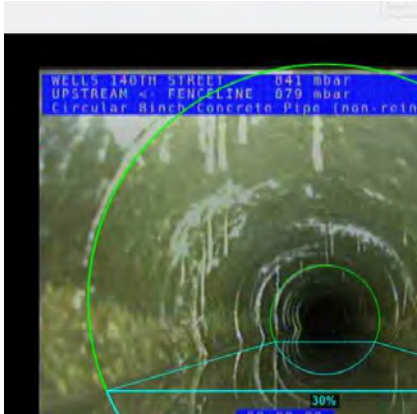
FENCELINE POINT (US)
UPSTREAM_a2819279-72f7-4f89-8429-1522c6179ea0_2020
0924_120726_904.jpg, 00:20:31, 800.47ft
Water Level, 30% of the vertical dimension / DEPTH 5' 9"

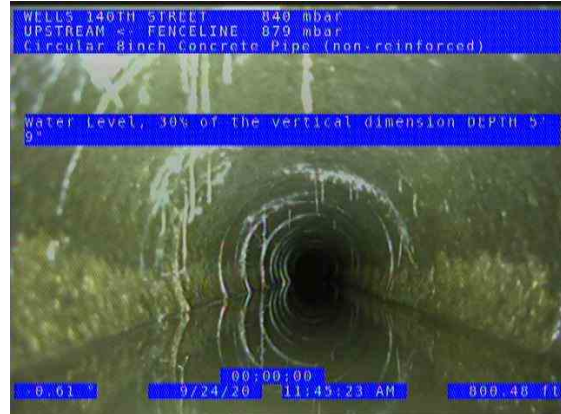
FENCELINE POINT (US)
UPSTREAM_979bc4a1-d85f-428f-b458-a797c7bcc3ad_20200
924_120743_508.jpg, 00:20:31, 800.47ft
Water Level, 30% of the vertical dimension / DEPTH 5' 9"

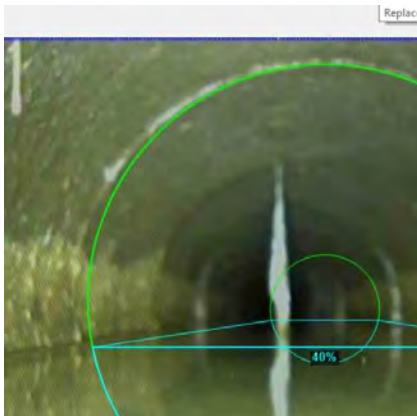
FENCELINE POINT (US)
UPSTREAM_d9dda0ad-a71a-4077-b267-19f6f7f21b3f_20200
924_121050_774.jpg, 00:23:37, 899.51ft
Water Level, 40% of the vertical dimension / DEPTH 4'

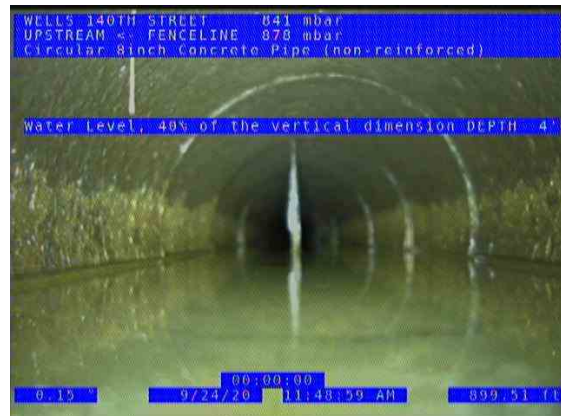
FENCELINE POINT (US)
UPSTREAM_02b59f98-1845-4bb0-87a4-fa75293ccc9e_2020
0924_121119_386.jpg, 00:23:37, 899.51ft
Water Level, 40% of the vertical dimension / DEPTH 4'

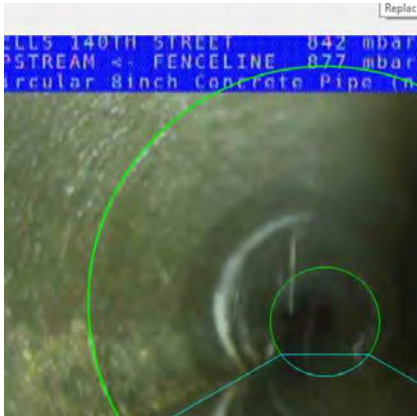
FENCELINE POINT (US)
UPSTREAM_14bafc3d-84ef-46d8-98e7-6c73e8b4929c_2020
0924_121357_384.jpg, 00:25:39, 970.39ft
Water Level, 20% of the vertical dimension / DEPTH 4" 3"

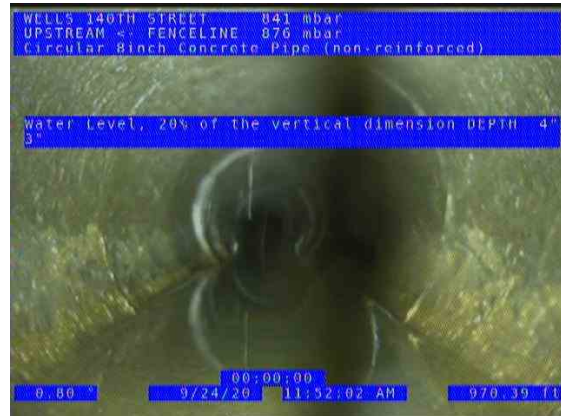
FENCELINE POINT (US)
UPSTREAM_1c3b8813-8310-422e-a5c5-394e9a241a91_202
00924_121422_197.jpg, 00:25:39, 970.39ft
Water Level, 20% of the vertical dimension / DEPTH 4" 3"

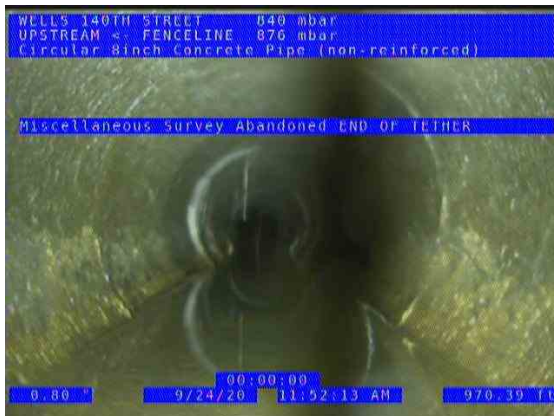
FENCELINE POINT (US)
UPSTREAM_37a94f49-c1b9-4e3d-94e2-4612c3b443be_2020
0924_121433_020.jpg, 00:25:42, 970.39ft
Miscellaneous Survey Abandoned / END OF TETHER

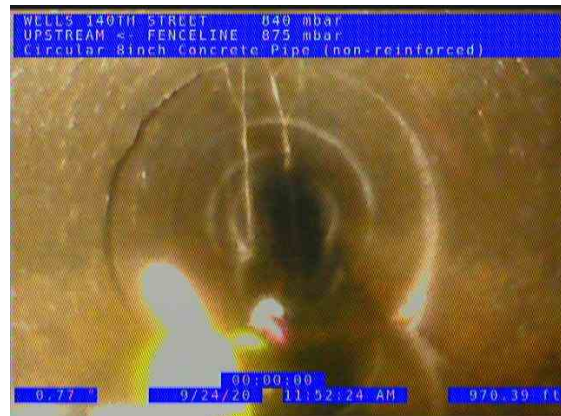
FENCELINE POINT (US)
UPSTREAM_69468ece-b8ea-48d6-aa52-e415b4f34cba_2020
0924_121444_057.jpg, 00:25:42, 970.39ft
Miscellaneous Survey Abandoned / END OF TETHER
