Faribault County, Minnesota

Judicial Ditch #19F

Staff Repair Report

October 2022

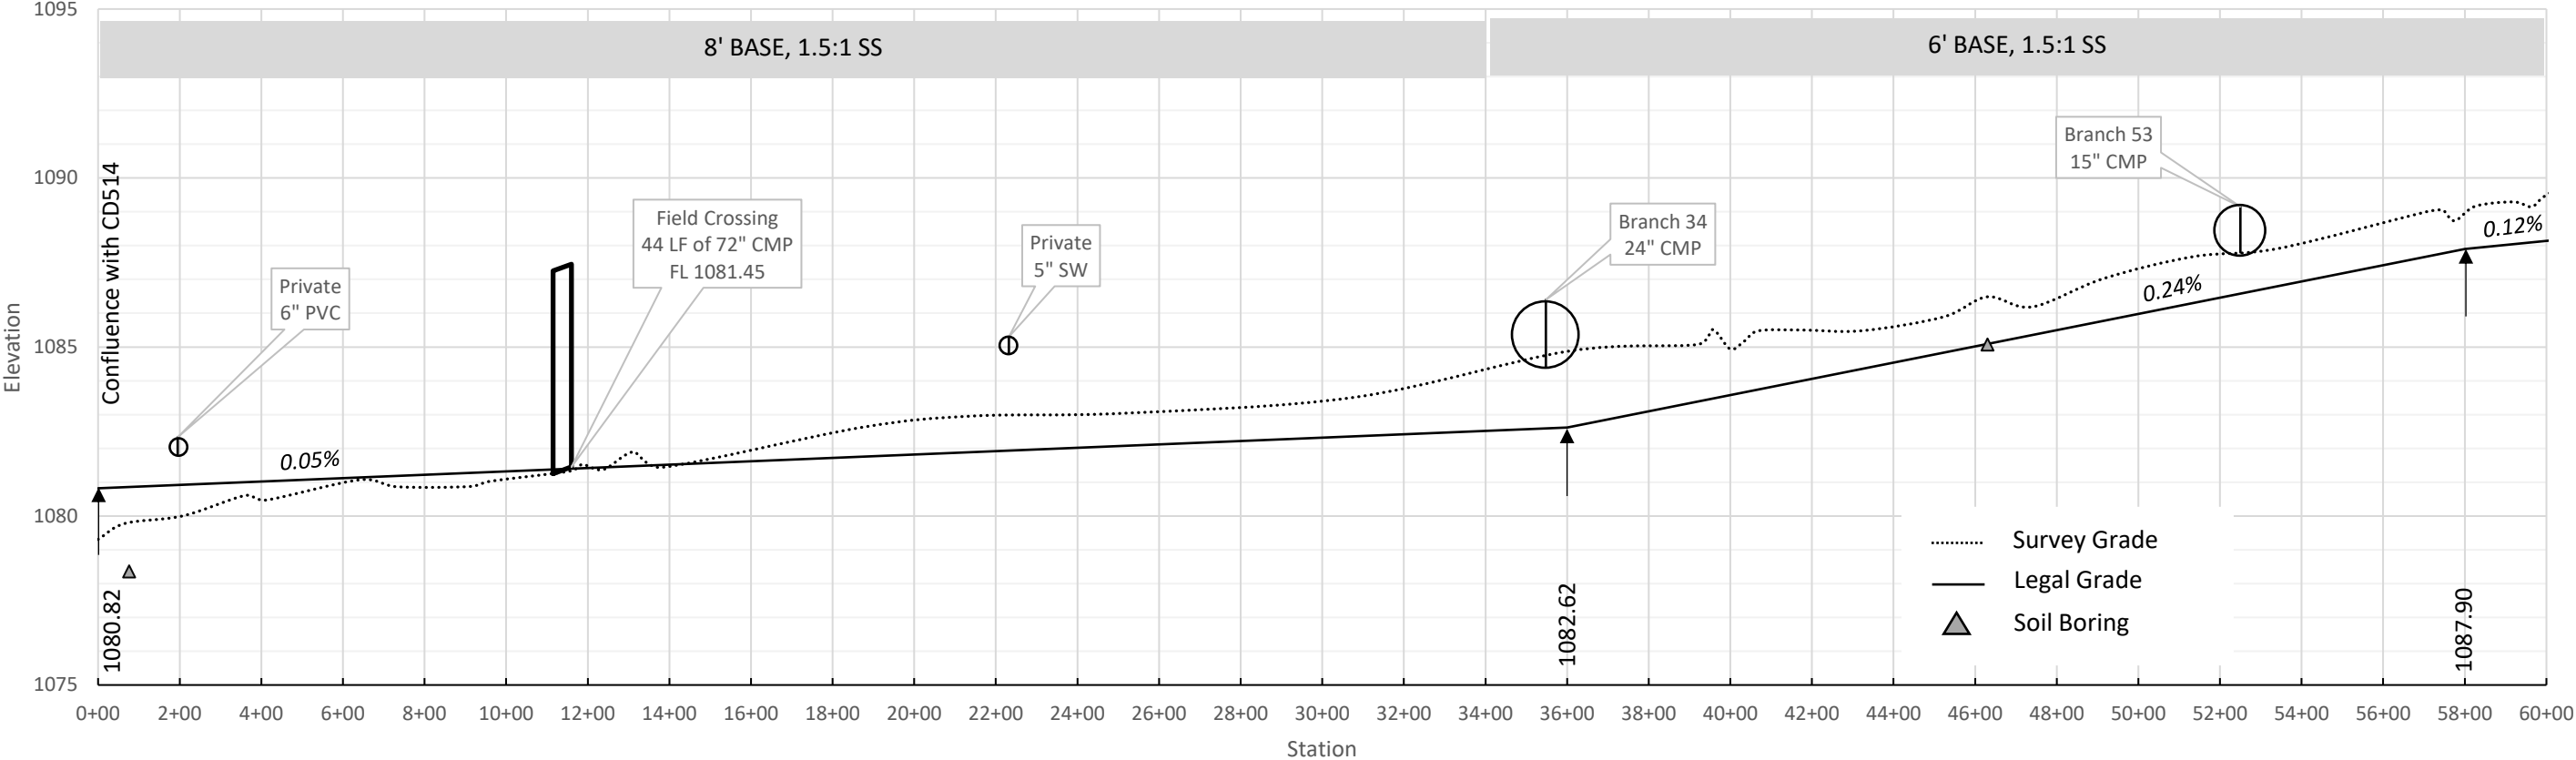
JD19F Main Open Ditch Profile

It is clear from the survey, soil, borings, and profile of the open ditch that large amounts of sediment have accumulated in the JD19F open ditch. The legal grade from the 1958 repair report provides a more accurate fit for the profile when considering soil borings and existing culvert flowline elevations. The profile from the 1963 repair report would result in multiple crossings above grade and an additional 1.5' of sediment needing to be removed from the open ditch. Even with the higher proposed repair grade, there are still locations where as much as 3 to 3.5' of sediment has accumulated in the channel.
