# REPAIR REPORT FOR:

## COUNTY DITCH NO. 24 REPAIR: FAIRBAULT COUNTY, MINNESOTA

JUNE 14, 2021

Project No. 19-23499

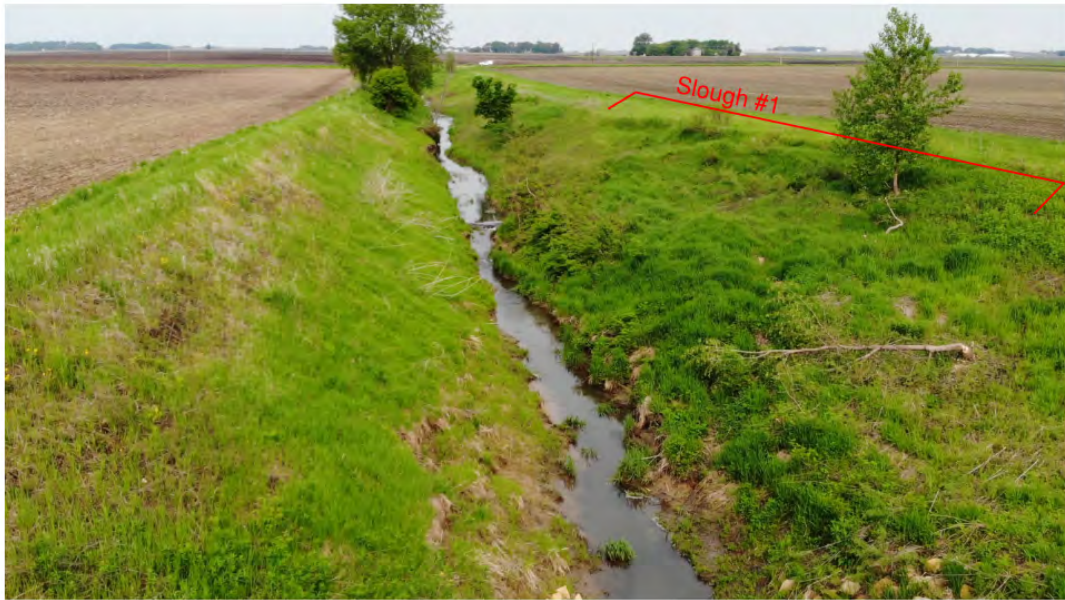
*Figure 3: Slough #1 viewing upstream*

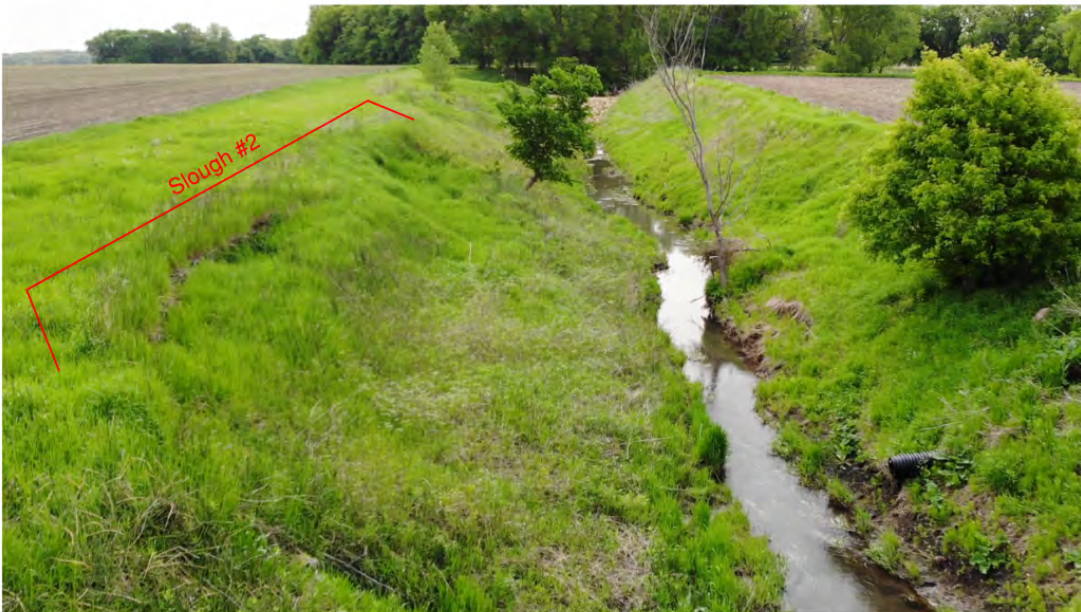
*Figure 4: Slough #2 viewing downstream*

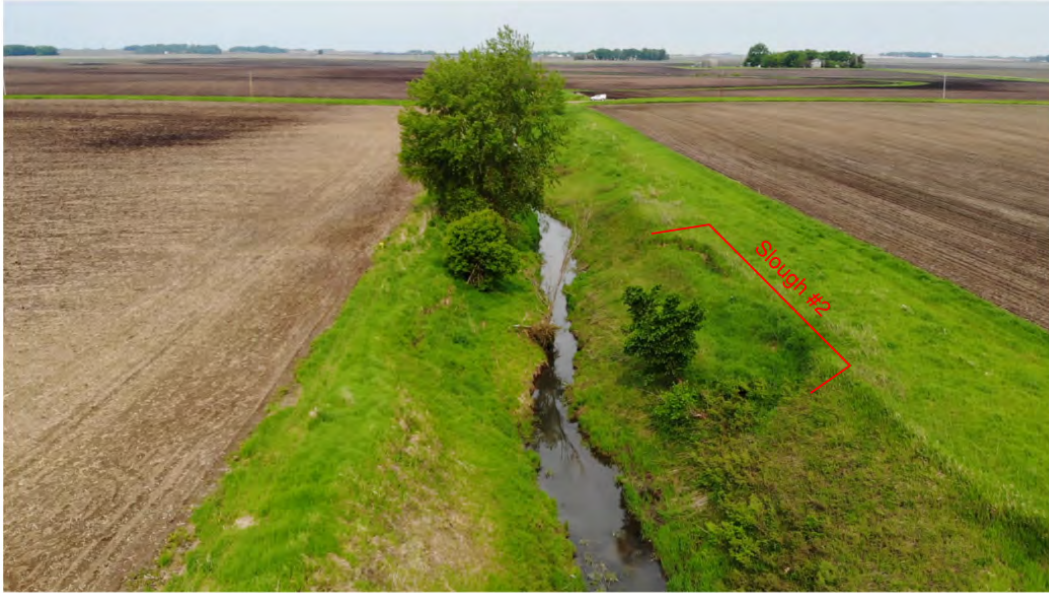
*Figure 5: Slough #2 viewing upstream*

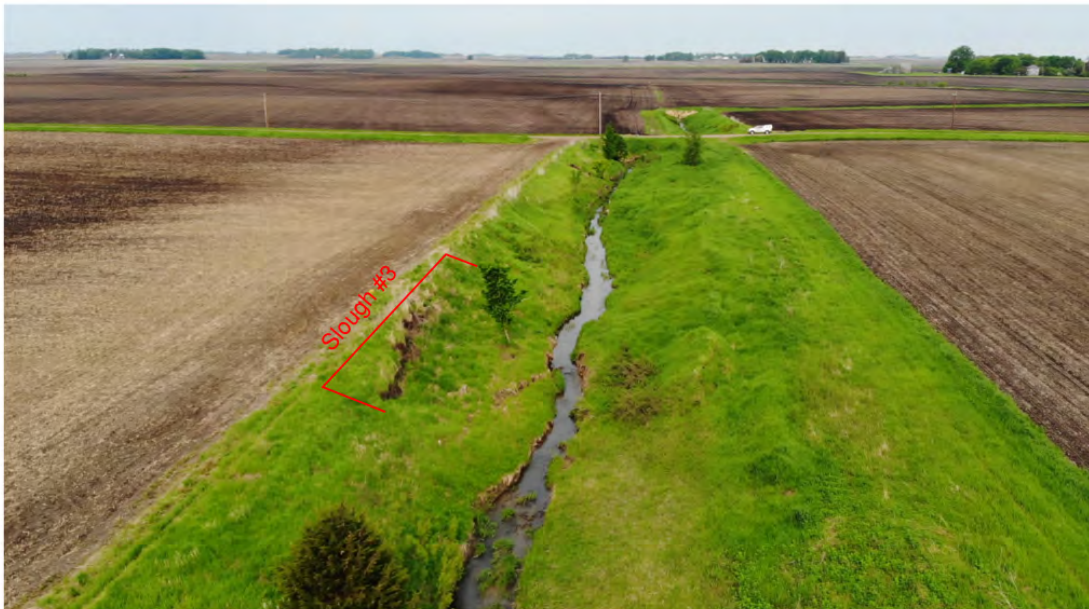
*Figure 7: Slough #3 viewing upstream*

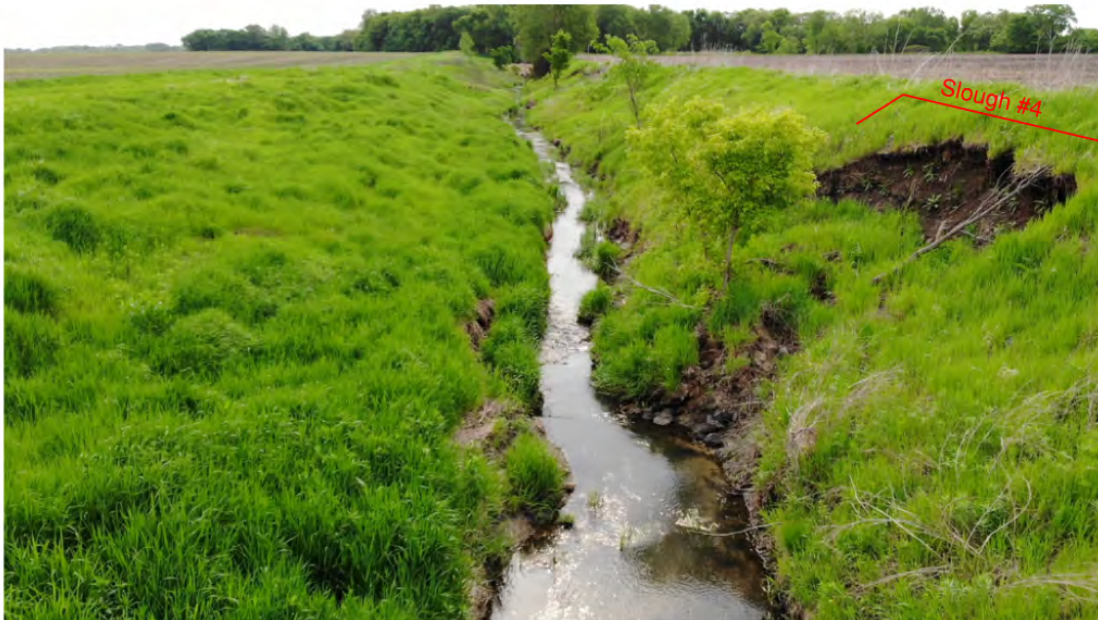
*Figure 8: Slough #4 viewing downstream*

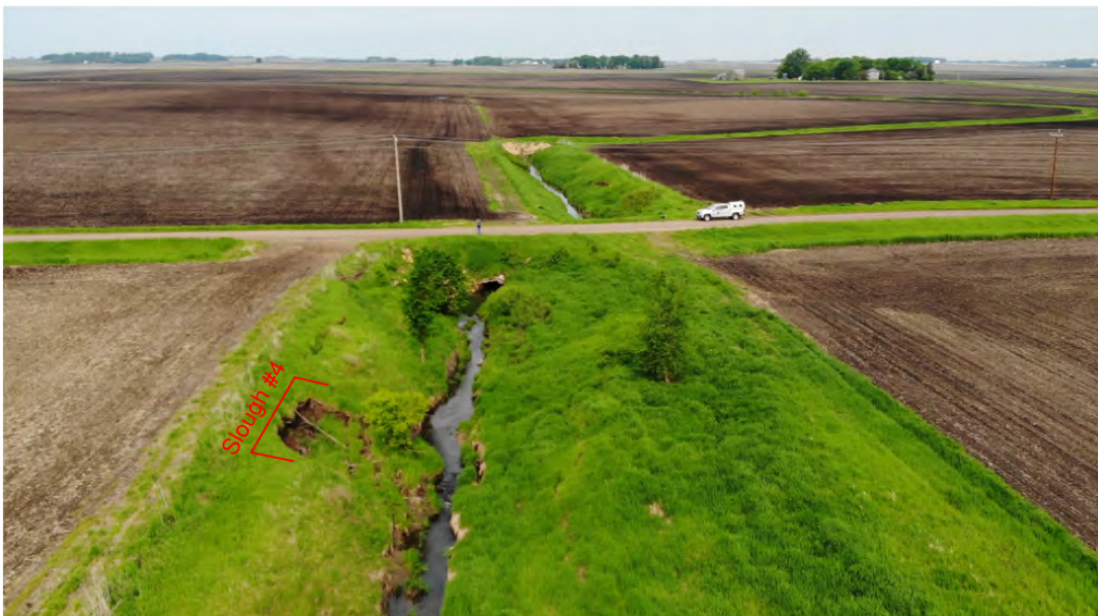
*Figure 9: Slough #4 viewing upstream*

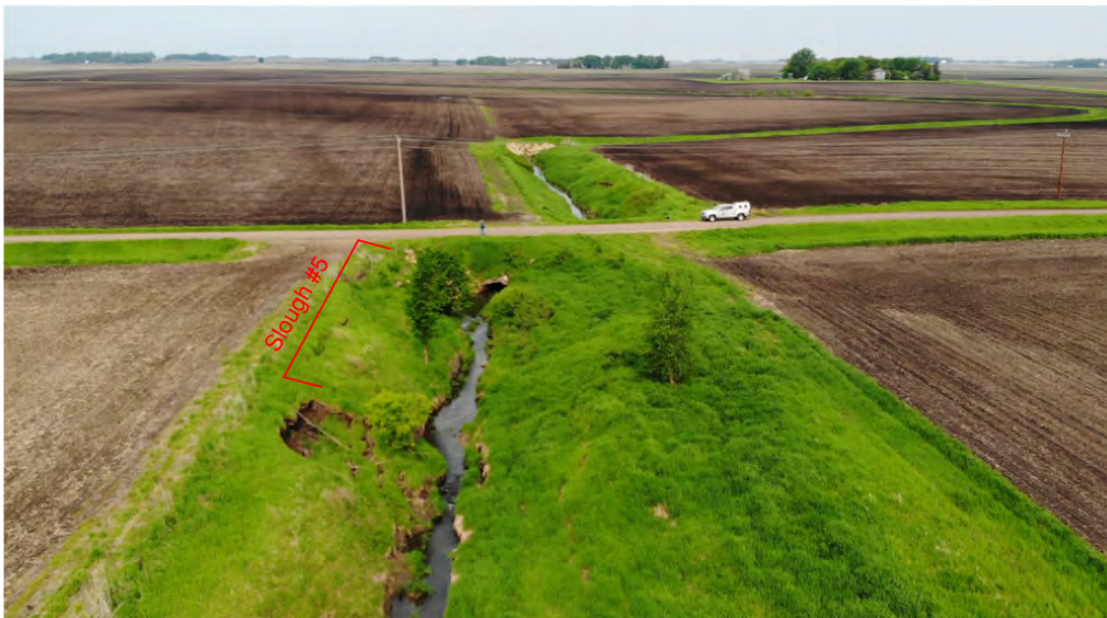
Figure 11: Slough #5 viewing upstream
