# REPAIR REPORT FOR:

## COUNTY DITCH NO. 55 REPAIR: FARIBAULT COUNTY, MINNESOTA

December, 2019

Project No. 18-22272

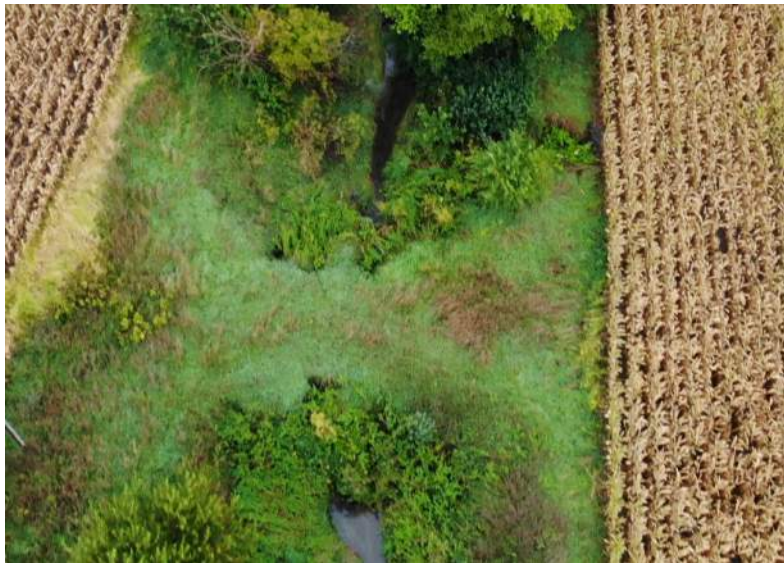
County Ditch No. 55 has a total of 9 culvert crossings. These include five road crossings and four field crossings. The crossings consist of both round culverts and box culverts. The box culverts at 480<sup>th</sup> Ave and 90<sup>th</sup> St are in good condition, but a number of the field crossings are made from corrugated metal pipe (CMP) and are in deteriorating condition. After the determination of legal grade, a few of the culverts have been determined to be above legal grade. Figure 8 shows the culvert at 90<sup>th</sup> Street (Section 20) which is over two feet above legal grade. Although Field Crossing #6 is not within the petition or proposed cleaning area, it was shown to be in poor condition and was determined to be above legal grade at the time of the drone flight in September, 2018 as seen in Figure 9.

*Figure 9. Field Crossing #6 in Section 30 of Brush Creek Township*

There are three culvert crossings recommended to be replaced as part of this repair. Culverts that are significantly above legal grade are proposed to be replaced. Culverts that are not planned to be replaced will still be addressed with maintenance items. Riprap protection will be placed on the upstream and downstream ends of the culvert to protect ditch banks from erosion such as scouring and downcutting. For culverts with accumulated sediment within, cleaning and sediment removal will take place.

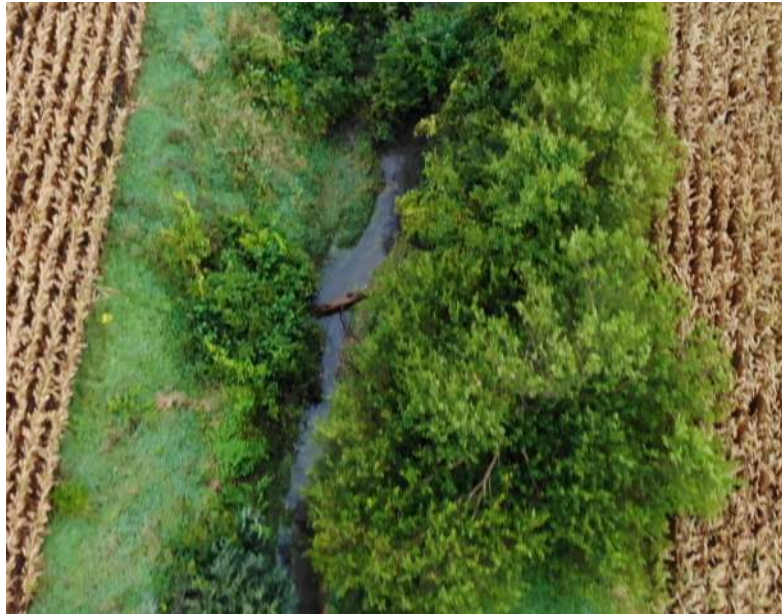
Picture #3: Fallen tree blocking ditch flow in NE  $\frac{1}{4}$  of NW  $\frac{1}{4}$  of Section 30 of Brush Creek Township

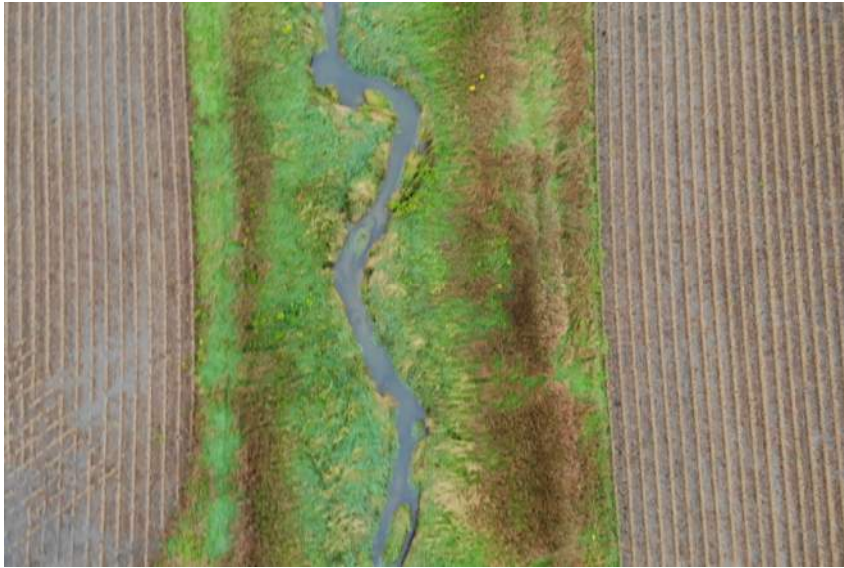
Picture #5: Meandering Channel in NW  $\frac{1}{4}$  of SW  $\frac{1}{4}$  of Section 24 of Emerald Township

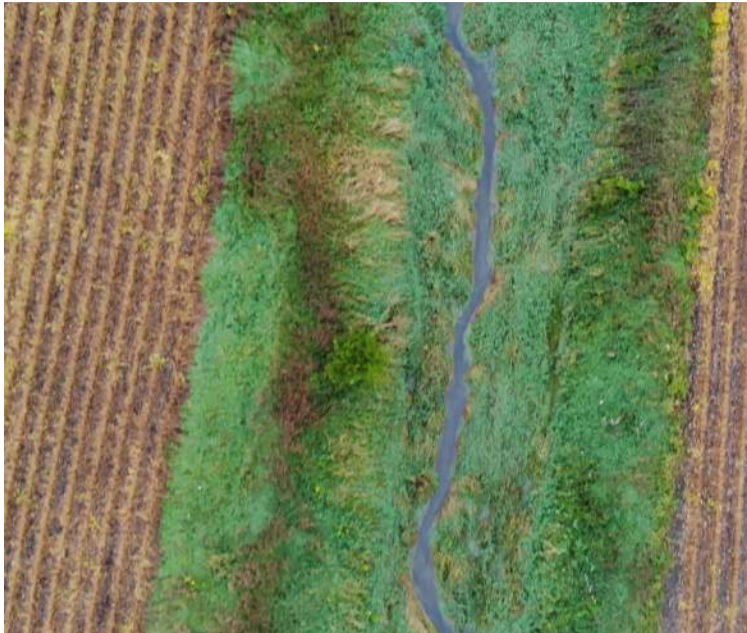
Picture #6: Natural 2-Stage Ditch Forming in SW  $\frac{1}{4}$  of SW  $\frac{1}{4}$  of Section 24 of Emerald Township

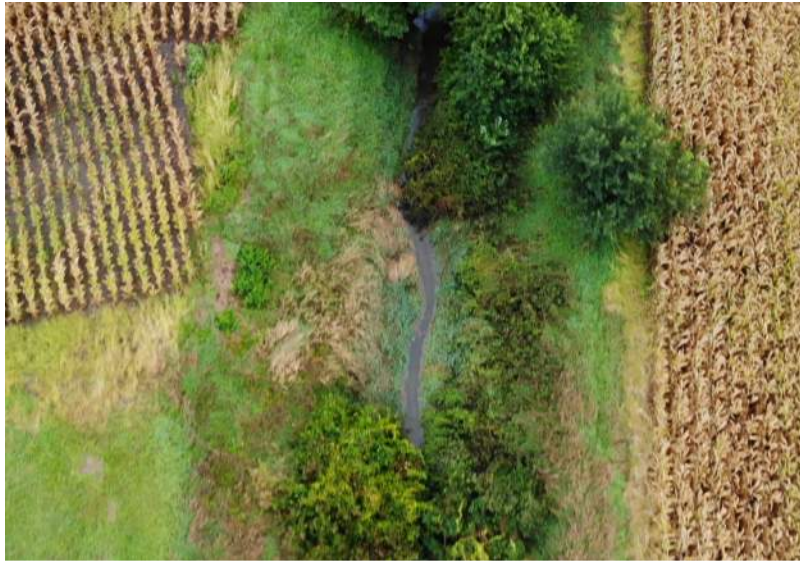
Picture #7: Heavy vegetation in ditch in NE ¼ of NW ¼ of Section 30 of Brush Creek Township

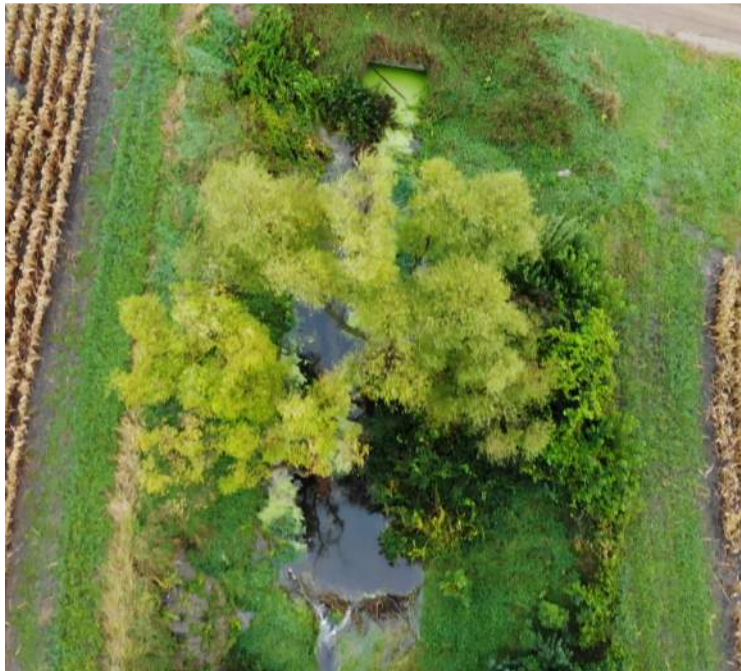
Picture #8: Beaver Dam and Culvert #7
